NONPOINT SOURCE SUCCESS STORY

Pennsylvania

Aquatic Ecosystem Restoration Efforts Manage Sediment and Improve Ecosystem Services and Functions in the Big Spring Run Watershed

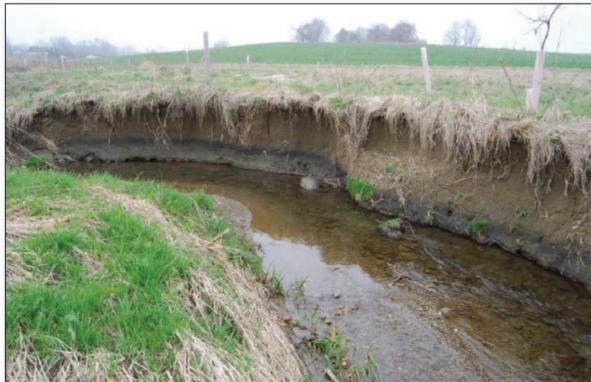
Figure 2. This area of Big Spring Run, directly downstream of the project area, represents the valley bottom conditions before restoration. The creek is cutting down through accumulated millpond mud and sending high levels of sediment downstream.

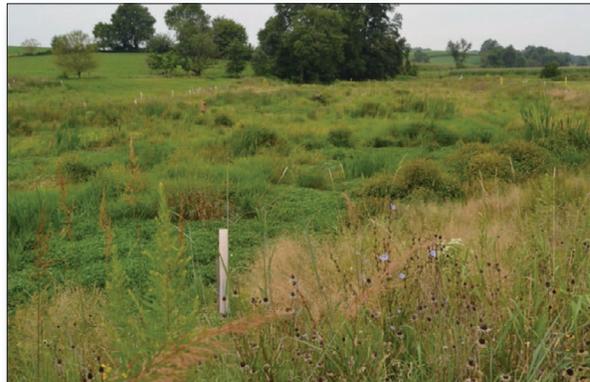
Figure 3. The project area, after restoration, shows the return of the site to its original valley bottom condition. After excavation, partners seeded the restored area with a specially designed native wetland seed mixture and added woody debris.

The exposed soils were seeded immediately after excavation with a specially designed native wetland seed mixture developed from on-site paleo-seed analyses and inference of natural plant communities. In spring 2012, additional native wetland seed mixtures were applied to the entire site to ensure development of a well-established natural wetland plant community (Figure 3).
