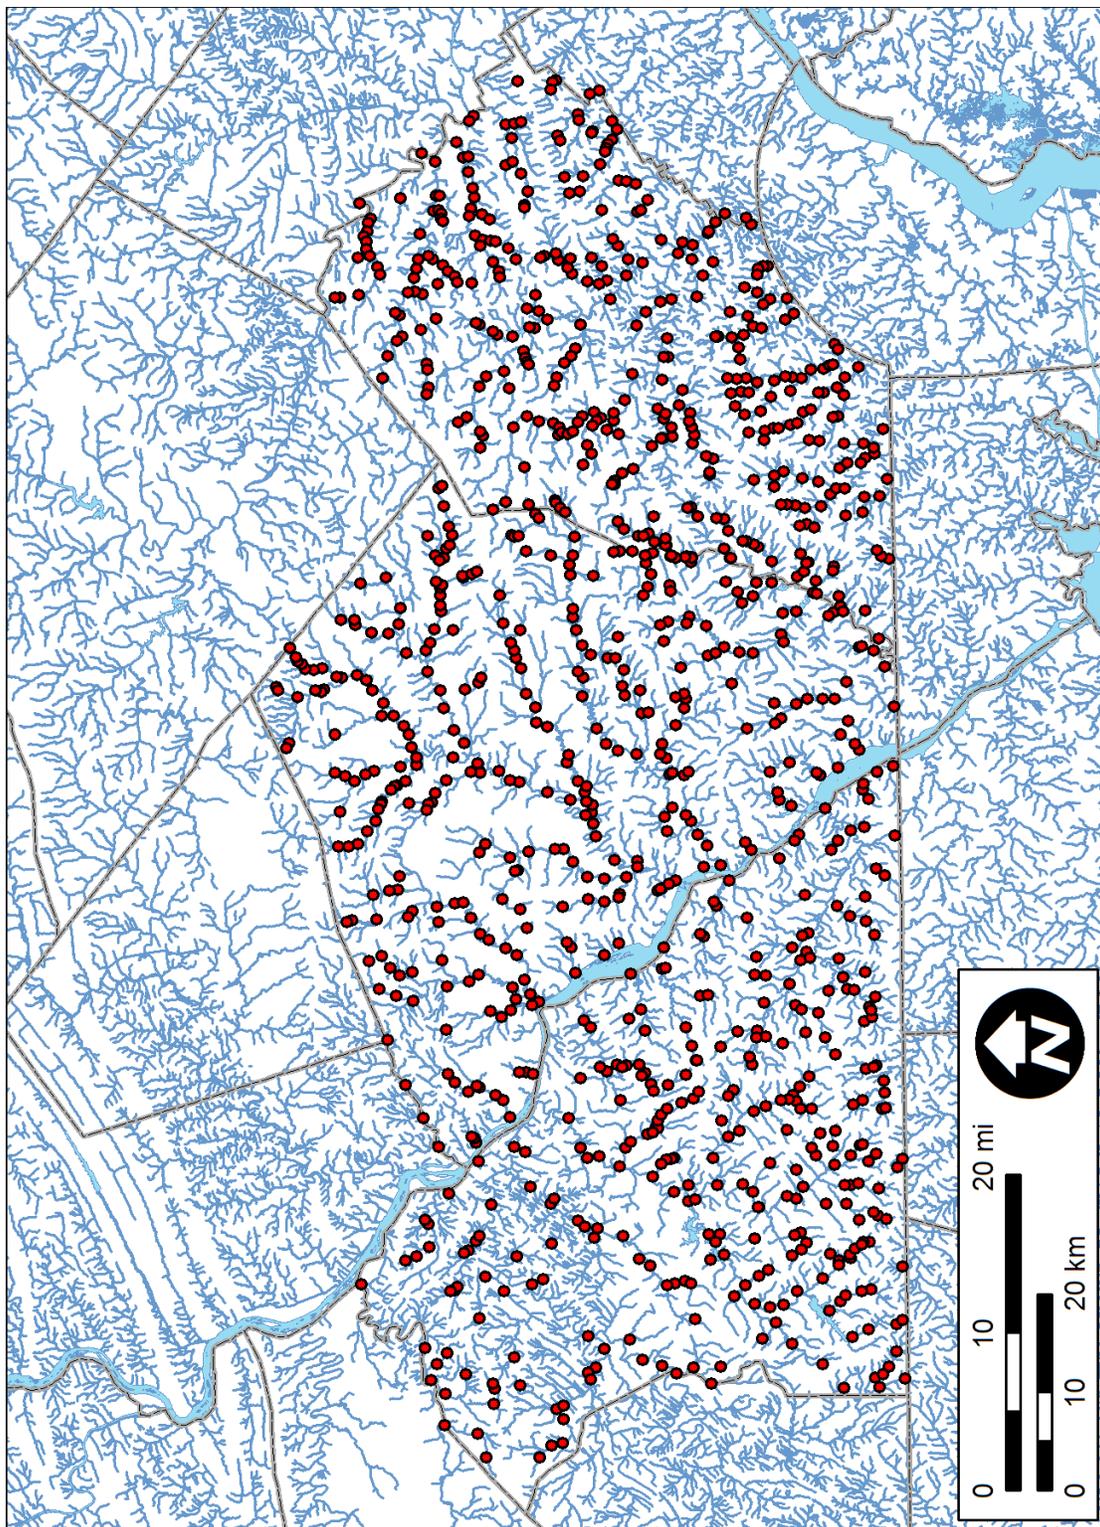
Figure 1. Milldams in York, Lancaster, and Chester Counties, southeastern Pennsylvania. Approximately 1200 milldams were located on historic mid- to late-19th century maps. Map sources: Atlas of York County, Pennsylvania (Nichols, 1876); Bridgen's Atlas of Lancaster County, Pennsylvania (Bridgens, 1864); Map of Chester County, Pennsylvania (Painter and Bowen, 1847).

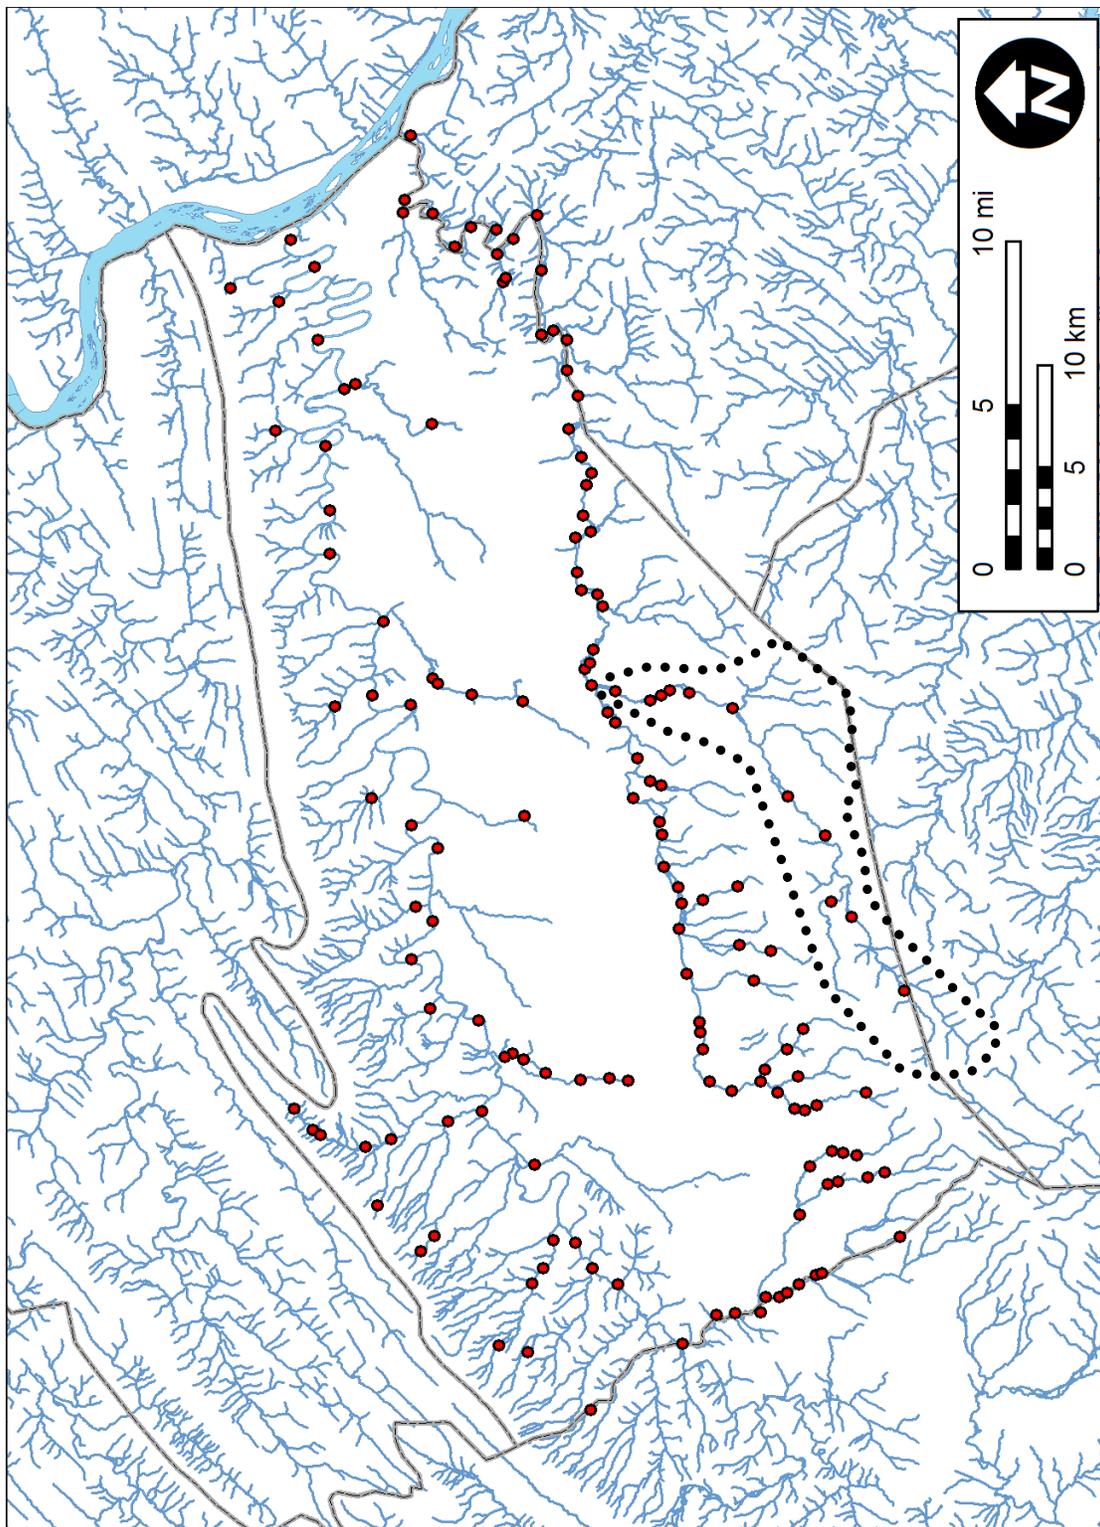
Figure 2. At least 11 milldams were located along ~15 miles of Mountain Creek (dotted outline), Cumberland County, in the mid- to late-1800s. Much of the milling on this stream was associated with iron mining, iron forge, and paper mill industries. The upstream-most of the two Mount Holly paper mill reservoirs, for which a small part of the dam was removed in 1985, is one of the case studies in this report. The Laurel Forge dam breached at least once during its history, in 1889, but was rebuilt and continues to exist as of this report. Map source: Atlas of Cumberland County, Pennsylvania (Bridgens, 1858).

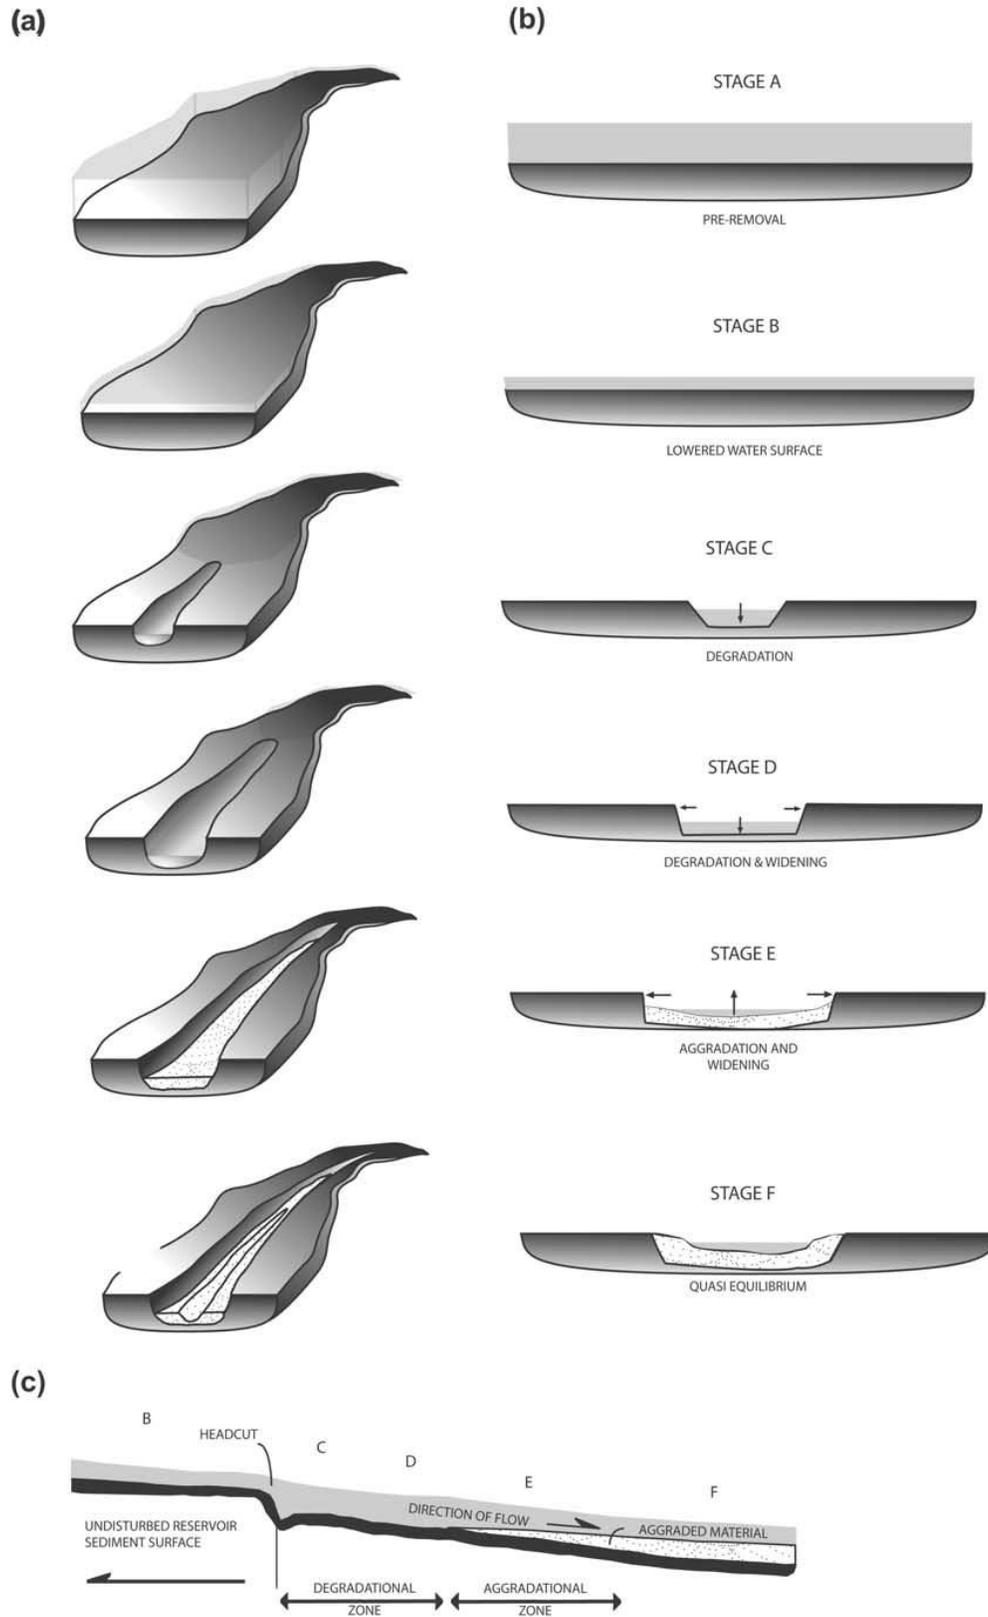
Figure 3. Conceptual model for incision and channel enlargement following dam breaching. (From Figure 12 in Doyle et al, 2003.)

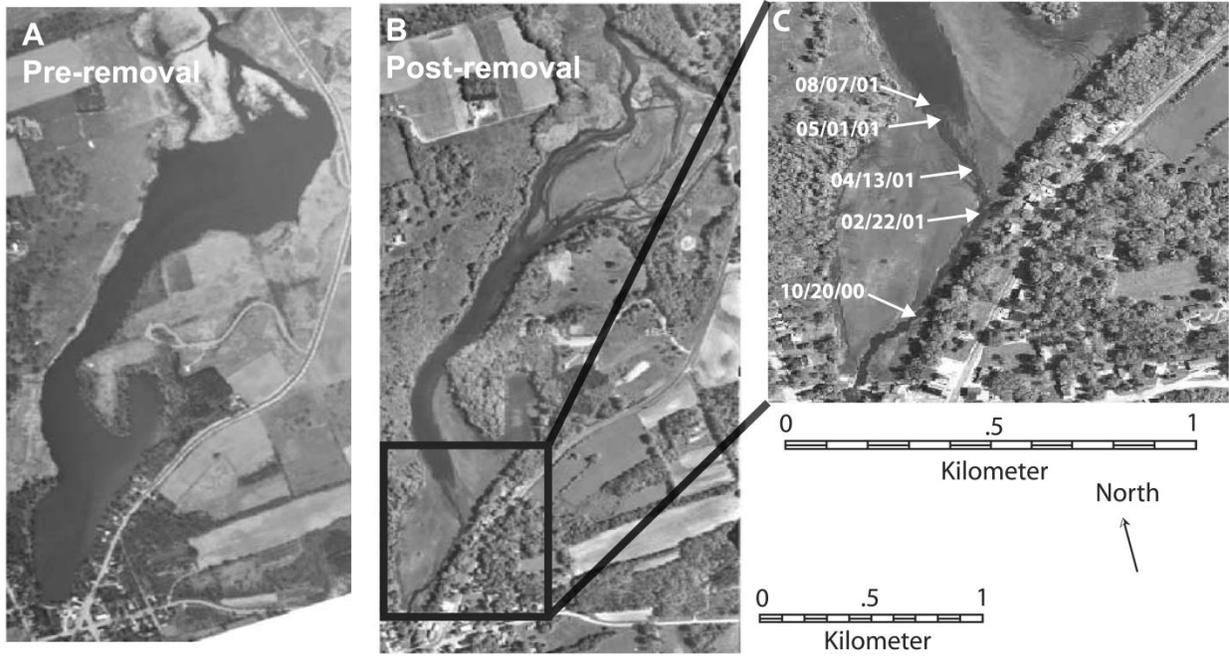
Figure 4. Rockdale reservoir on the Koshkonong River before (a) and after (b) dam removal. The inset map (c) indicates change in head-cut location over a ten month period (From Doyle et al, 2003).

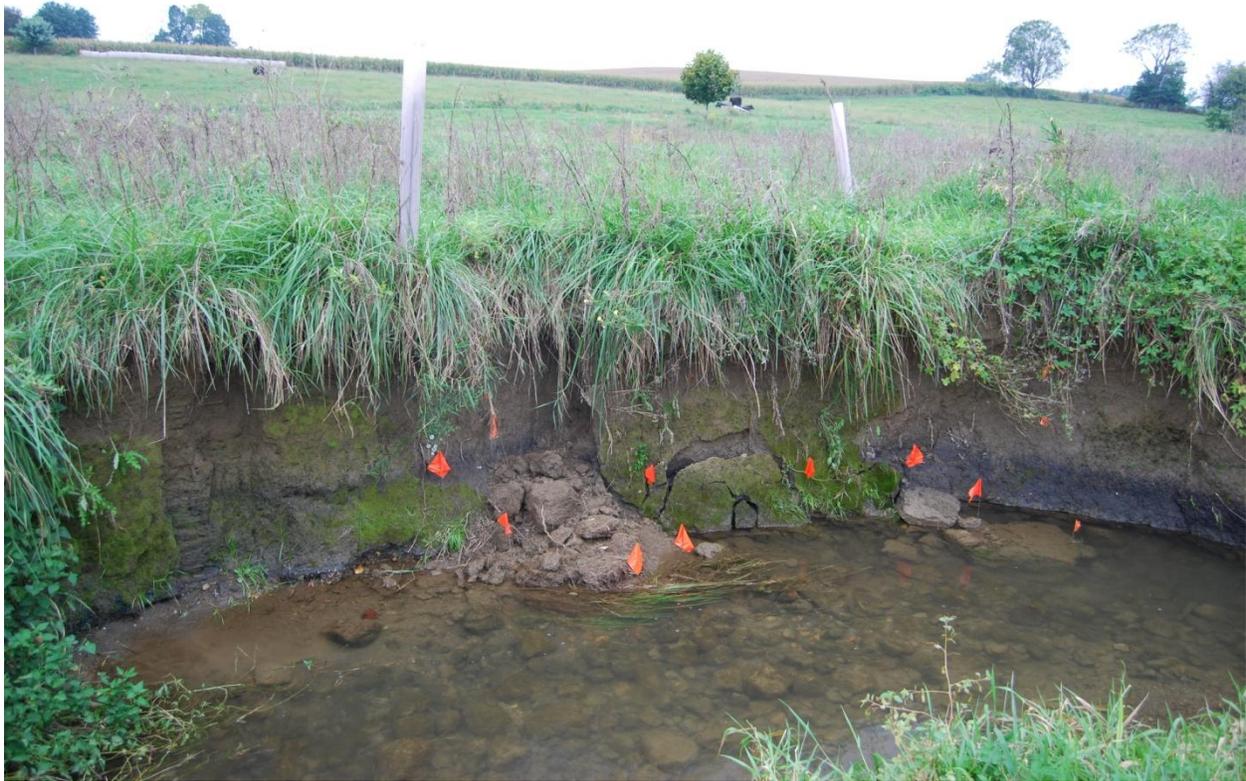
Figure 5. Examples of typical bank erosion by gravitational forces along Big Spring Run, Pennsylvania. Bank-failure along fracture planes sub-parallel to the stream bank occurred within 36 hours of the water stage dropping after a storm on August 29, 2009. This high stage event nearly reached the top of the bank, enabling much of the bank to be wetted, and was preceded by two high flows in the previous 3 weeks of August. Failure masses are marked by orange flags. One slab lies face down in the water on the far right, and a smaller slab rests behind it against the bank. The slab in the middle right slid down and is partly broken, but remains upright and rests on the bed, below water. The slab on far left slid down and disintegrated as it hit the bed, forming a pile of loose sediment. All of these failure masses were washed away during subsequent flows, most notably during a relatively long duration event that occurred in late October of 2009.

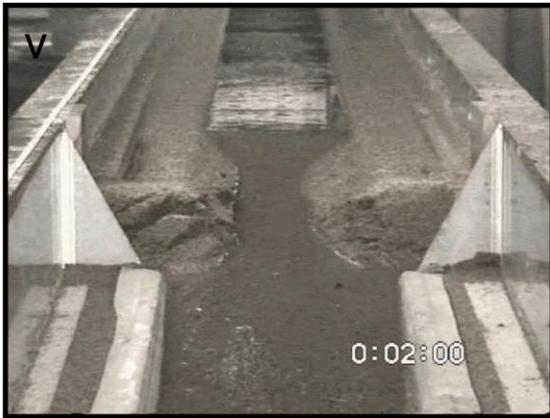
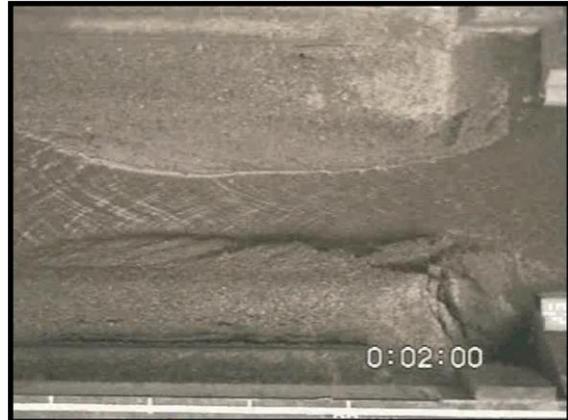
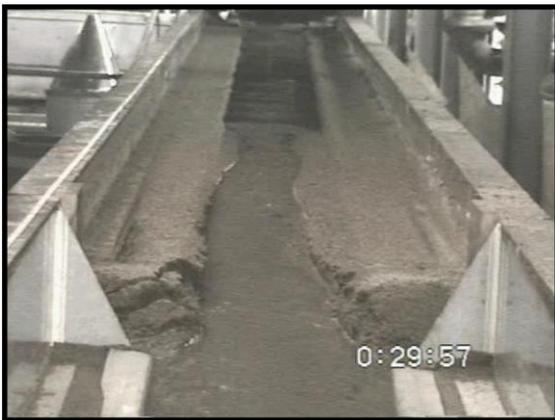
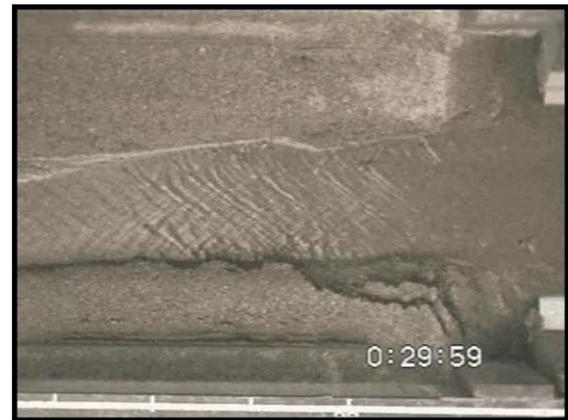
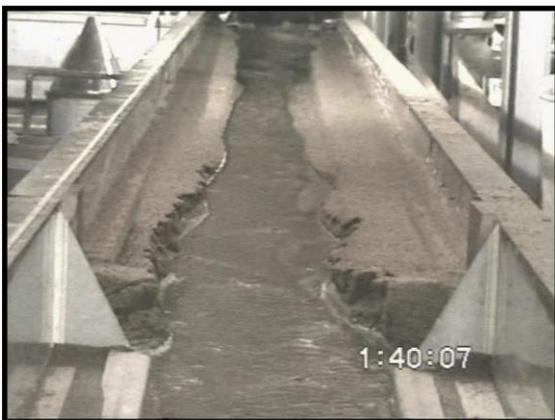
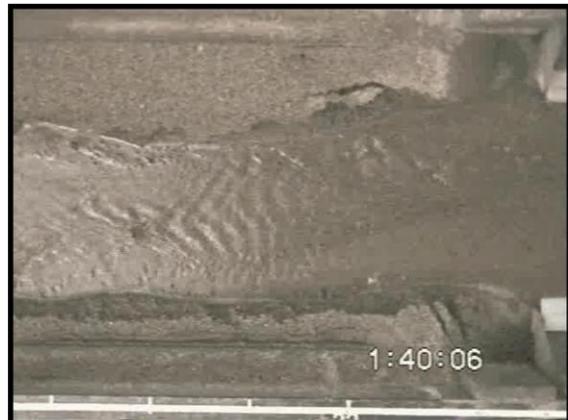
Figure 6. Still photos from video footage of a dam breach in a laboratory flume study by Cantelli et al (2004). Time stamps in the lower right corner indicate hours and minutes since dam breaching. Note that after the knickpoint propagates upstream, a short period of channel narrowing occurs as mass fails into the excavated channel area, then channel widening occurs as banks continue to erode laterally. (From Cantelli et al, 2004.)

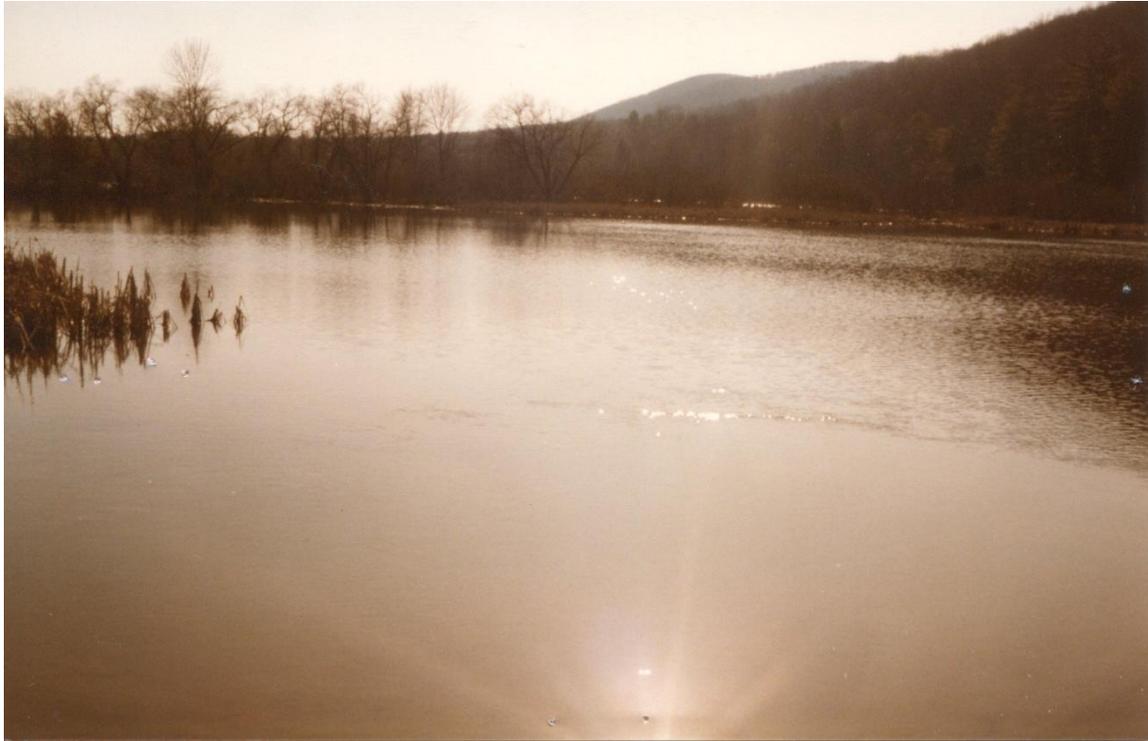
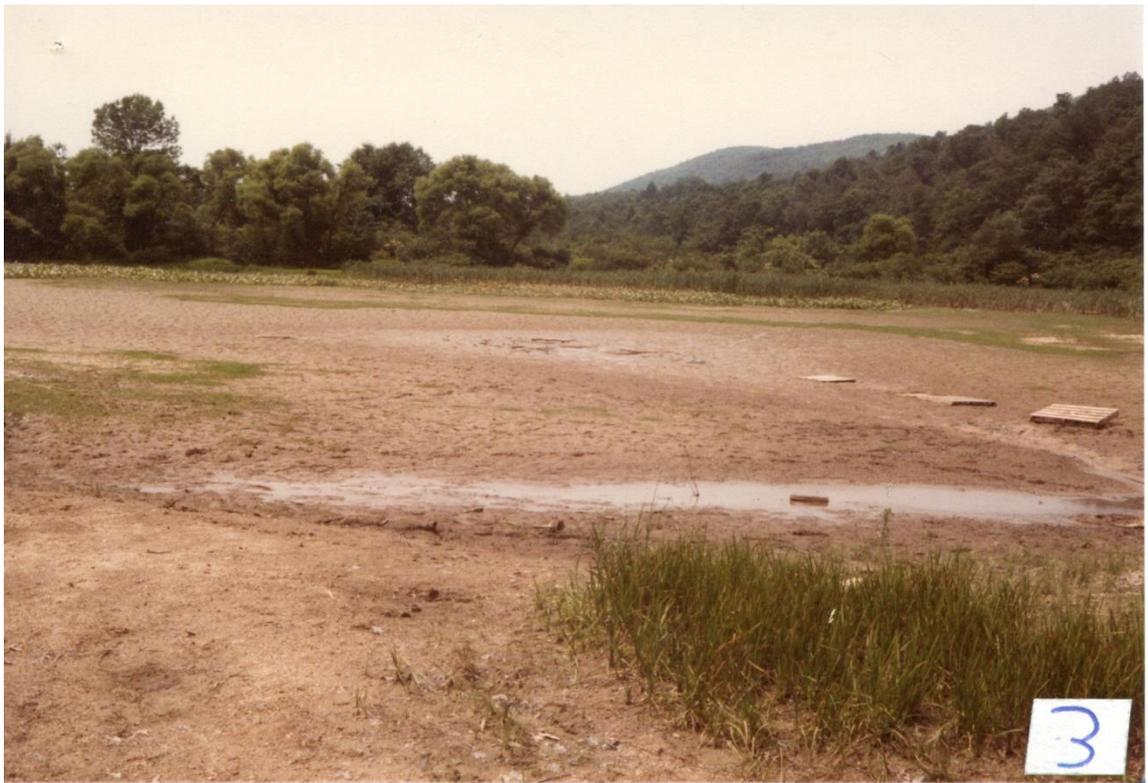
Figure 7. (a) The Eaton-Dikeman pond at upstream-most Mt Holly paper mill (see Figure 2) in March, 1964, before dam breaching in July 1985. (b) Former reservoir sediment surface exposed in March 1986, showing vegetation cover of grasses. Trees in the near distance had grown along the banks of the channel that entered the reservoir. Within a decade, trees had begun to grow across much of this surface.

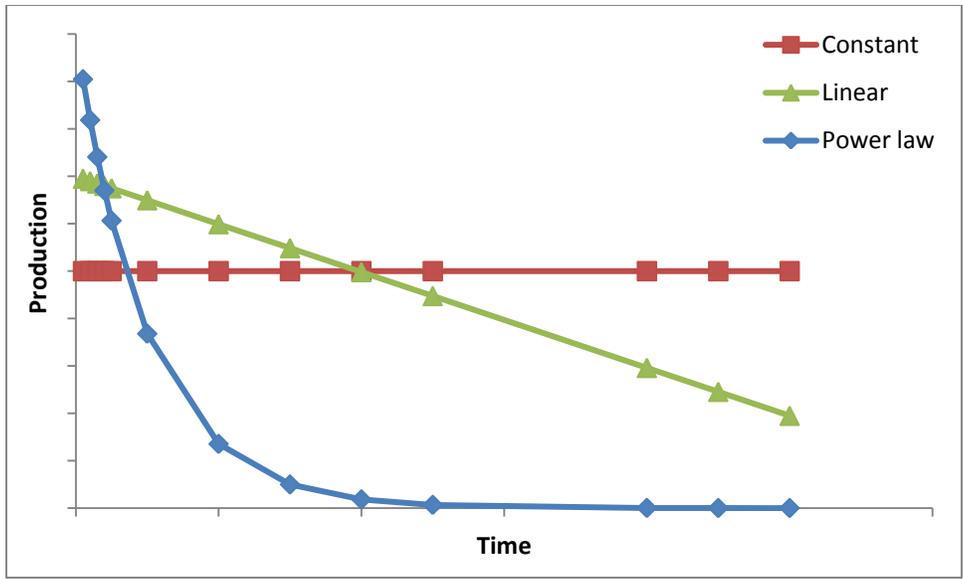
Figure 8: Schematic diagram of hypothetical trends in reservoir erosion (or sediment production from the reservoir) with time: constant, linear decrease, and power function decay.

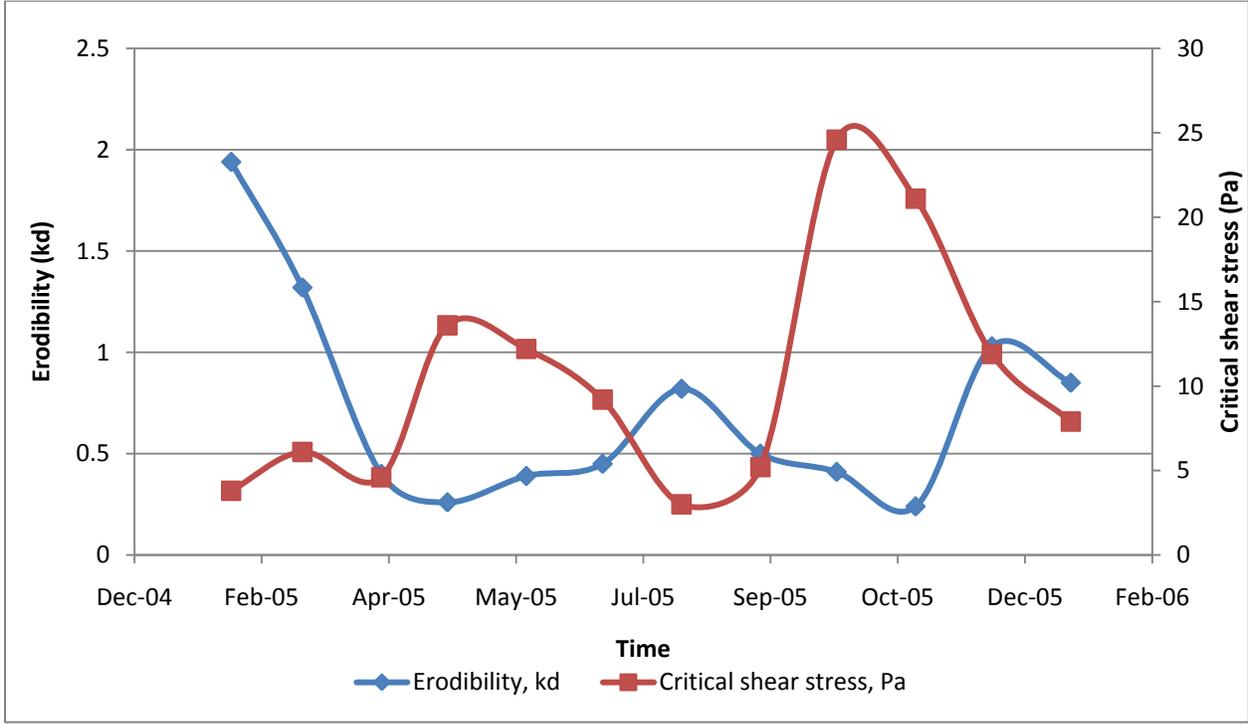
Figure 9. Data from Wynn et al (2008) are plotted here to demonstrate seasonal variation in critical shear stress and erodibility. Critical shear stress and erodibility values are from Wynn et al (2008). Note that critical shear stress is lowest and bank erodibility highest during winter months as a result of freeze thaw. These are the months when erosion rate is likely to be greatest for flow of a given magnitude.

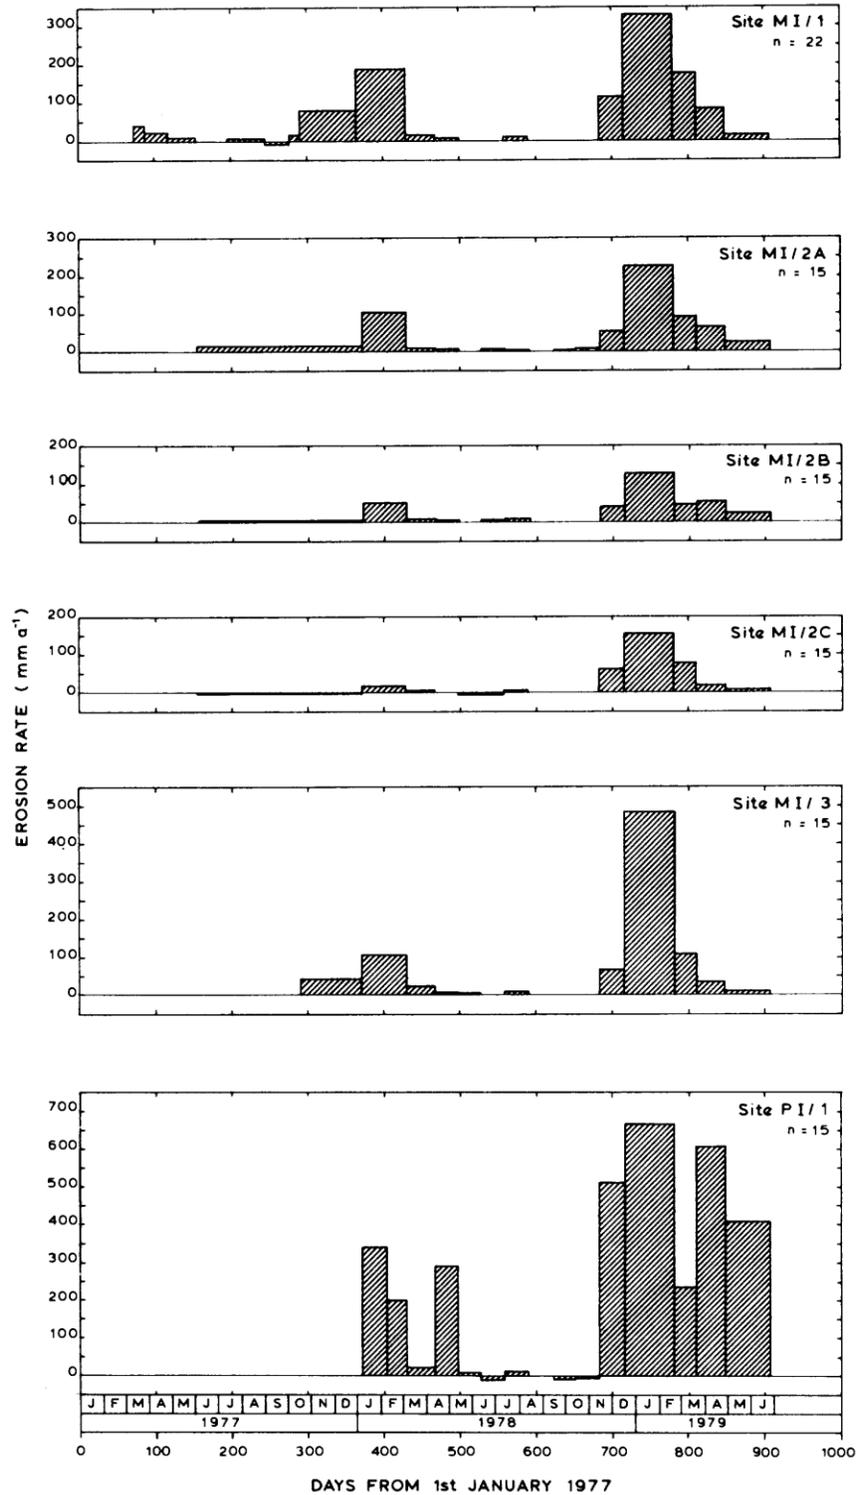
Figure 10. Average bank erosion rate measured with time for the 6 sites monitored by Lawler (1993). Each column represents a measurement interval of ~30 days. Number of measurement periods result in n = 15 or n=22. Note strong seasonality: highest erosion rates occur primarily in the winter, from December through March, but also in April, May, and June. Little to no erosion occurs in other months. (From Figure 2, Lawler, 1986).

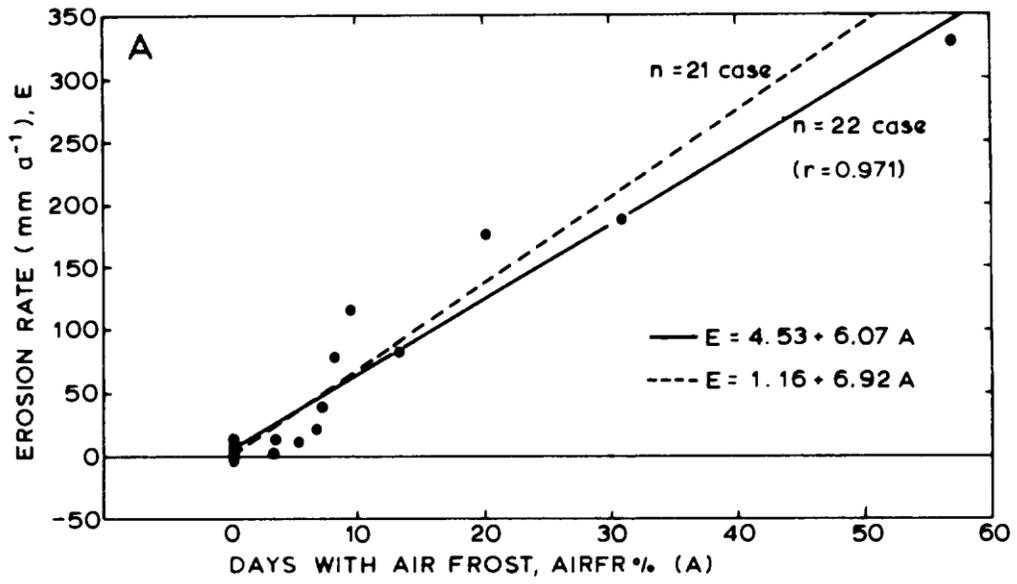
Figure 11. Relation between bank erosion rate, E, and number of days with air frost. (From Figure 3a, Lawler, 1986.)

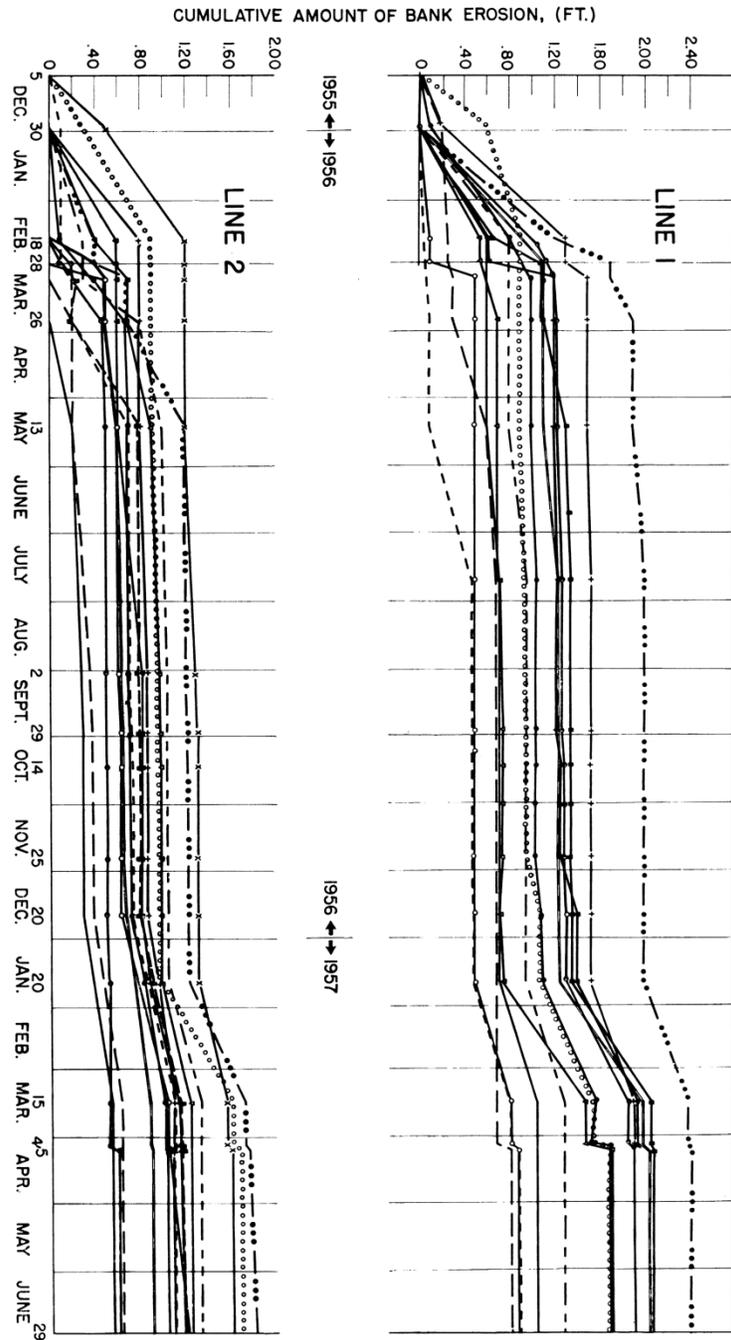
Figure 12. Points spaced about a meter apart along two lines parallel to the stream bank were monitored for bank erosion from December 1955 to June 1957 by Wolman (1959). These measurements revealed that the majority of bank erosion and retreat occurred during winter months and was associated with freeze-thaw processes. (From Figure 4, Wolman, 1959).

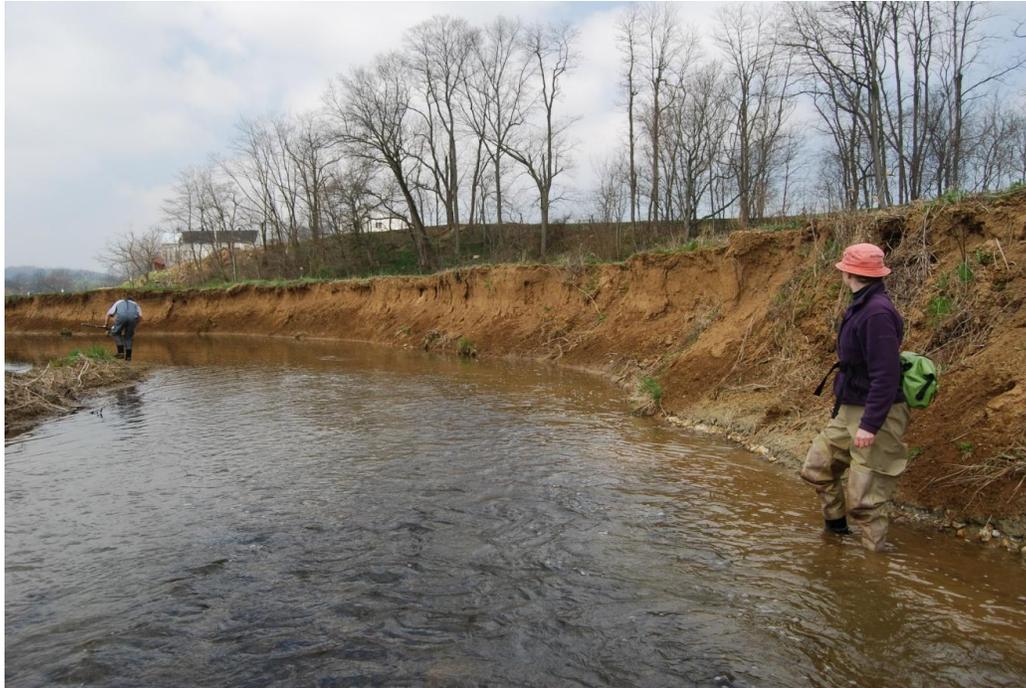
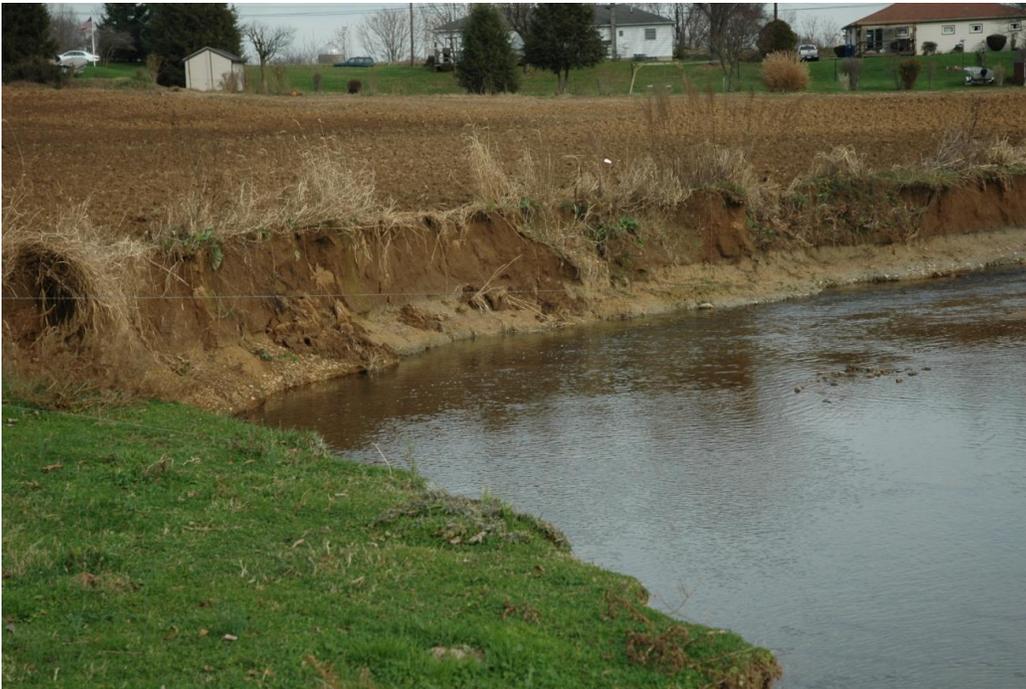
Figure 13: Photo of debris apron formed by freeze-thaw throughout the winter months along Big Beaver Creek, southern Lancaster County. (a) Photo of stream bank on April 1, 2009, with apron of debris from winter freeze-thaw cycling still in place. (b) Photo of stream bank in May, 2007, after most of the apron from the previous winter had been washed away. Dark red-brown silt, clay, and fine sand in upper two thirds of bank are historic millpond sediment. Underlying clay-rich sediment with pockets of gravel and a thin, dark soil at top is a two-dimensional view of the toe of a colluvial slope (note proximity to valley margin) formed by hillslope processes (e.g., slopewash, creep, and solifluction). The colluvial slope grades laterally to a buried wetland soil about one foot lower to the right in view. The thin wedge of colluvium and adjacent wetland formed the original valley bottom landscape prior to European settlement, milldam building, and submergence. (Photos by Dorothy Merritts and Cheryl Shenk.)

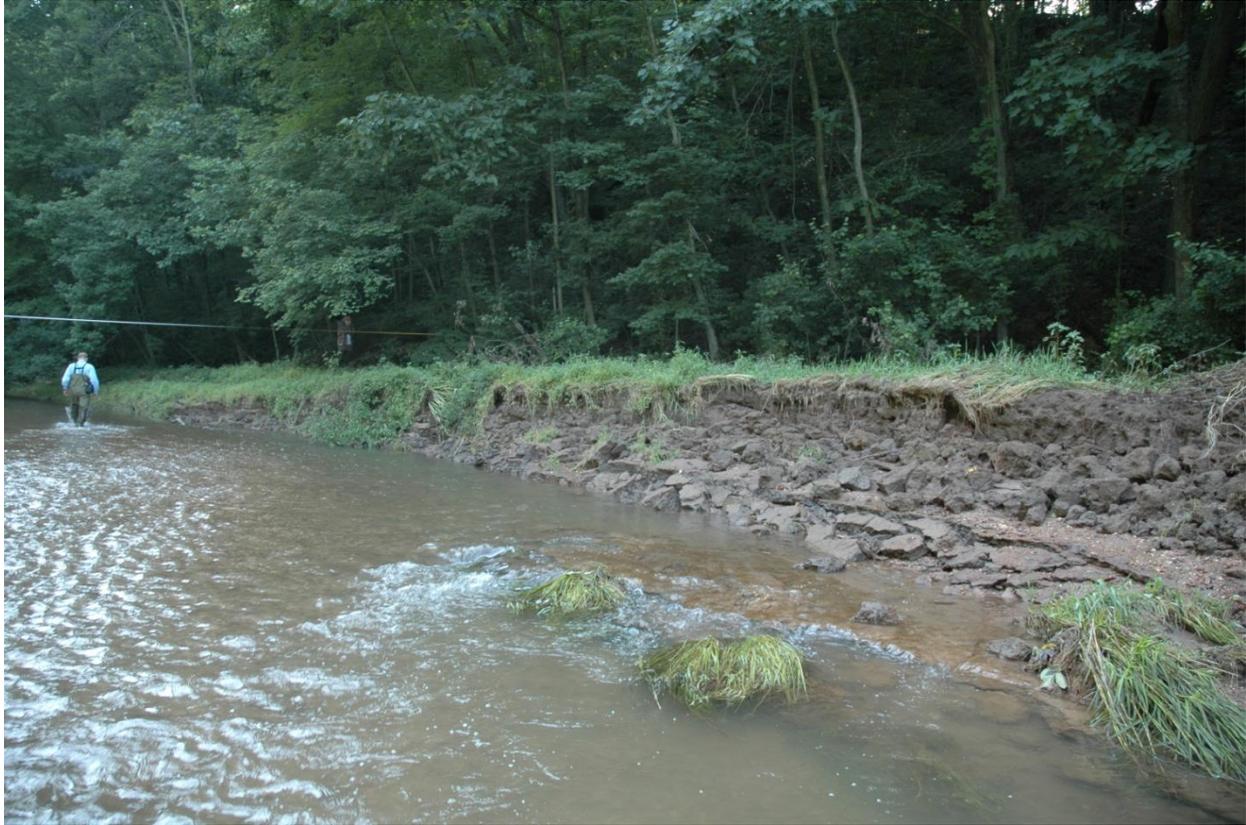
Figure 15. Bank collapse was substantial during a July storm in 2006, nearly 5 years after dam breaching in September, 2001, at Hammer Creek pump station dam (see location on Figure 14) Repeat surveys by PA DEP (Jeff Hartranft and Scott Cox) indicates that erosion rates during 2004-2007 were as high as ~20 ft/yr.

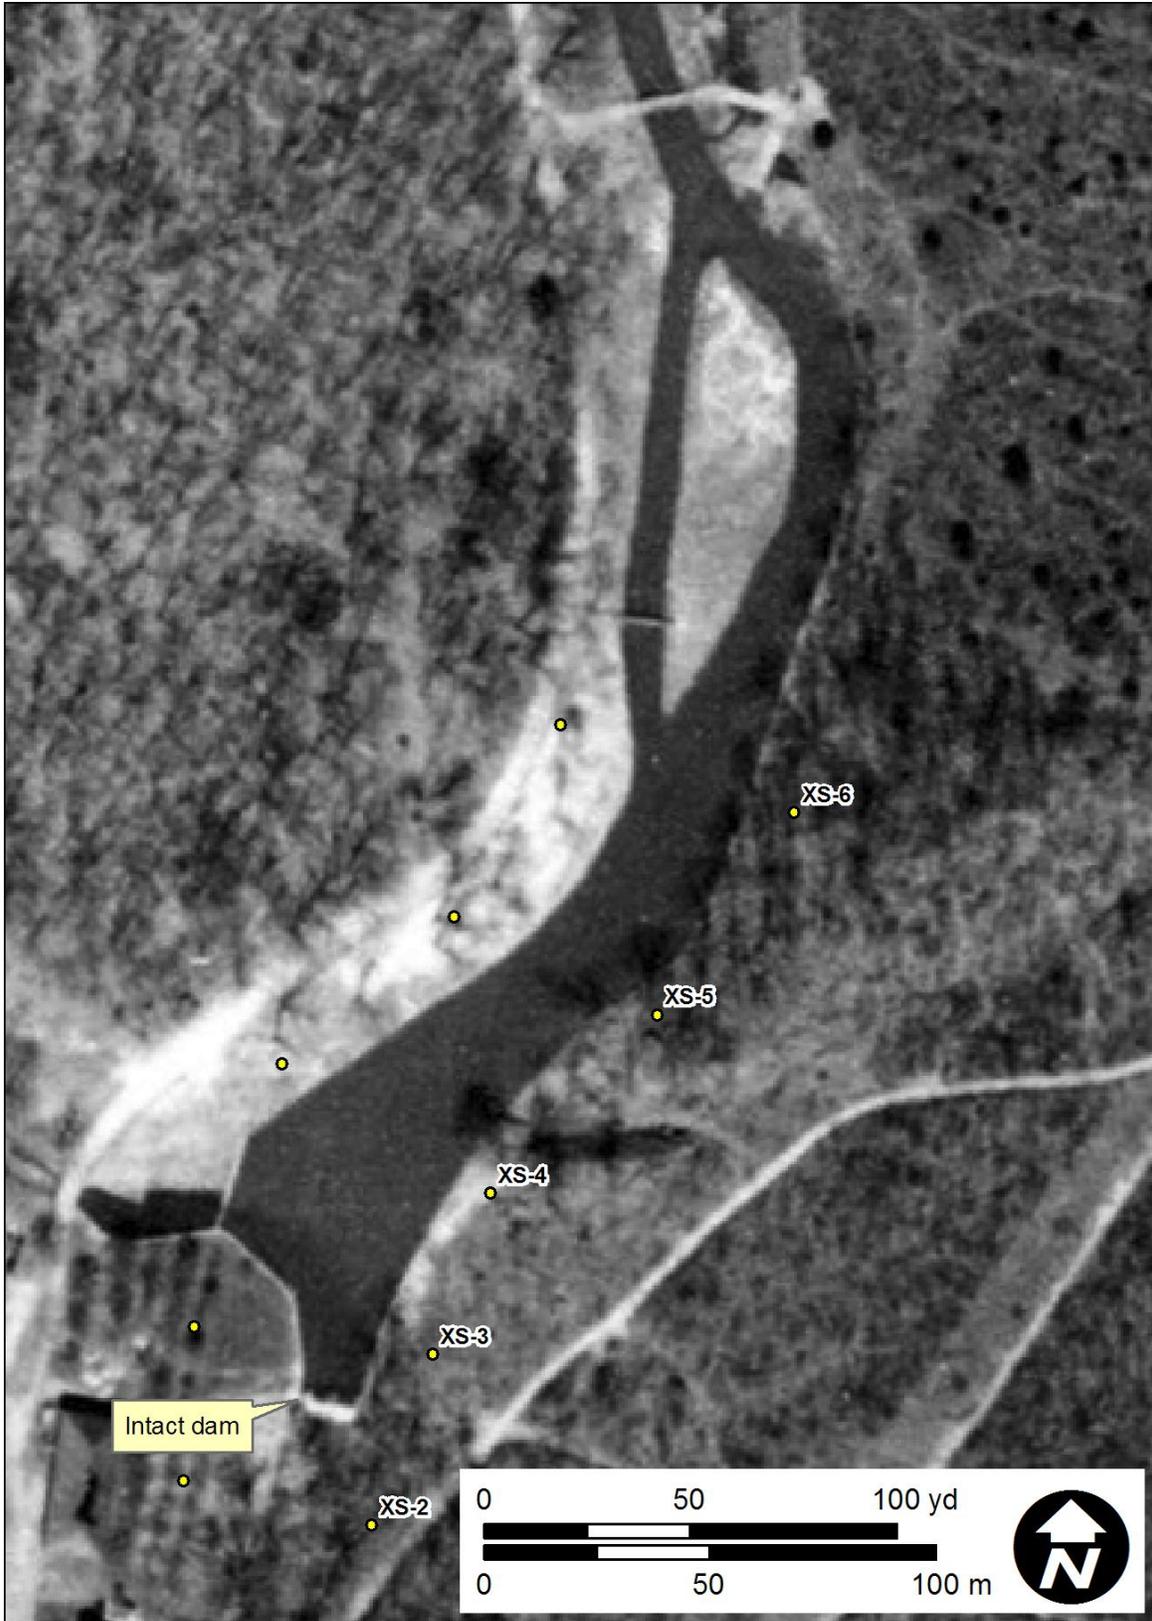
Figure 16. Hammer Creek, 1940 aerial photo with locations of dam and channel cross-section endpoints. Channel cross-sections were established in 2001, just prior to dam breaching.

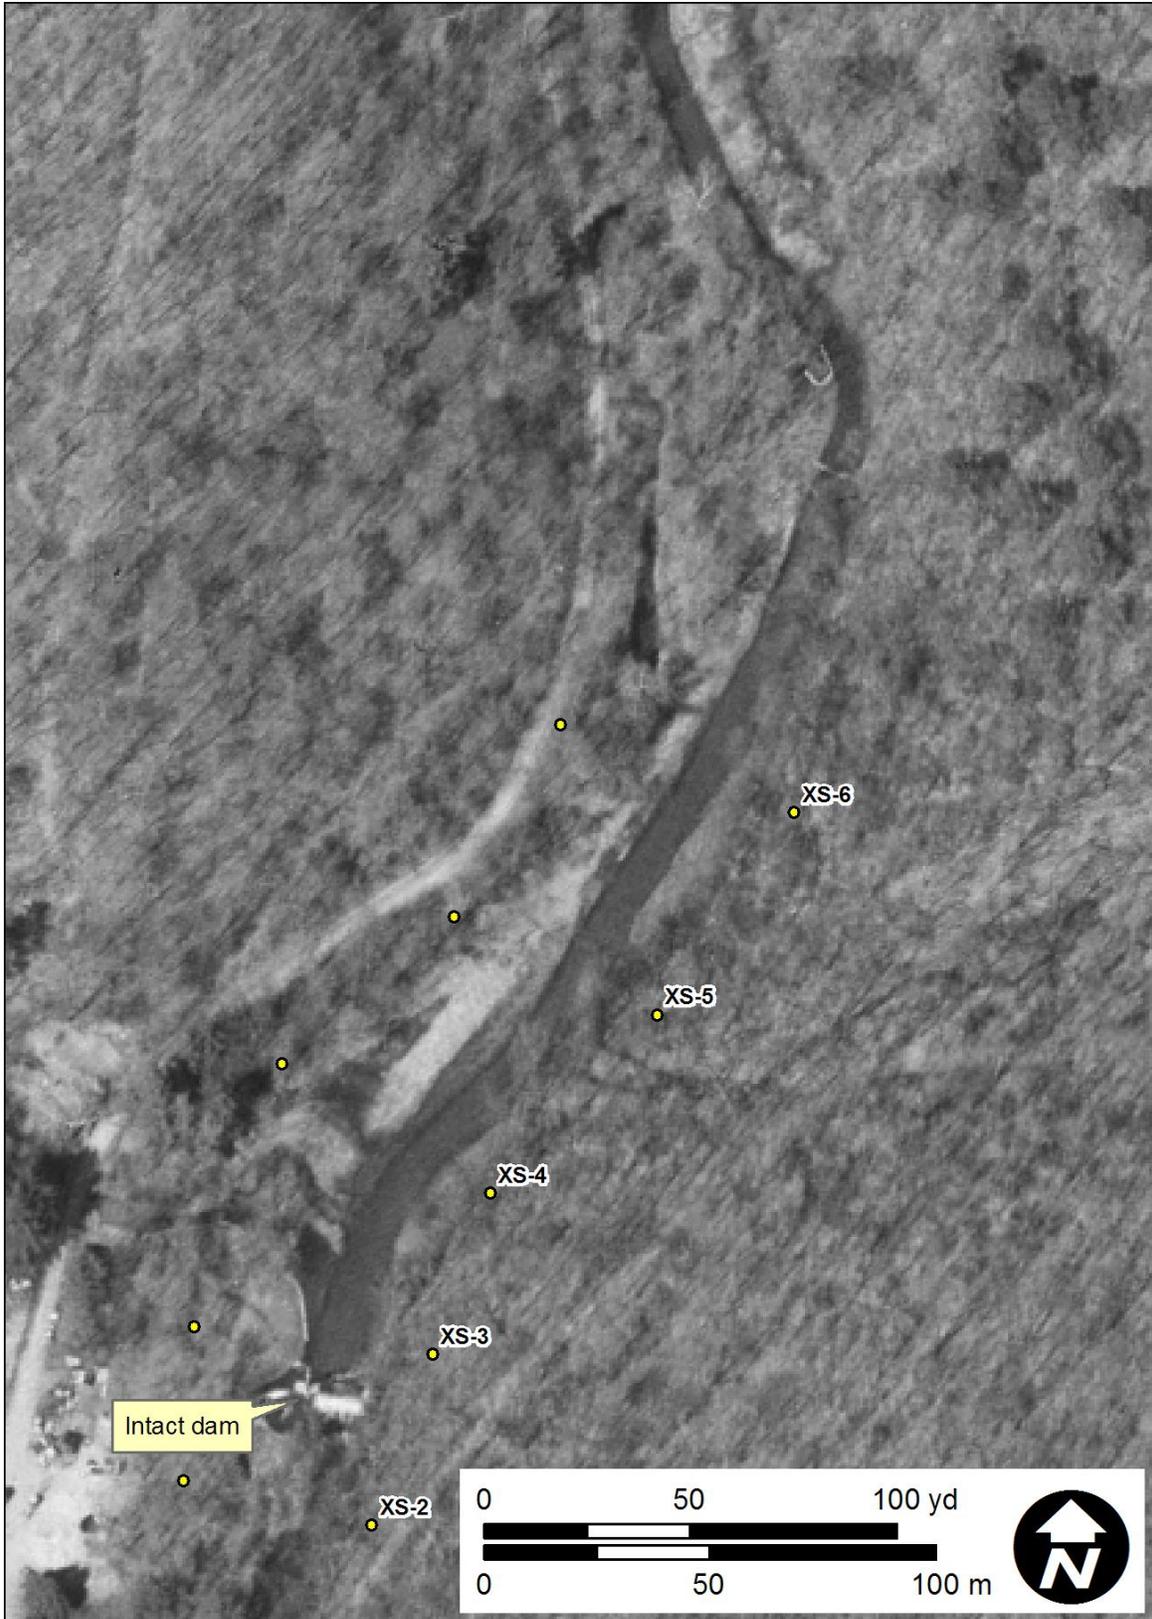
Figure 17. Hammer Creek, 1993 orthophoto with locations of dam and channel cross-section endpoints. Channel cross-sections were established in 2001, just prior to dam breaching.
