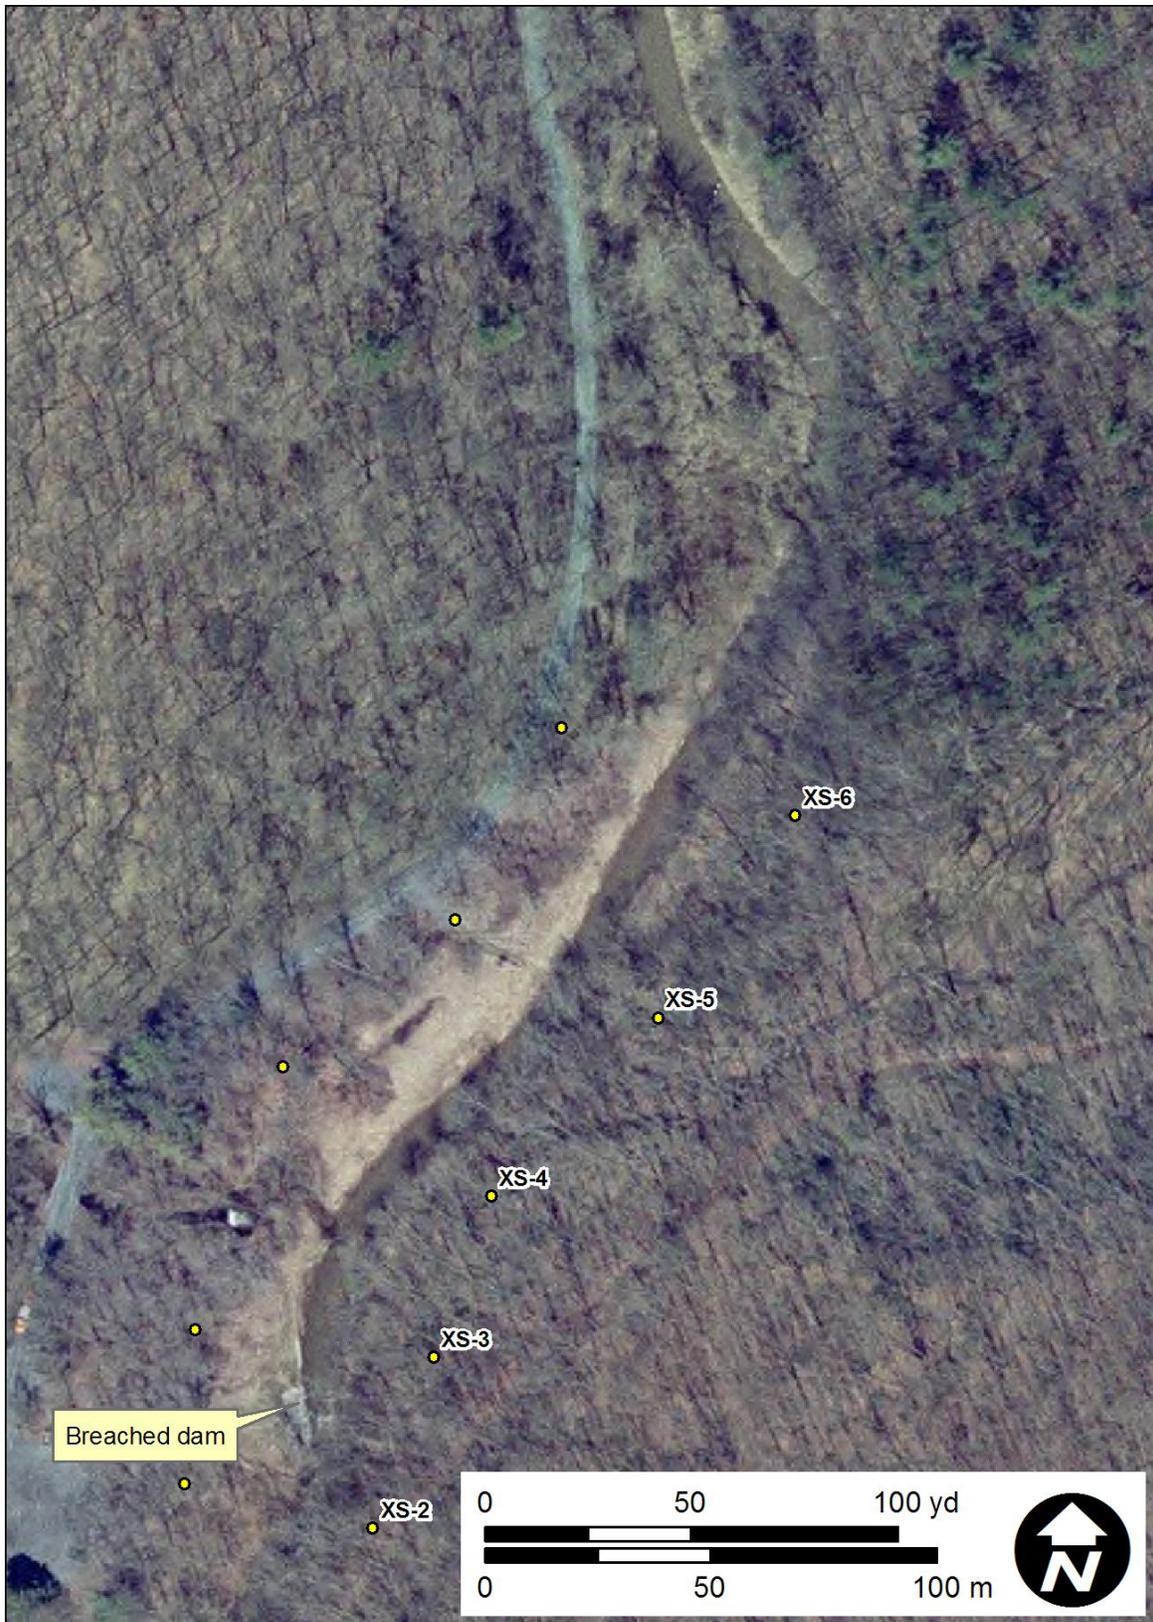
Figure 18. Hammer Creek, 2005 orthoimage with locations of dam and channel cross-section endpoints. Channel cross-sections were established in 2001, just prior to dam breaching.

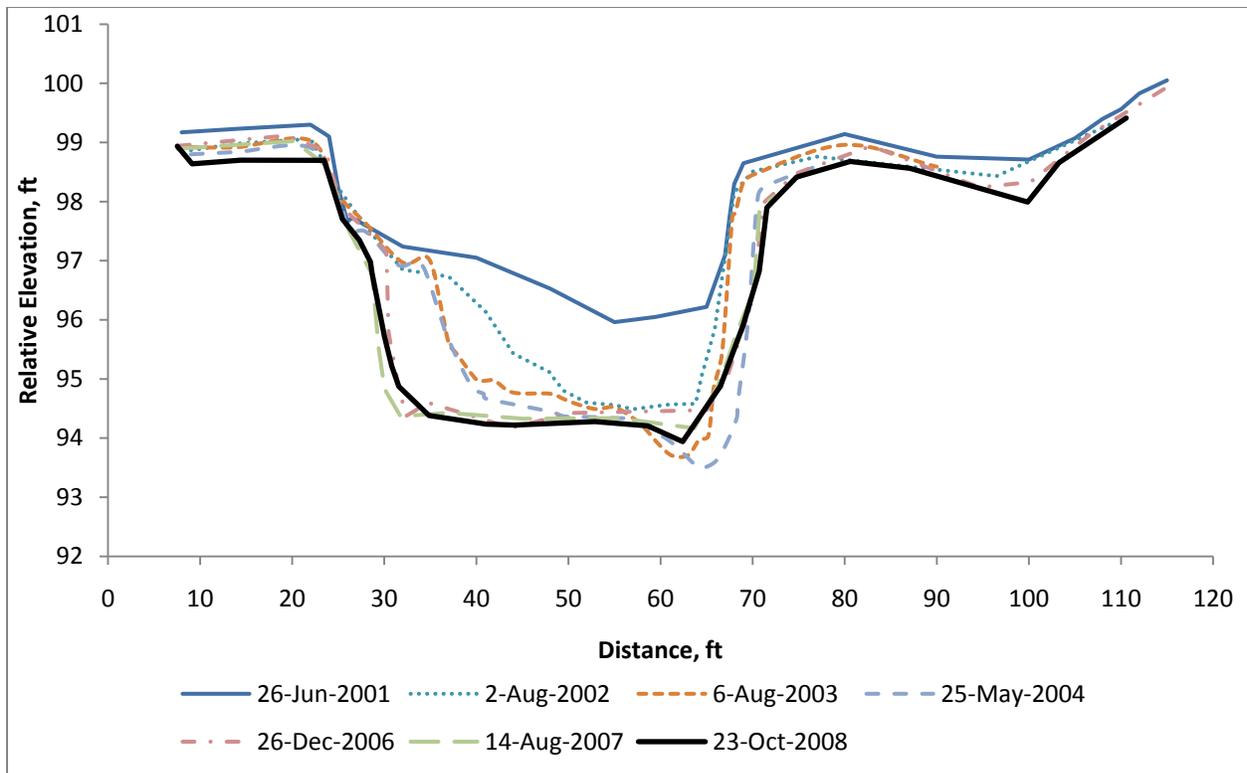
Figure 19a. Change in cross-section XS-5 at Hammer Creek from initial survey prior to dam breach (26-Jun-2001) to recent survey (23-Oct-2008).

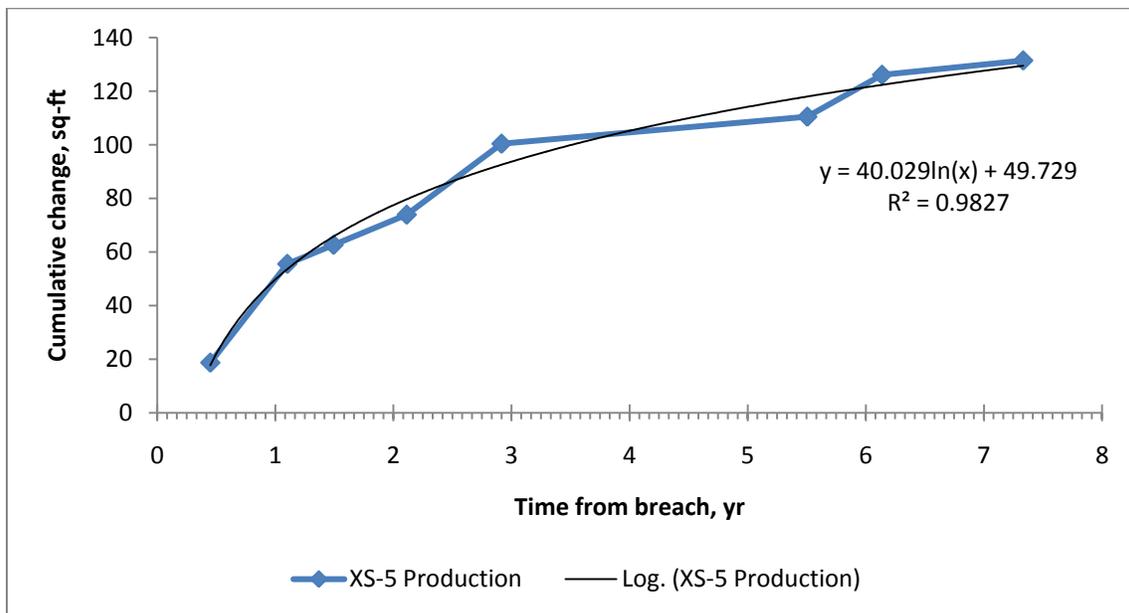
Figure 19b. Cumulative production from cross-section XS-5 closely resembles a function of the natural logarithm of the time elapsed since dam breach. In this case, sediment production is presented as raw data in the form of square feet of area removed from the cross section over time, not as normalized production with respect to bank height and channel length.

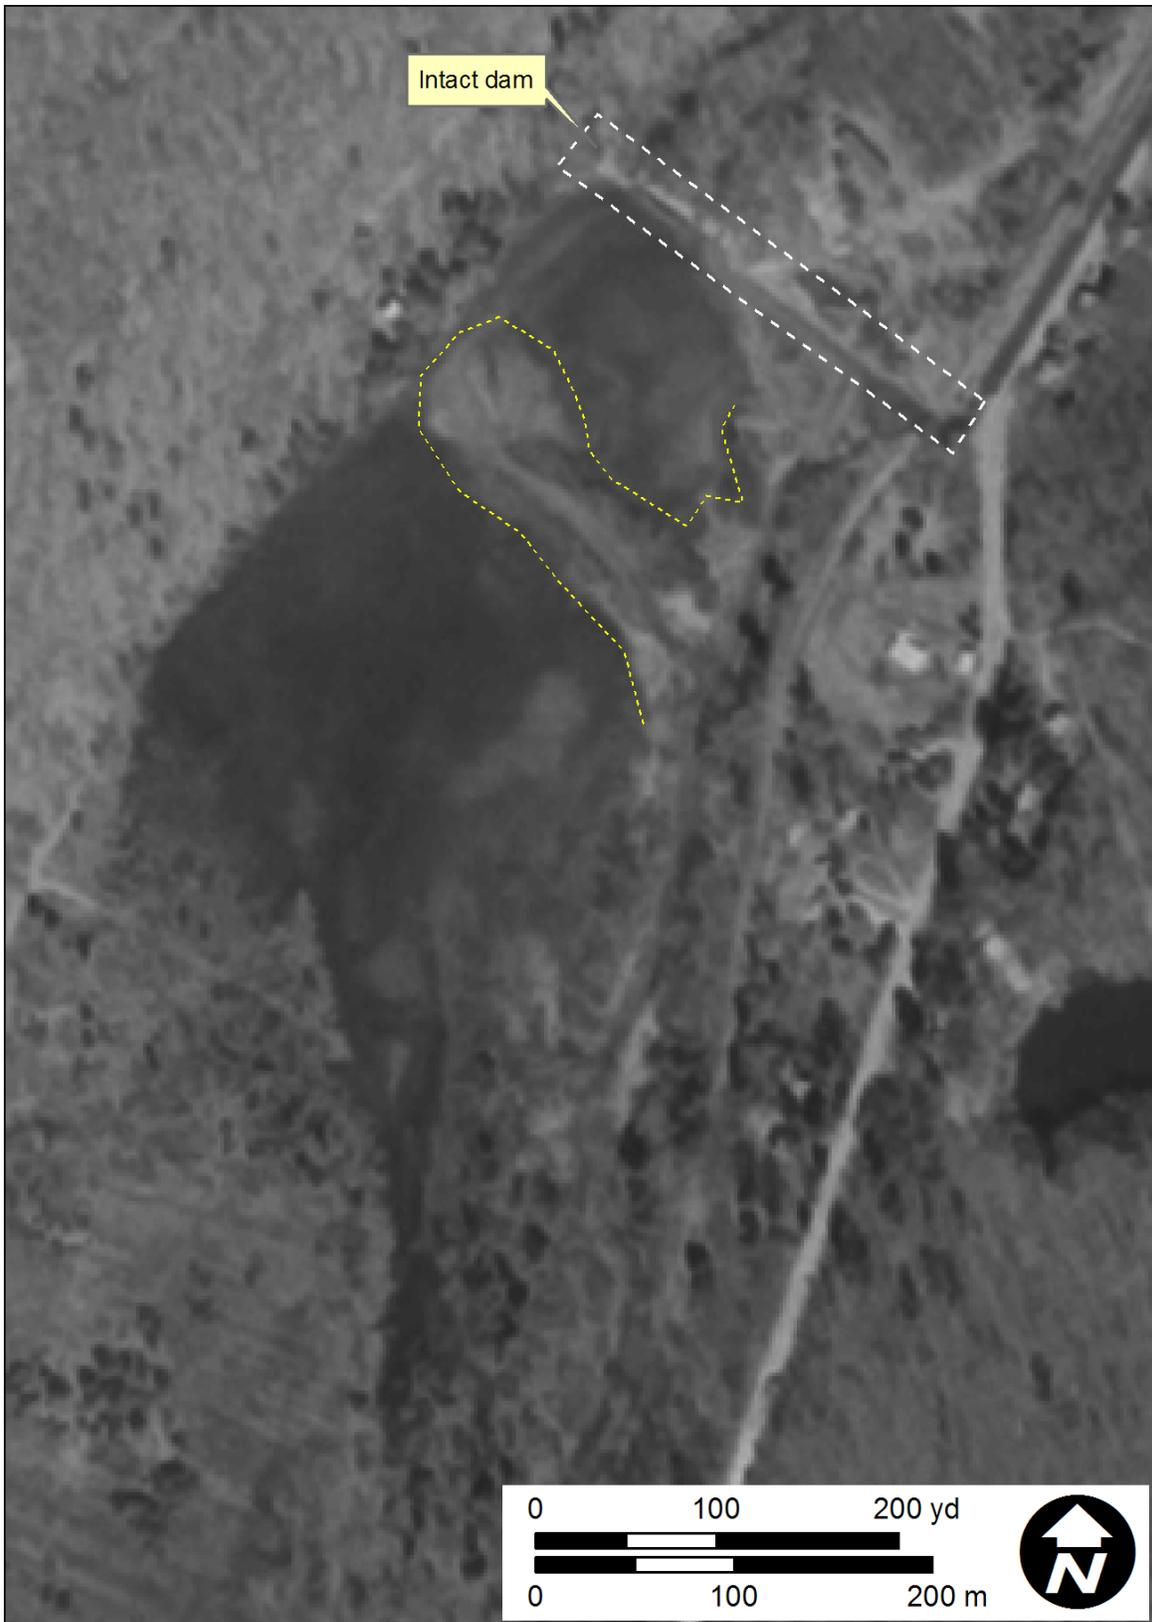
Figure 20. Mountain Creek, 1968 aerial photo. The Eaton-Dikeman Paper Mill pond was shallow with a delta (outlined in yellow) building into the pond center. The 700 foot-long dam is clearly visible and spans the valley of Mountain Creek.

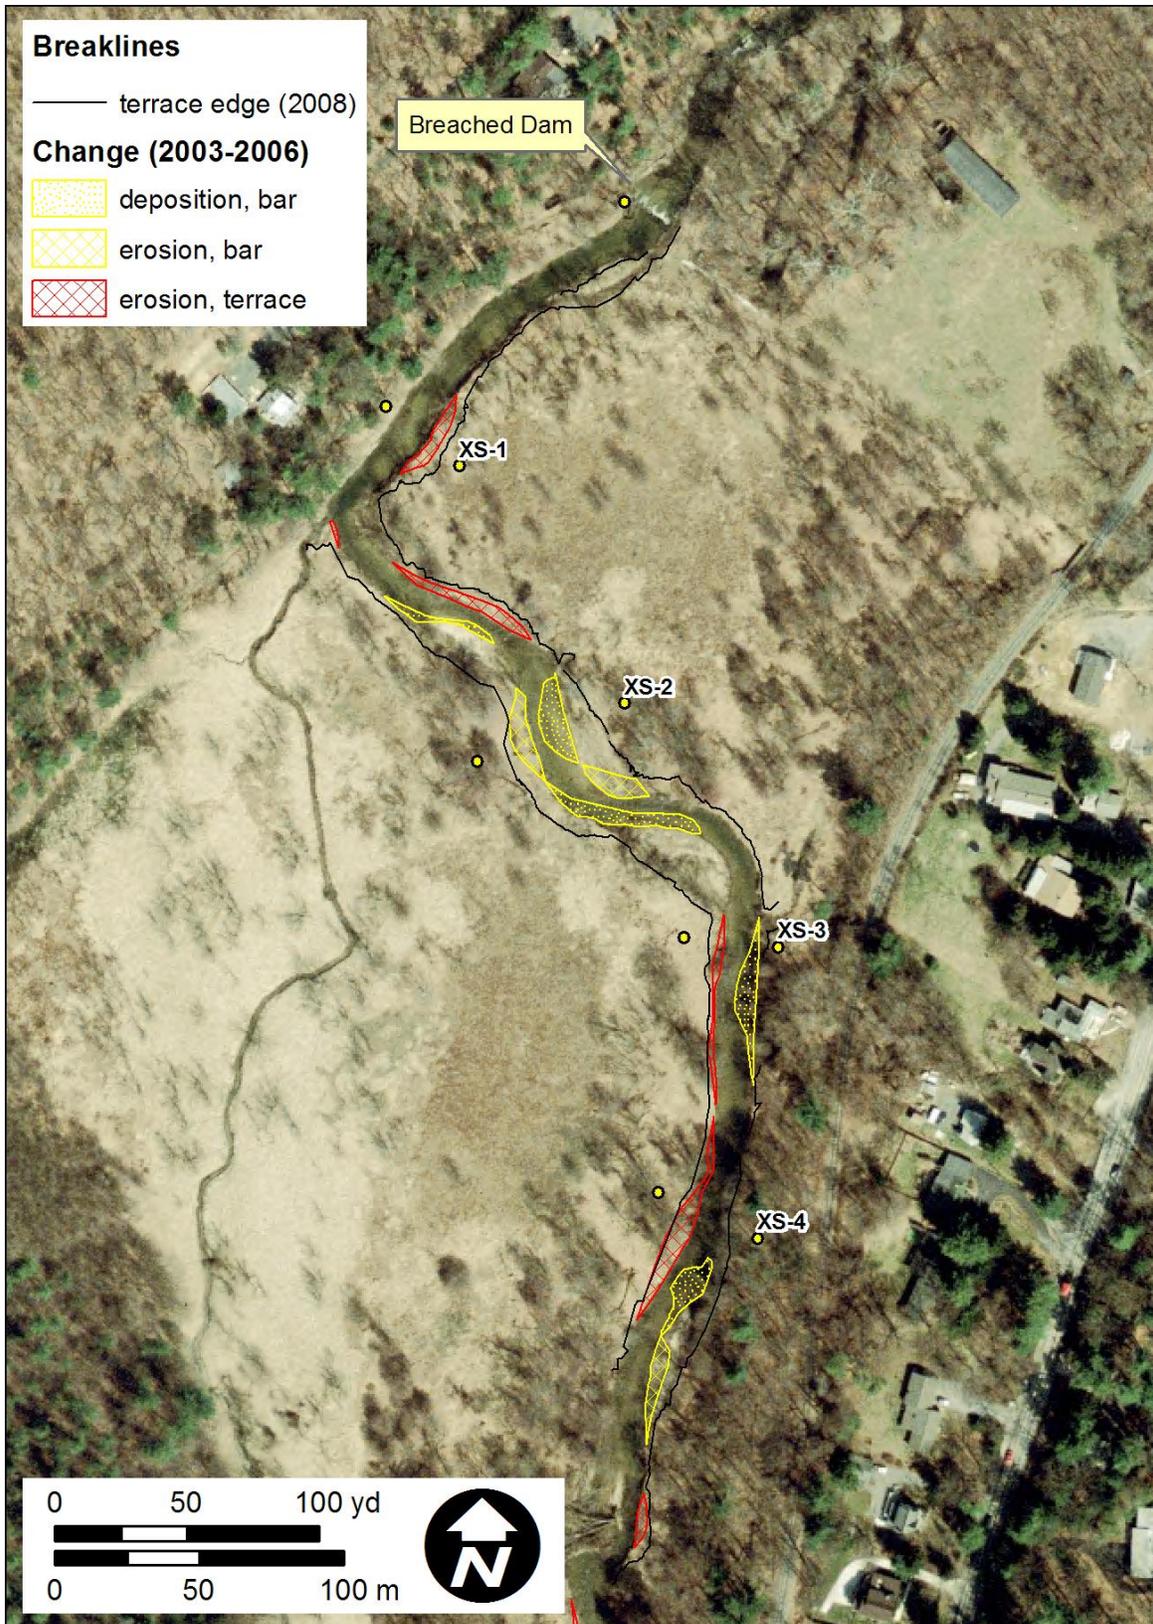
Figure 21. Mountain Creek, 2003 orthoimage, overlain with changed areas digitized by comparison of 2003 and 2006 orthoimages. Solid black lines represent terrace edge breaklines surveyed in 2008.

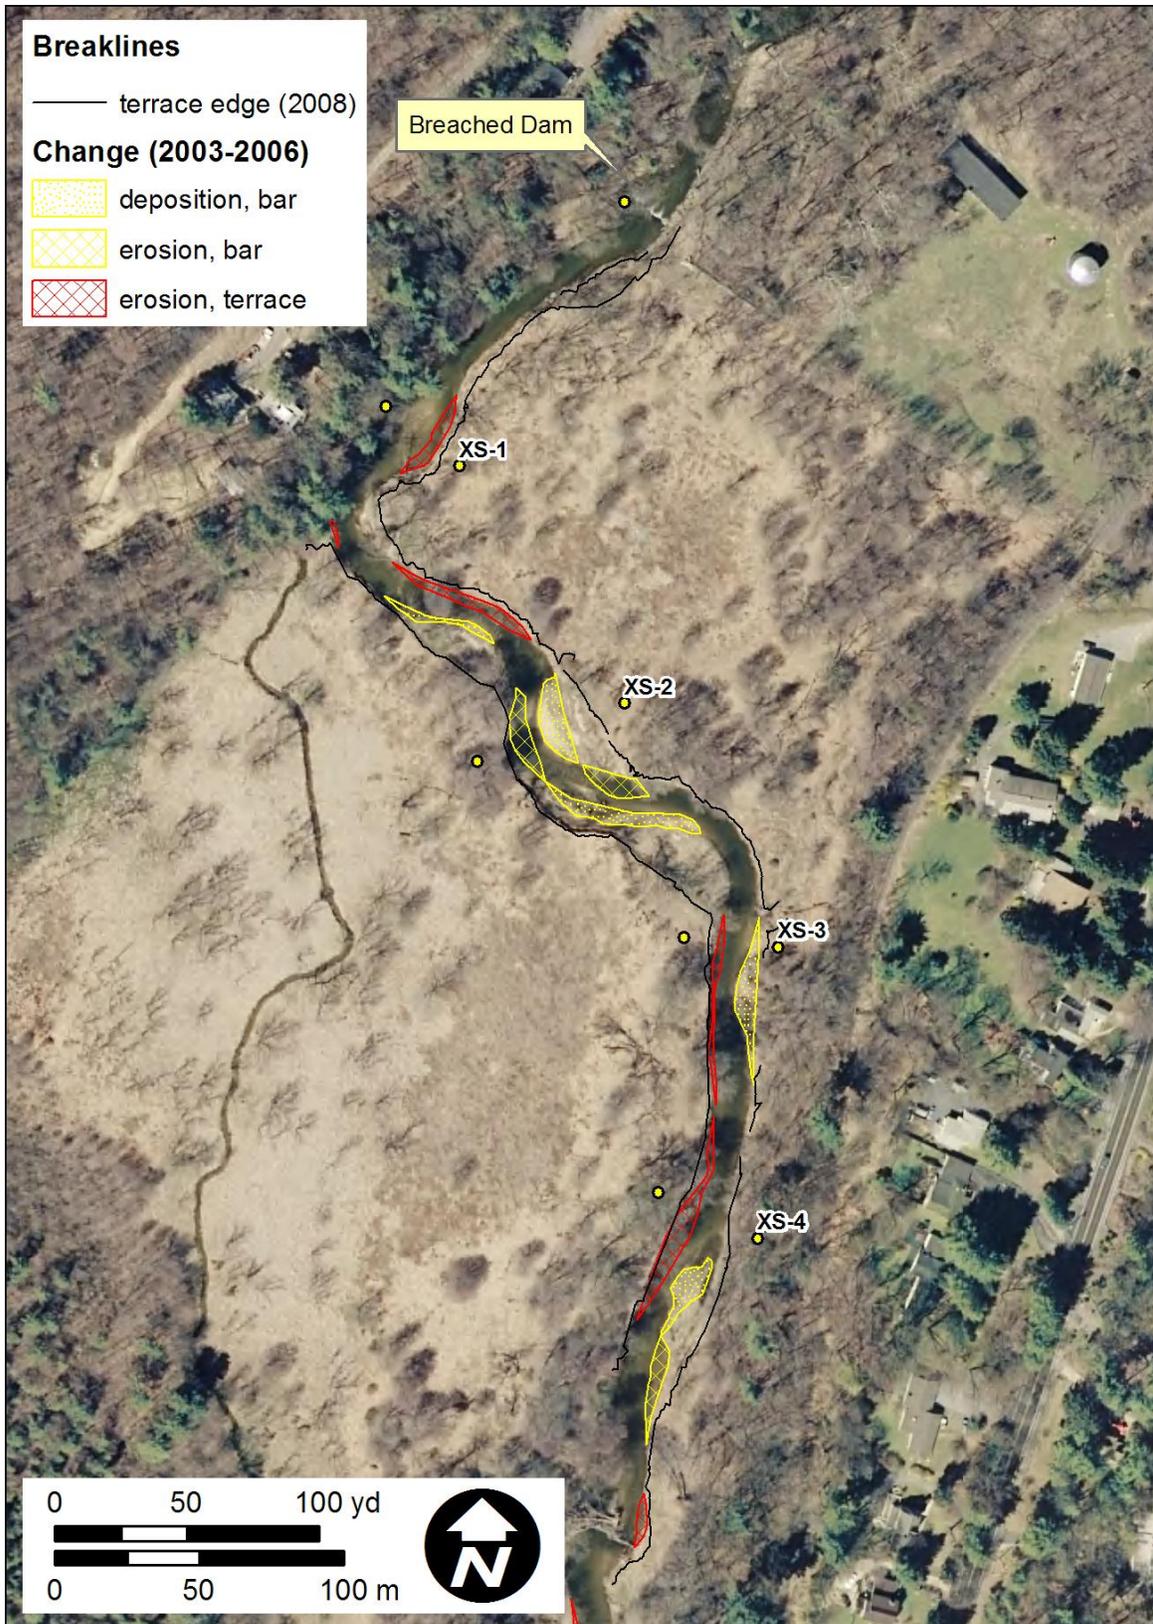
Figure 22. Mountain Creek, 2006 orthoimage, overlain with changed areas digitized by comparison of 2003 and 2006 orthoimages. Solid black lines represent terrace edge breaklines surveyed in 2008.

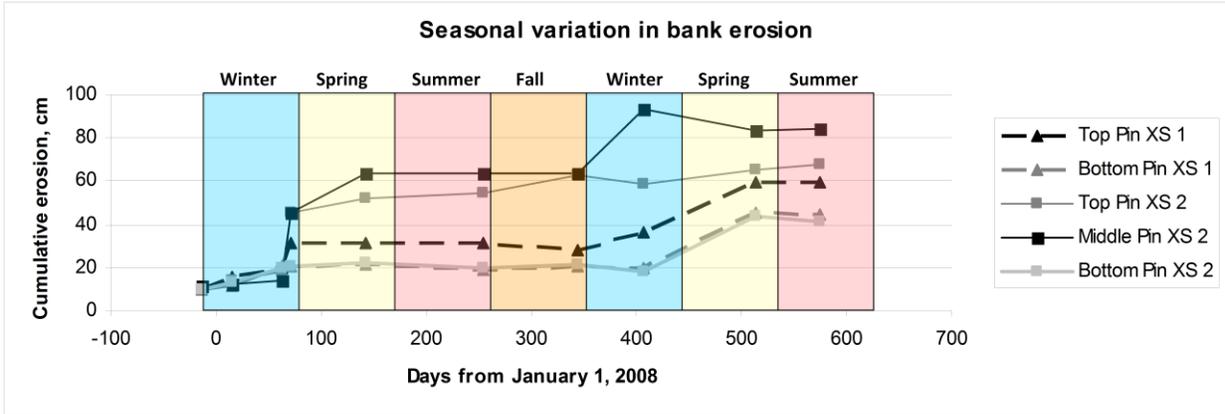
Figure 23. Bank erosion pins at cross sections 1 and 2 on right and left stream banks, respectively, reveal that the majority of bank retreat occurred during the mid- to late winter and spring seasons. This same phenomenon was observed by Wolman (1959) and Lawler (1983, 1996) and attributed by these earlier workers to freeze-thaw processes.

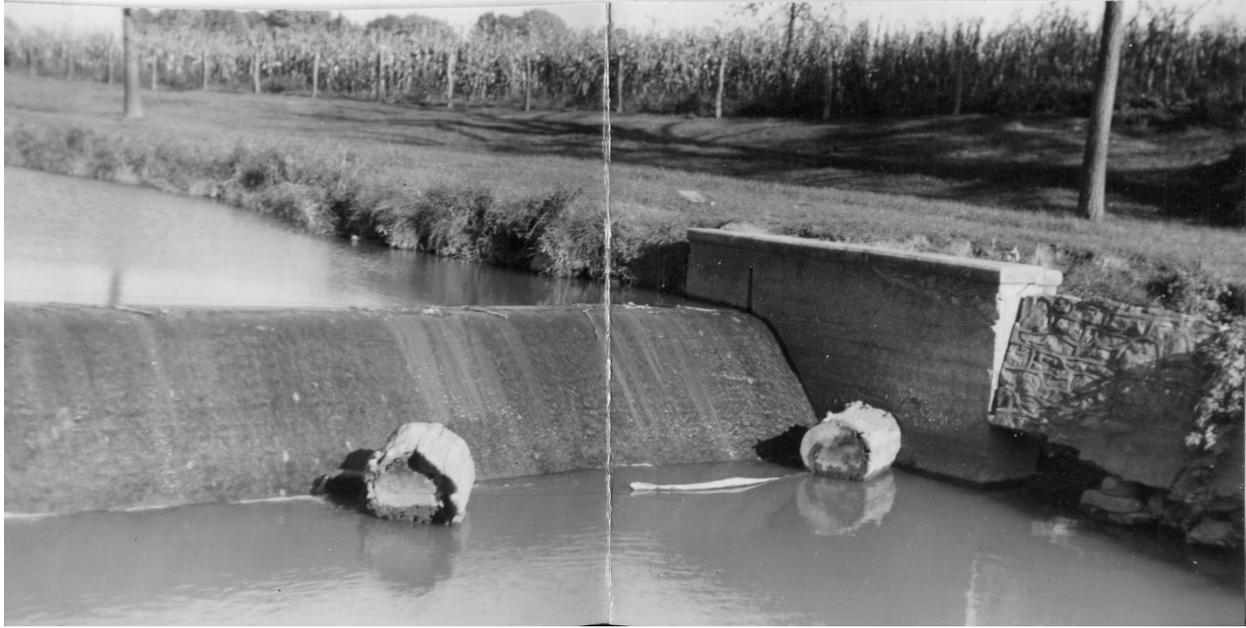
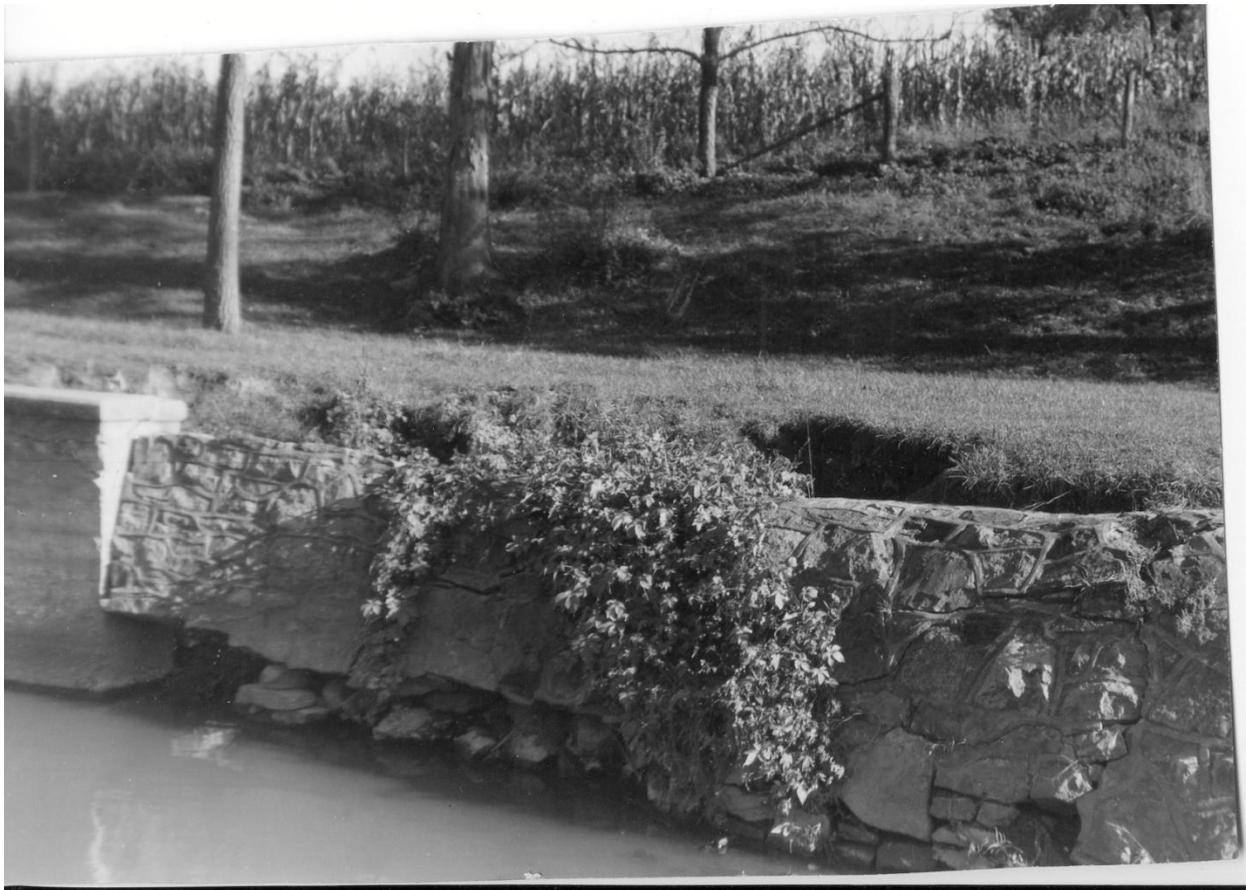
Figure 24. State inspection photos of the inset dam on Conoy Creek at Masonic Home that was built in 1930. Photos are dated October 20, 1959. The inspector made specific note of the wasting along the left wall as shown in the lower photo.

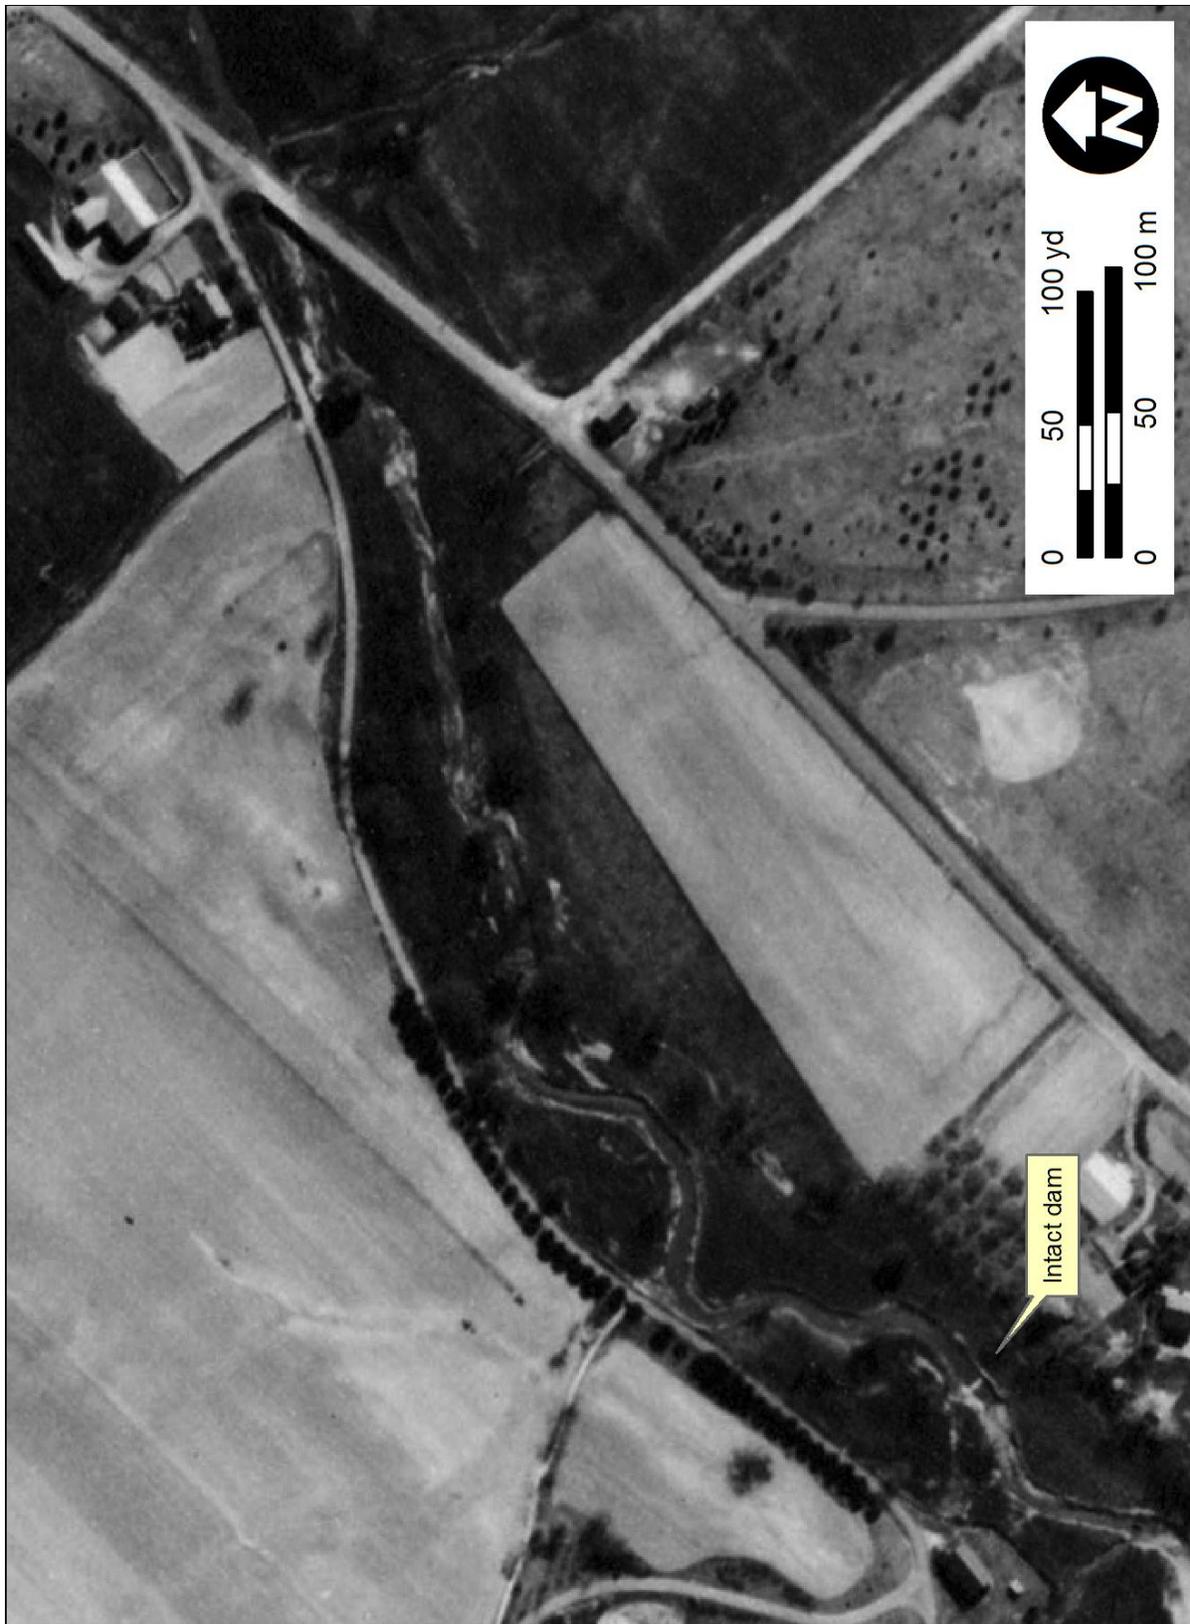
Figure 25. Conoy Creek, 1940 aerial photo. The inset dam was slightly lower than the older millpond surface, enabling the stream to remain slightly incised within the older sediment. The stream was “silted up” according to a 1959 inspection.

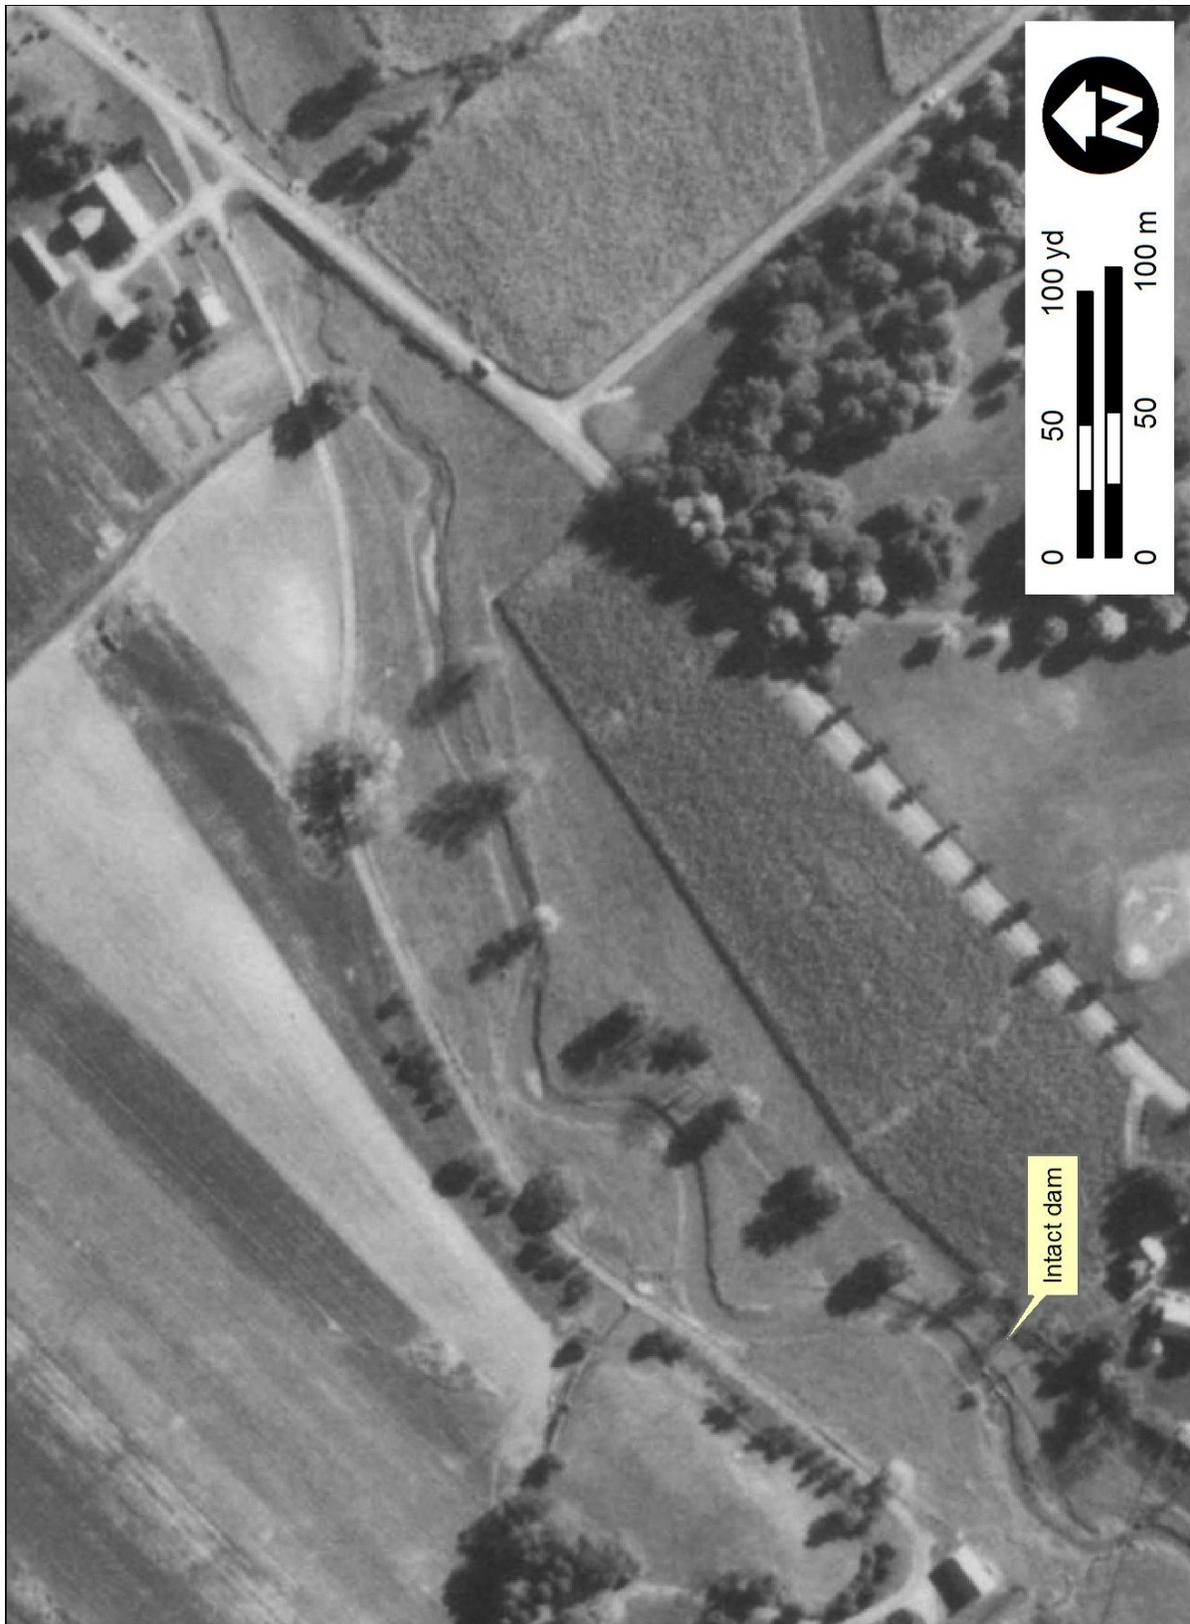
Figure 26. Conoy Creek, 1971 aerial photo. Although the left (southern) wall of the dam is partly eroded against the valley margin, its backwater effect still impacts the stream.

Figure 27. Conoy Creek, cross section locations shown on a 2005 orthoimage. The stream has cut far left of the dam, into the valley margin, and the upstream channel has incised and widened (compare to downstream) since 1971 (see Figure 26).

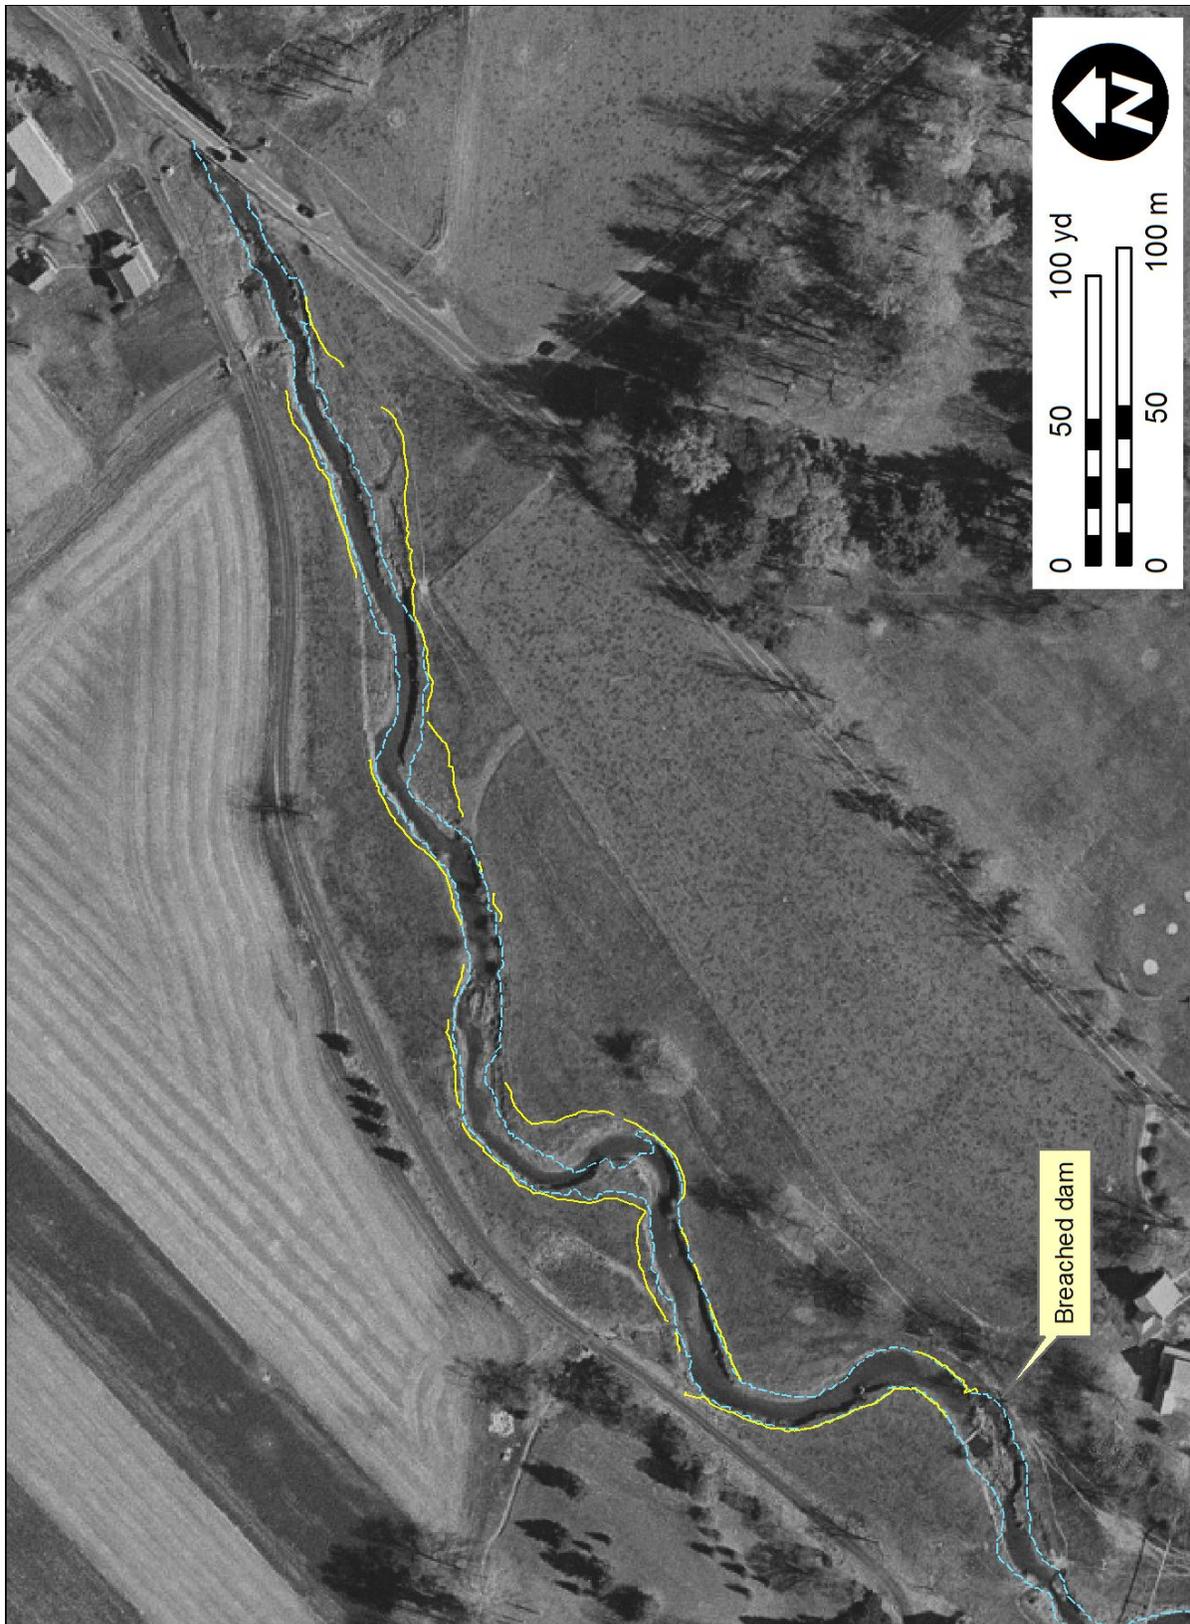
Figure 28. Conoy Creek, breaklines surveyed with GPS in 2008, overlain on a 2001 orthoimage.

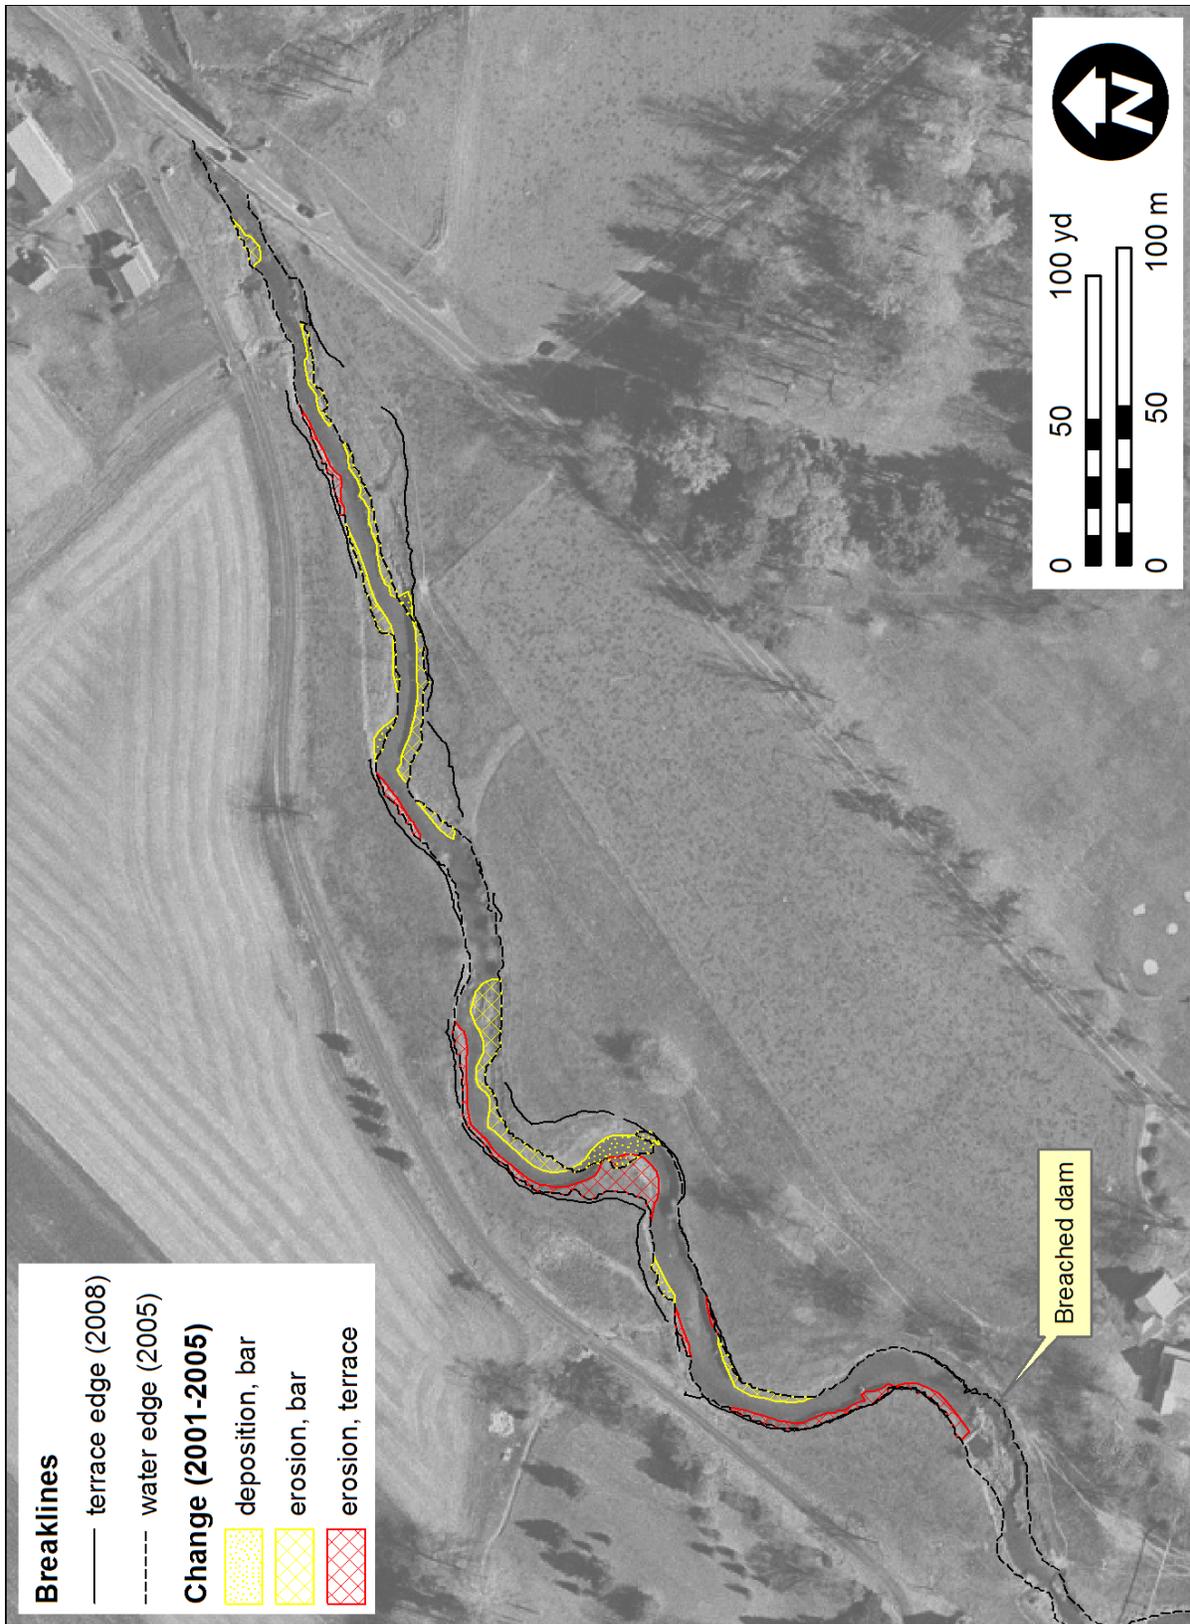
Figure 29. Conoy Creek, changed areas between 2001 and 2005, overlain on a 2001 orthoimage.

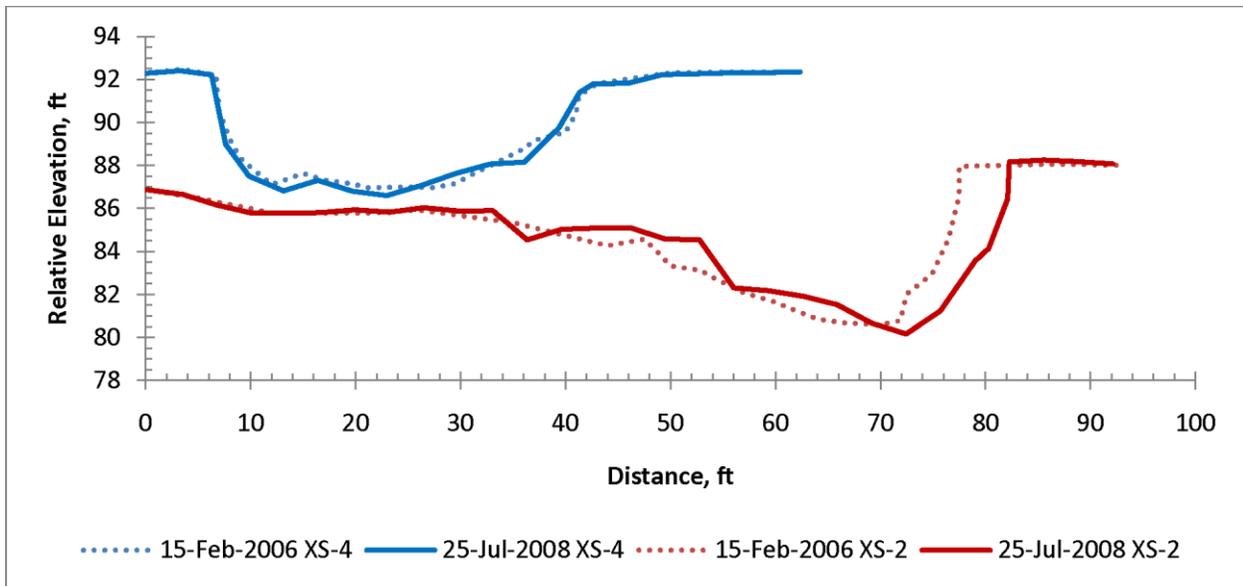
Figure 30. Cross sections XS-2 and XS-4 between 2006 and 2008. Note that XS 4 is located just upstream of the dam, and the left margin is cutting into deeply weathered bedrock (saprolite) and colluvial gravel. The dam continues to control the bed at XS 4 (i.e., a local grade control structure). The right bank of XS 4, ~900 ft upstream of the dam, consists of fine-grained historic millpond sediment. Left bank is a prograding (left to right) bar that consists mostly of sand and gravel. Elevations are not absolute.

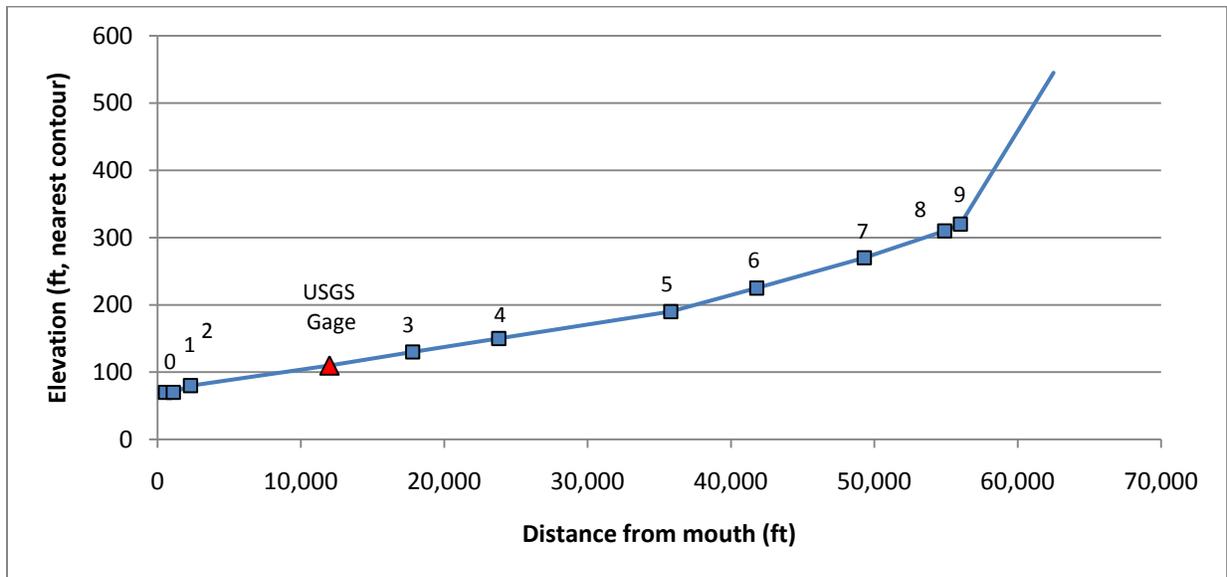
Figure 31. Long profile of Valley Creek from head to mouth, at its confluence with the Schuylkill River, with locations of 10 dams numbered in sequence for reference in this report. All dams except Dam #2 were built in the 18th to 19th centuries. Dam #2 was built in the 1920s as an inset dam (see Figure 34d) within the incised reservoir of Dam #1, which was breached in 1920. This 20th c. inset dam was built in approximately the same location as an 18th c. dam that supplied water to the Lower Forge, a Revolutionary-war era iron forge. The millpond formed by Dam #1 submerged the Lower Forge and its dam; the forge and a race were exposed by incision and bank erosion after Dam #1 breached in the 1920s. Average dam spacing along Valley Creek is ~5100 feet. Elevations are from Chester County elevation data, with 5-foot contour interval, obtained from PASDA.

Figure 35. Two breached 18th to 19th c. dams at the mouth of Valley Creek. See Figure 31 for locations along the length of Valley Creek and Figure 32 for historic maps depicting these dams and the mills for which they supplied water.

Figure 36. (a) View upstream of right bank of Valley Creek with remnant of wall or foundation of mill building that existed immediately downstream of mill dam for Dam #0 (see Figures 31 and 32) in the 19th century. This mill building is labeled "Mill" in Figure 32. (b) View of right bank with remnants (stone slabs) of breached dam exposed beneath roots of large tree at left center of view. This dam is referred to as Dam #1 in Figures 31 and 32. Dam crossed the stream and was attached to a rib of bedrock exposed on left bank. See Figures 34a and 34c for views of this dam before and after breaching. (c) View upstream of right bank illustrating collapse of fine-grained laminated sediment deposited in slackwater millpond conditions upstream of Dam #1 during the 19th century. Note person with 2-meter stadia rod for scale in center of photo. See Figure 34b for a historic photo of this pond taken before the dam was breached in 1920. All three photos were taken by the authors on 17th April 2010.

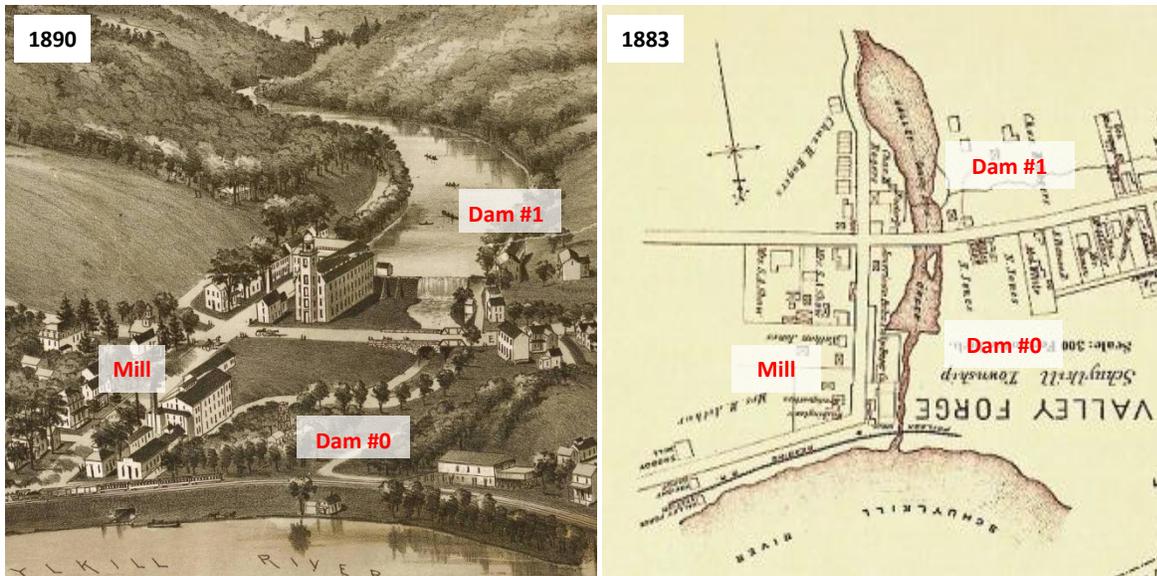
Figure 32. A 19th century bird's eye view (left), and map (right) of the mouth of Valley Creek near Valley Forge and General Washington's Revolutionary War headquarters (lower left) illustrate mill dams, ponds, and buildings and their changes with time. Note that the dam labeled as Dam #0 appears on the 1883 map but not on the 1890 bird's eye view. This breached dam is shown in cross section view in the left stream bank in Figure 36b. Dam #1 was built in 1789. Birds-eye view on left is by artist Albert E. Downs and published in 1890. Map on right from 1883 is from Breou's Official Series of Farm Maps, Chester County published by W.H. Kirk, 1883, courtesy of Nancy Romig of the Western Pennsylvania Genealogical Society. Compare these images to a recent Google Earth 3-D view in Figure 35.
