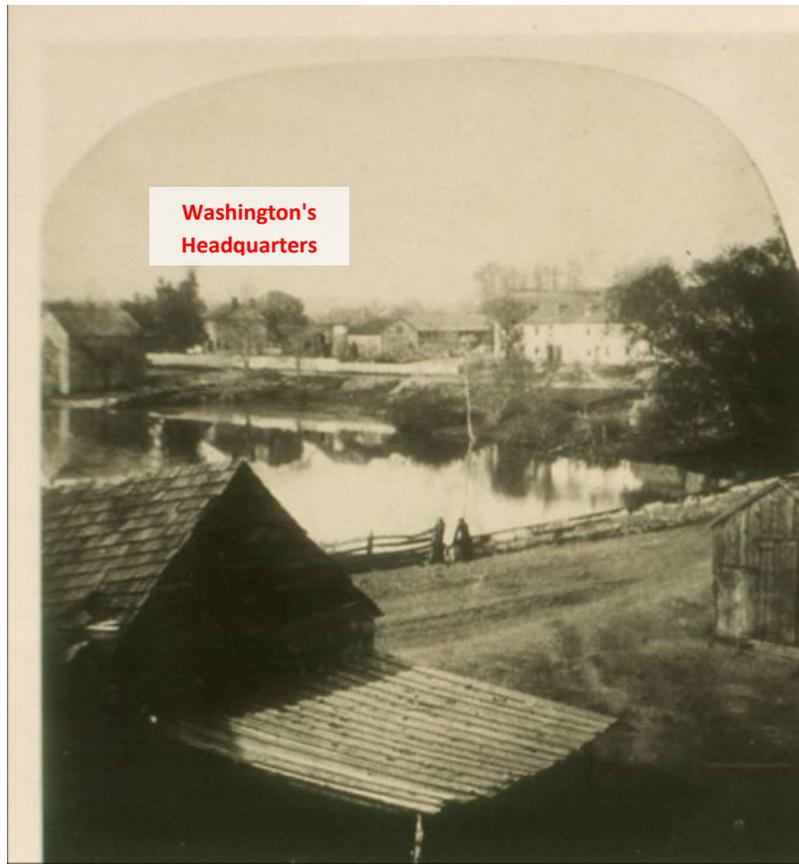
Figure 33. Pre-Civil war stereoscope of Valley Forge Village showing mill pond created by dam (#0 on long profile) near the Schuylkill River. Image from the files of Valley Forge National Historic Park, courtesy of Kristina Heister.

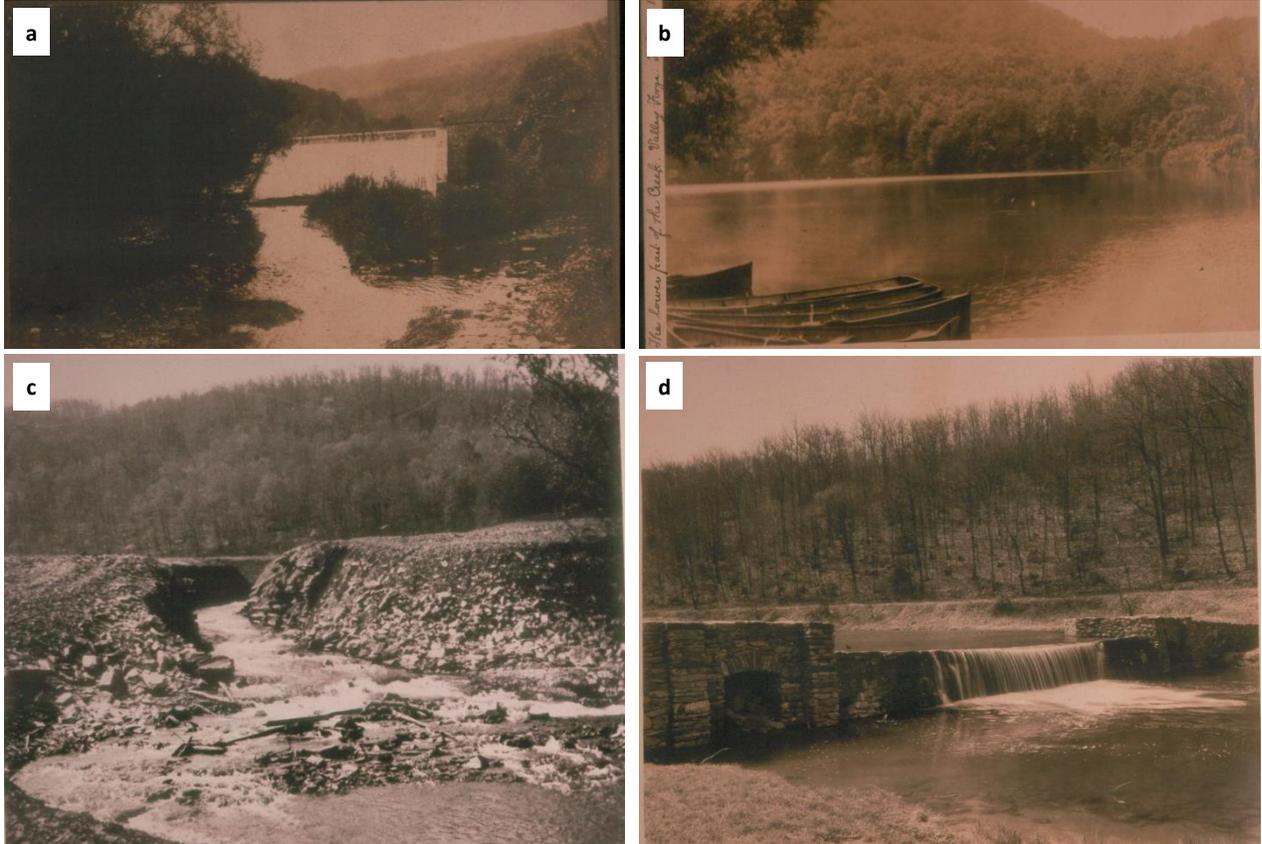
Figure 34. (a) Seventeen foot high dam (#1 on long profile) built in 1789 just south of the Route 23 bridge. (b) Mill pond created by 17-ft dam (#1 on long profile) on Valley Creek extended to the covered bridge about 2.7 km upstream. (c) Valley Creek incision after breaching of 17-ft high dam (#1 on long profile) south of Route 23, with Mt. Misery in the background. (d) Dam (#2 on long profile) built in the 1920's (still existing today) at site of original (18th c.) lower forge dam. Note the high banks that form a prominent sub-horizontal bench in the distance; these were formed by sedimentation to the level of the crest of Dam #1, located about 1200 ft downstream. Dam #2 was constructed within the incised reservoir of Dam #1 after it was breached in 1920. Images from the files of Valley Forge National Historic Park, courtesy of Kristina Heister.

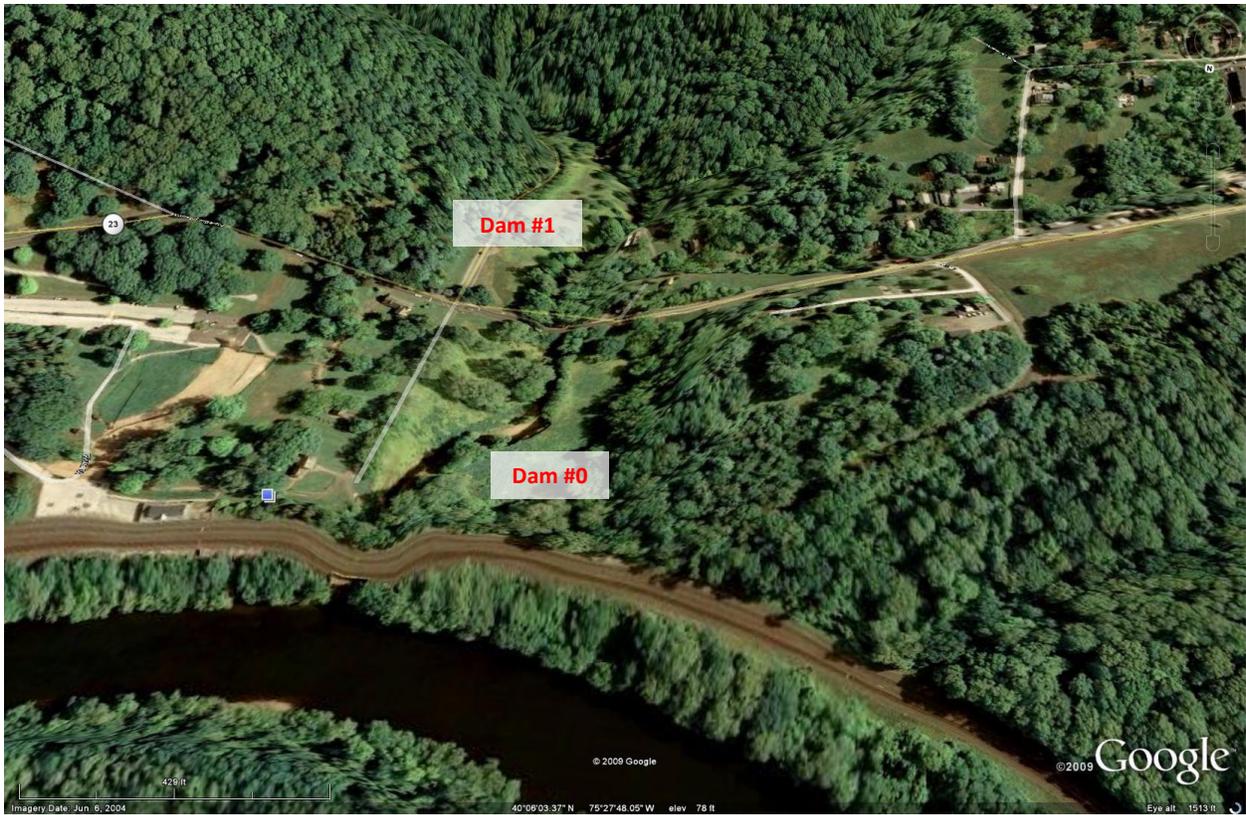
Figure 35. Two breached 18th to 19th c. dams at the mouth of Valley Creek. See Figure 31 for locations along the length of Valley Creek and Figure 32 for historic maps depicting these dams and the mills for which they supplied water.

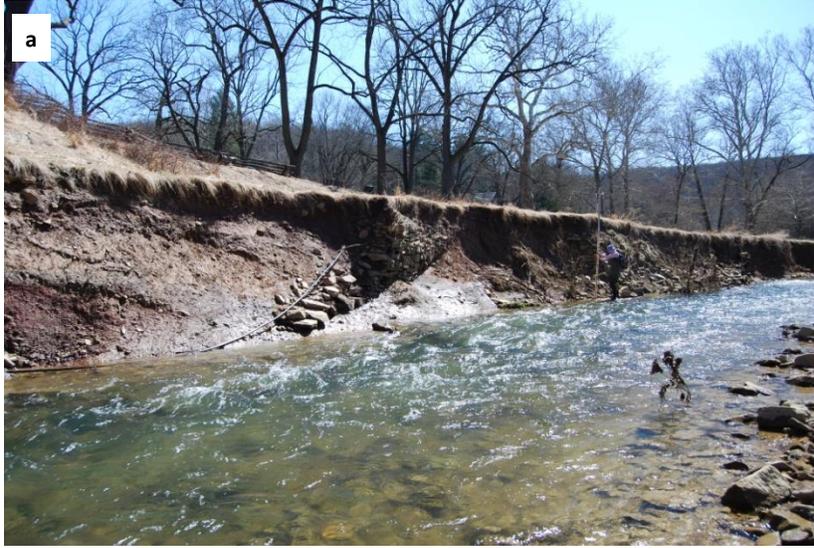
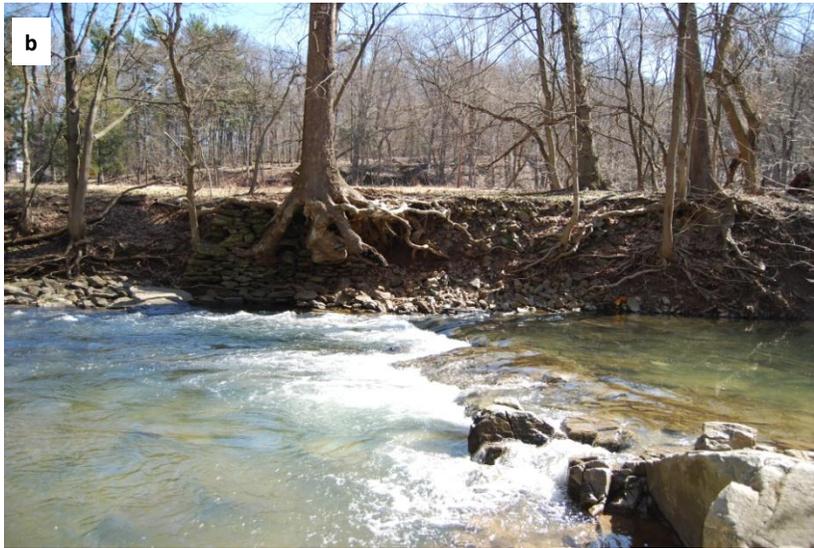
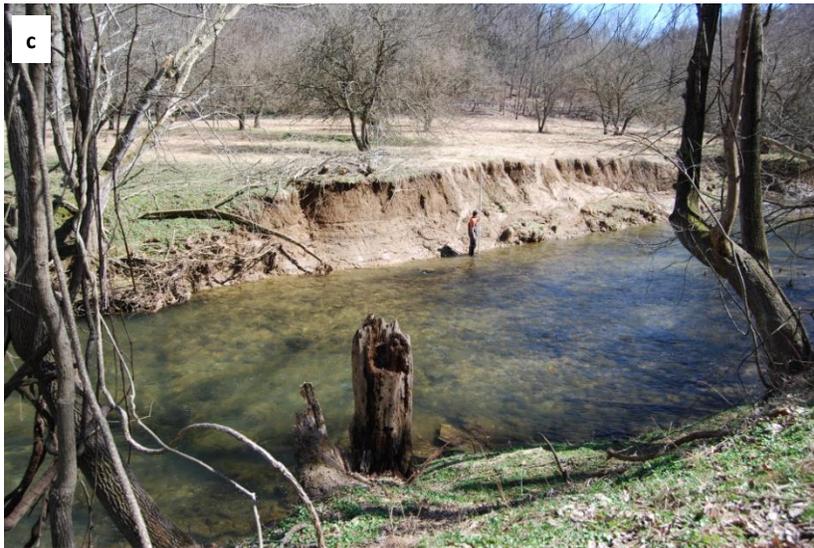
Figure 36. (a) View upstream of right bank of Valley Creek with remnant of wall or foundation of mill building that existed immediately downstream of mill dam for Dam #0 (see Figures 31 and 32) in the 19th century. This mill building is labeled "Mill" in Figure 32. (b) View of right bank with remnants (stone slabs) of breached dam exposed beneath roots of large tree at left center of view. This dam is referred to as Dam #1 in Figures 31 and 32. Dam crossed the stream and was attached to a rib of bedrock exposed on left bank. See Figures 34a and 34c for views of this dam before and after breaching. (c) View upstream of right bank illustrating collapse of fine-grained laminated sediment deposited in slackwater millpond conditions upstream of Dam #1 during the 19th century. Note person with 2-meter stadia rod for scale in center of photo. See Figure 34b for a historic photo of this pond taken before the dam was breached in 1920. All three photos were taken by the authors on 17th April 2010.

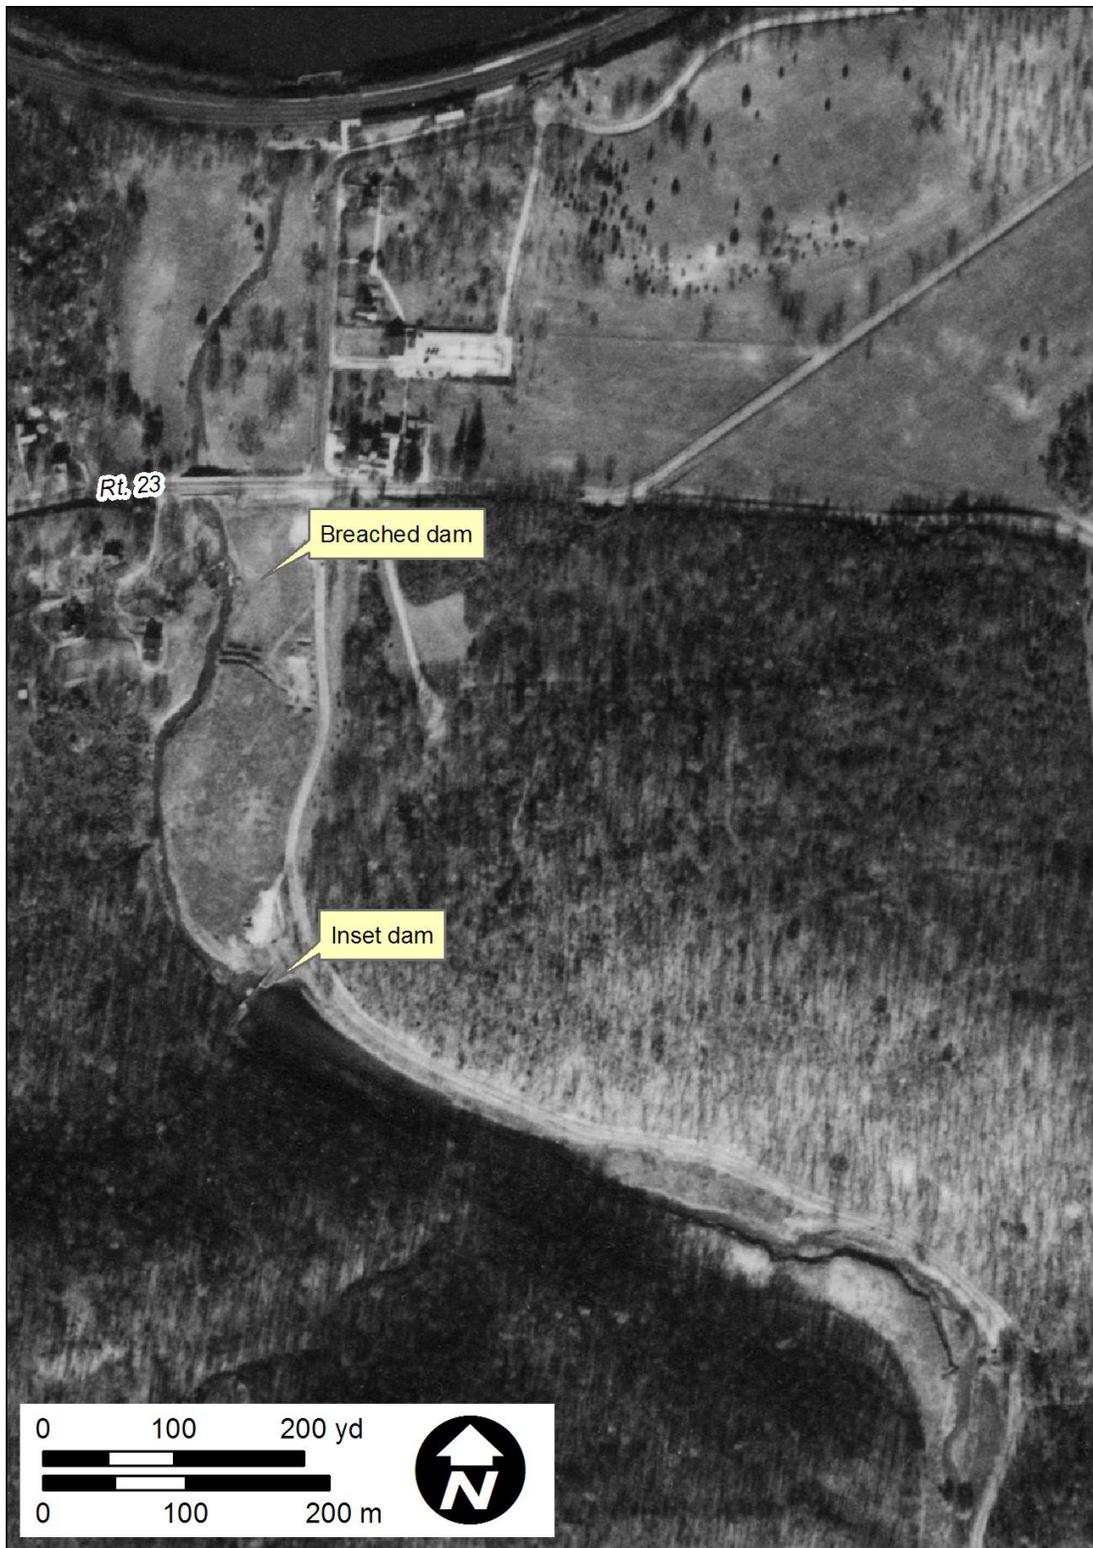
Figure 37. Valley Creek, 1937 aerial photo. Pennsylvania Route 23 overpass of Valley Creek and known dam locations are indicated. The stream reach shown corresponds to the 0 to 1600 m distance (0 to 5250 ft) on figure 2 of Fraley, 2009. Breached dam is dam #1, and inset dam is dam #2.

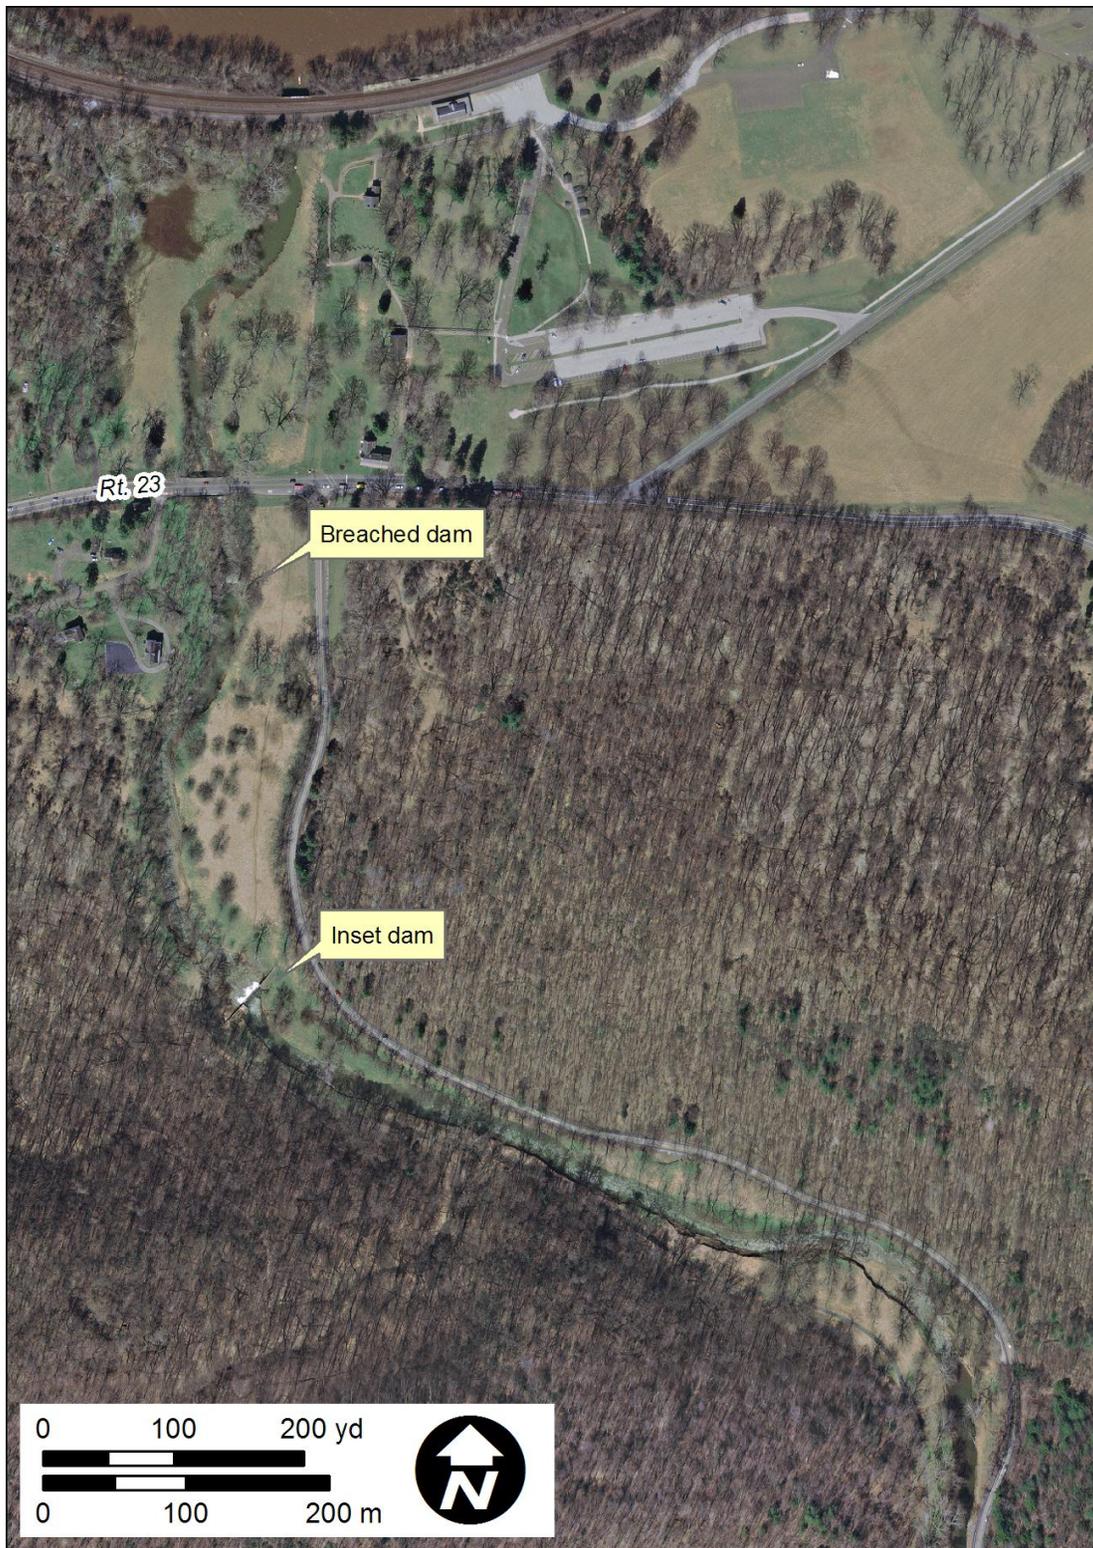
Figure 38. Valley Creek, 2005 orthoimage. Note that the incised channel between the breached and inset dam is mostly against the left (west) valley margin, in bedrock and colluvium on left bank. The inset dam is lower than the older millpond sediment surface, resulting in emergent channel banks upstream of the local base level control from this dam. Breached dam is dam #1, and inset dam is dam #2.

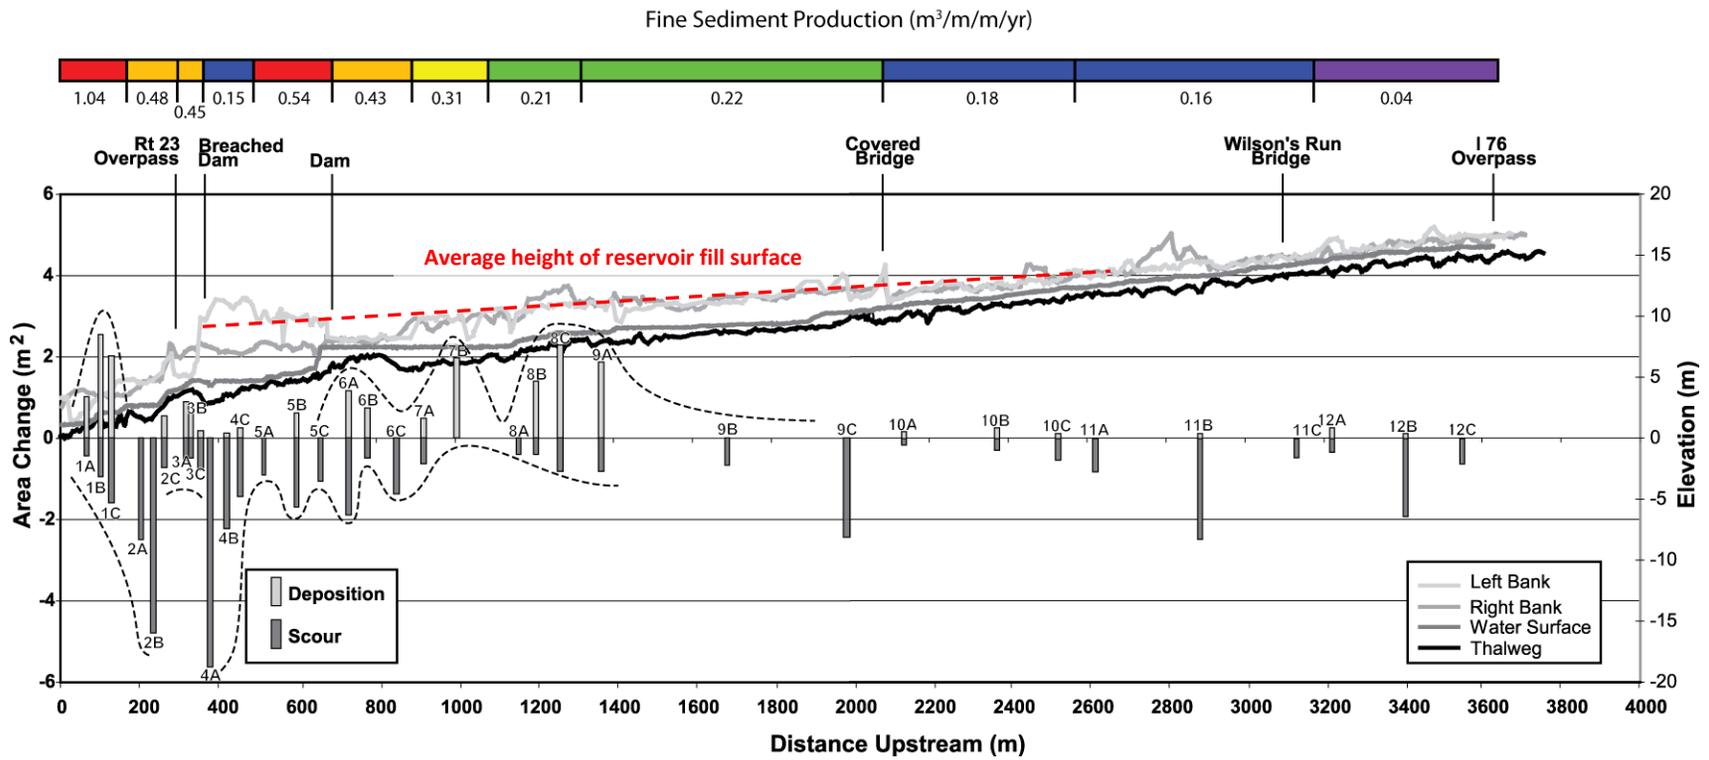
Figure 39. Long profile of Valley Creek modified from Figure 2 of Fraley et al (2009). Colored plot along top was added to original figure to show fine-sediment production values for bank erosion (calculated from data in Fraley, 2006, and Fraley et al, 2009, for each reach). Higher unit production values are located upstream of the breached 19th c. dam (originally 17-ft high, referred to as Dam #1 in Figures 31 and 32) and decrease in the upstream direction, with exception of a short reach at the breached dam where bedrock occurs in the left bank and remnants of the dam occur in the right bank. Sediment deposition in the bed (see bottom of plot) occurs at two locations: 1) in a slackwater just upstream of the railroad crossing at the confluence with the Schuylkill River; and 2) for a distance of about 700 m upstream of the inset dam located at 700 m on the long profile). The inset dam is referred to as Dam #2 in Figures 31 and 32. Note that the slackwater surface from the inset dam appears on the thalweg in the long profile, and the fill terrace from the 17-ft high breached dam (Dam #1 in Figures 31 and 32) appears as high left and right banks that diminish in height from the dam upstream (line added to illustrate this level). An historic photo (see Figure 34b) shows the slackwater from this pond extending at least to the covered bridge at a distance of 2000 m upstream. Apparent irregularities in this reservoir fill surface are the result of the modern channel location with respect to valley walls and road embankments.

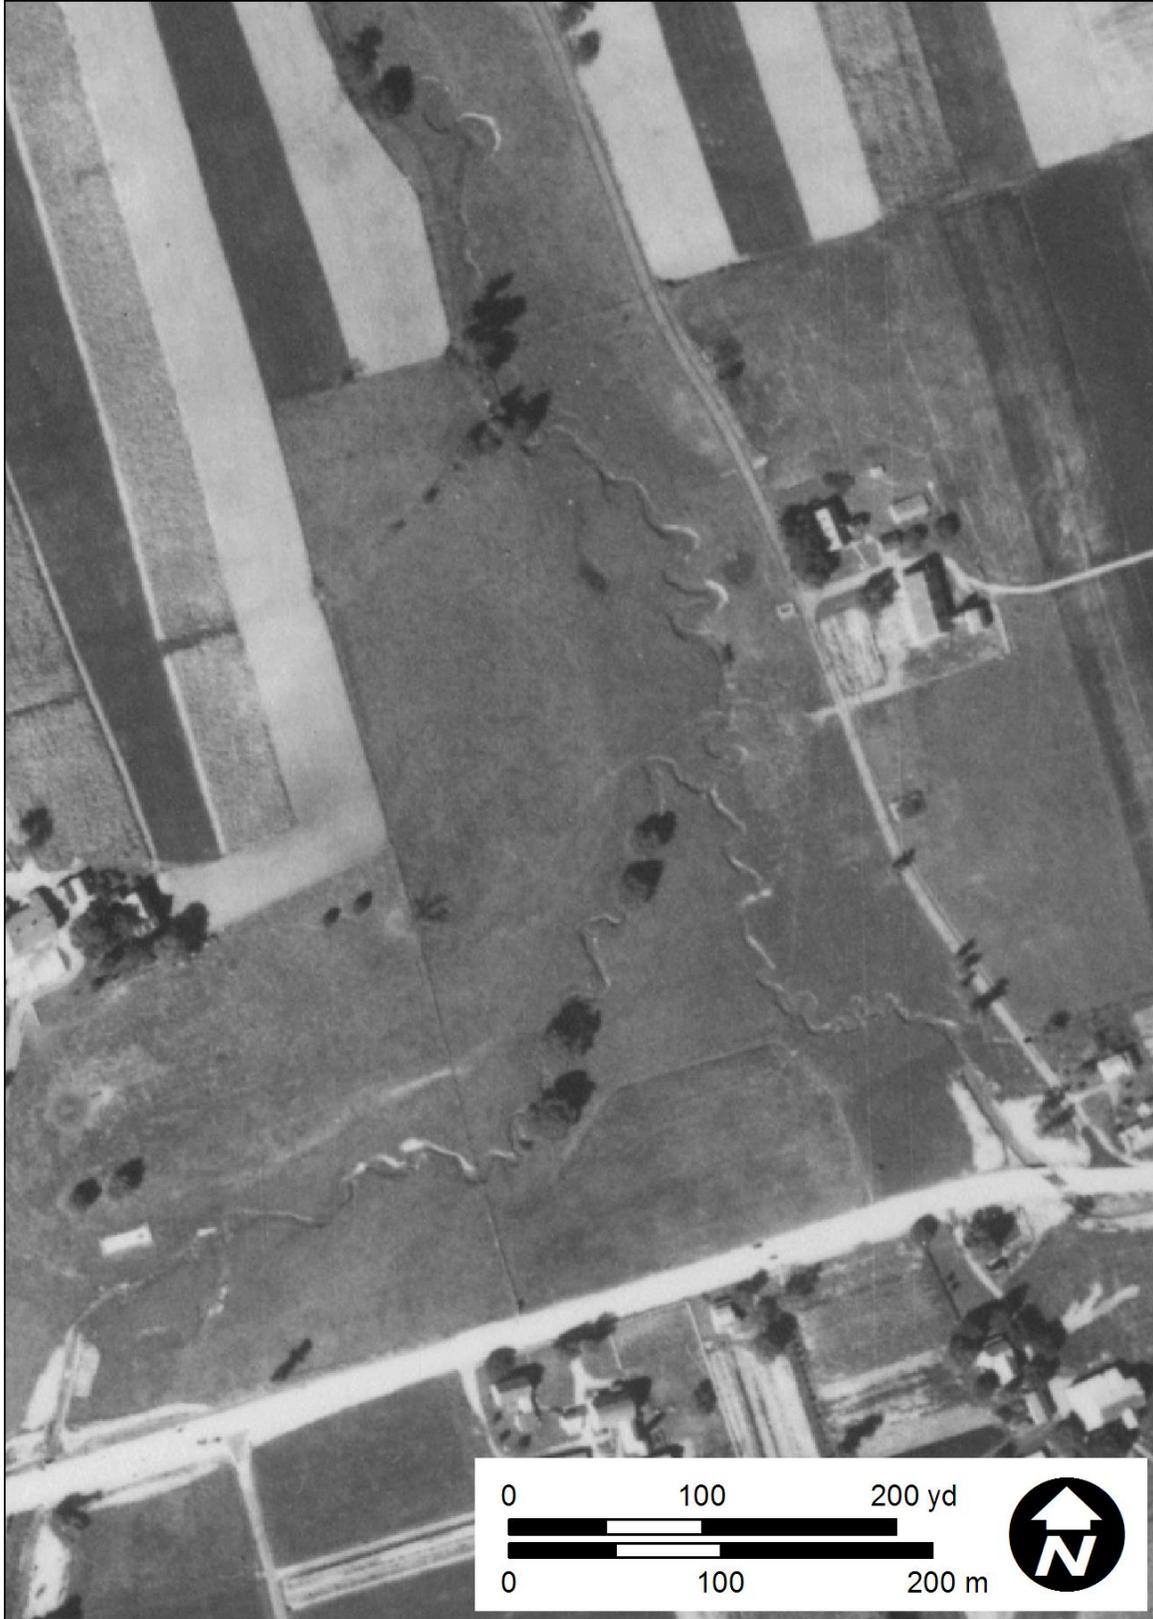
Figure 40. Big Spring Run, 1957 aerial photo. Note incised, meandering stream, and recent channel modification of both tributaries near the road at bottom (south) during road construction and modification with bridge building.

Figure 41. Big Spring Run, 2005 orthoimage. Compare sinuosity of eastern tributary (right) and mainstem near southeast-northeast oriented fenceline near top with channel sinuosity in 1957 (Figure 40).

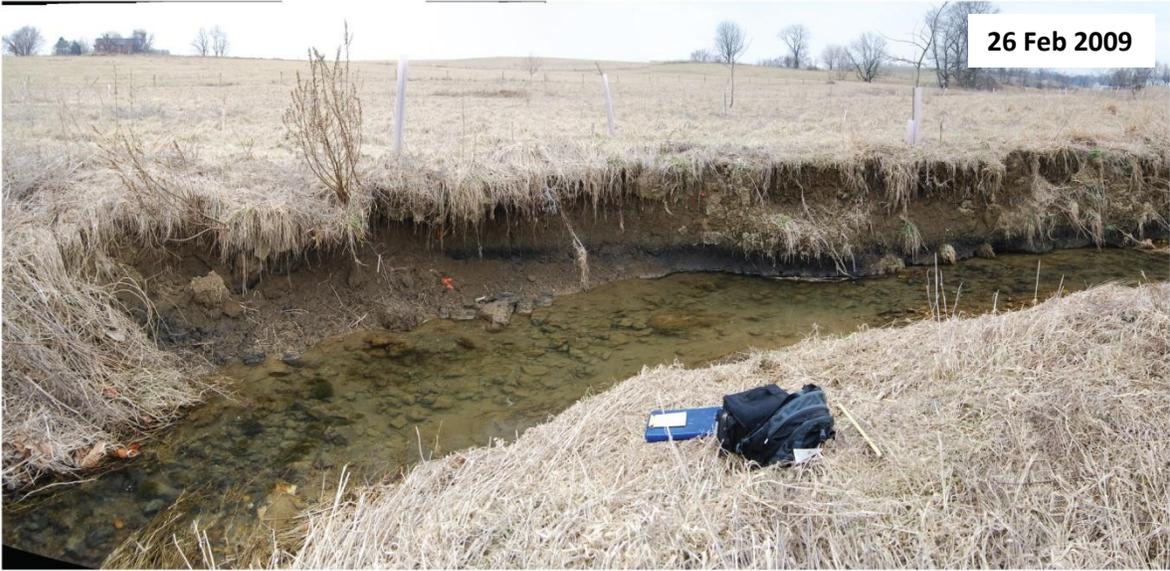
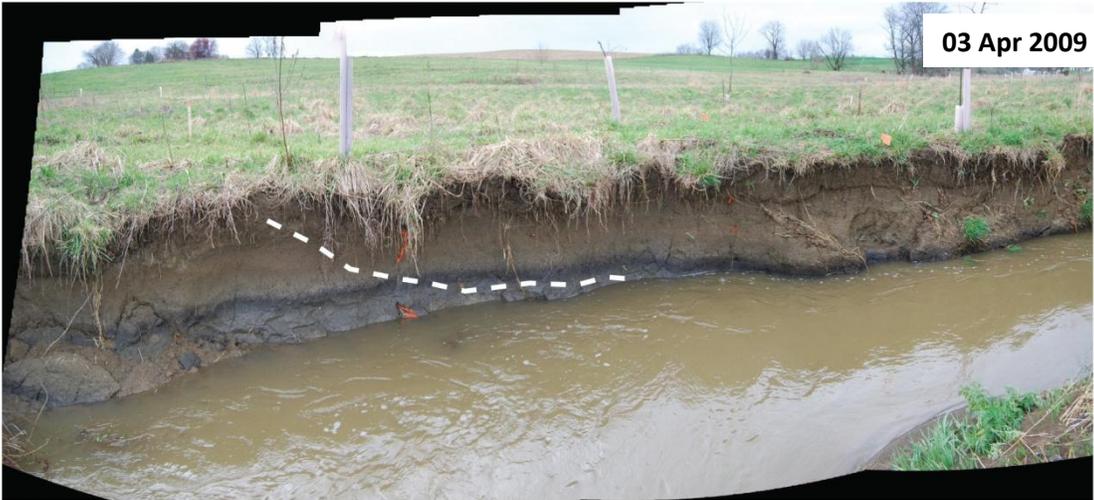
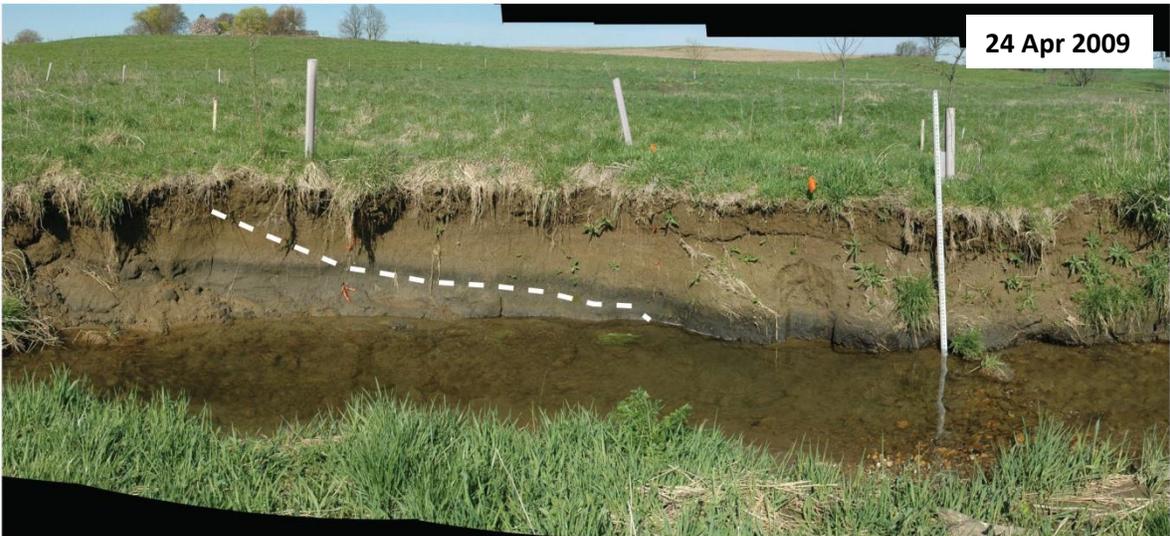
Figure 42. Bank pins at Big Spring Run reveal that more lateral bank erosion occurs in the winter than in other seasons. We observed freeze-thaw processes and needle ice in the banks of Big Spring Run in the winters of 2008-2009 and 2009-2010, and documented the growth of an apron of debris (top photo) from freeze-thaw processes during these winters. This apron was washed away (white dashed line, middle and bottom photos) during spring thaw and spring to summer rains that caused higher flow. Dark, buried soil is original valley bottom topography that predates historic sedimentation. Note that the buried soil indicates the toe of a hillslope sloping toward the valley bottom wetland (left to right). Darker soil at right is the hydric soil; thinner soil on left might be a grassland soil (work in progress, Laura Kratz, F&M).

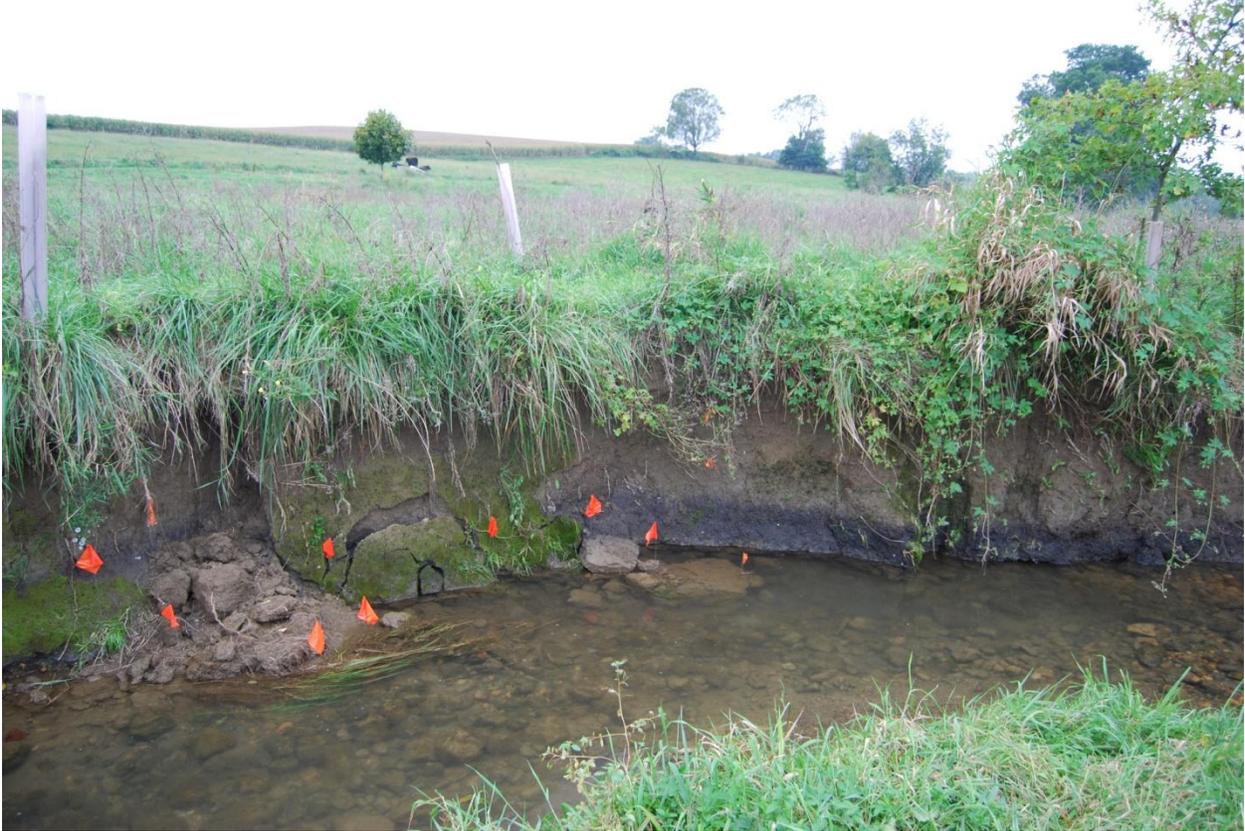
Figure 43. Bank-failure along fracture planes sub-parallel to the stream bank occurred within 36 hours of the water stage dropping after a storm on August 29, 2009. This high stage event nearly reached the top of the bank, enabling much of the bank to be wetted, and was preceded by two high flows in the previous 3 weeks of August. Failure masses are marked by orange flags. Drying of the banks throughout the summer contributes to the sub-vertical fracturing of cohesive silt and clay along failure planes that are perpendicular to the direction of minimum stress. Undercutting at the base of the bank also contributes to fracturing. The minimum stress direction, perpendicular to the bank face, results from removal of sediment by bank erosion and the consequent loss of buttress support.

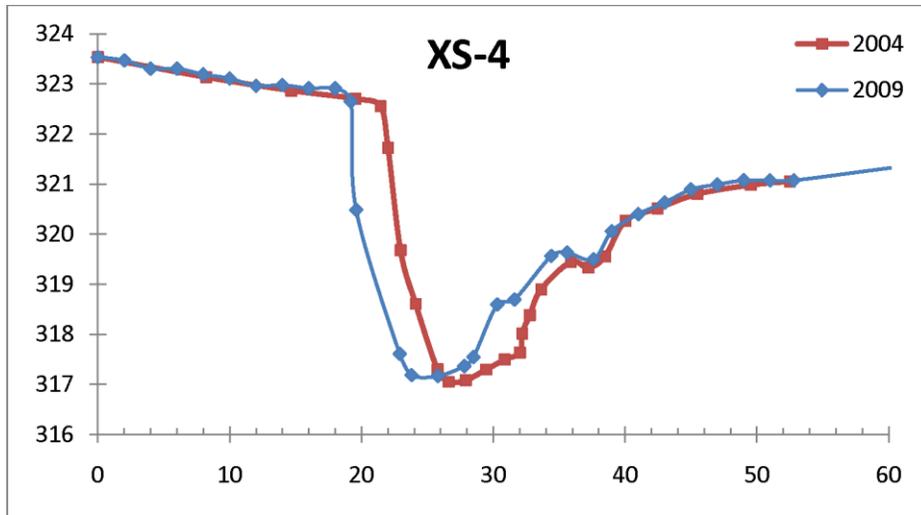
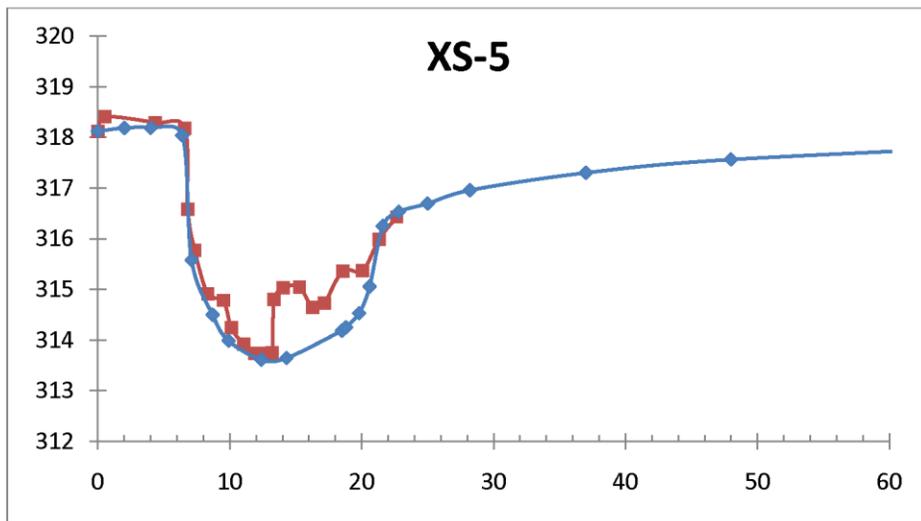
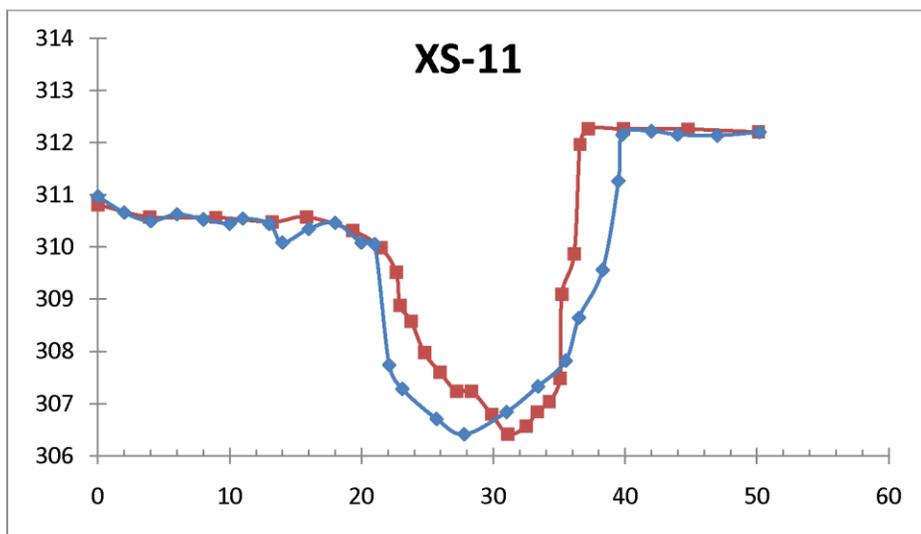
Figure 44. Change at Big Spring Run, cross-sections XS-4, XS-5, XS-11, from 2004 to 2009. Cross section surveys done with total geodetic station.

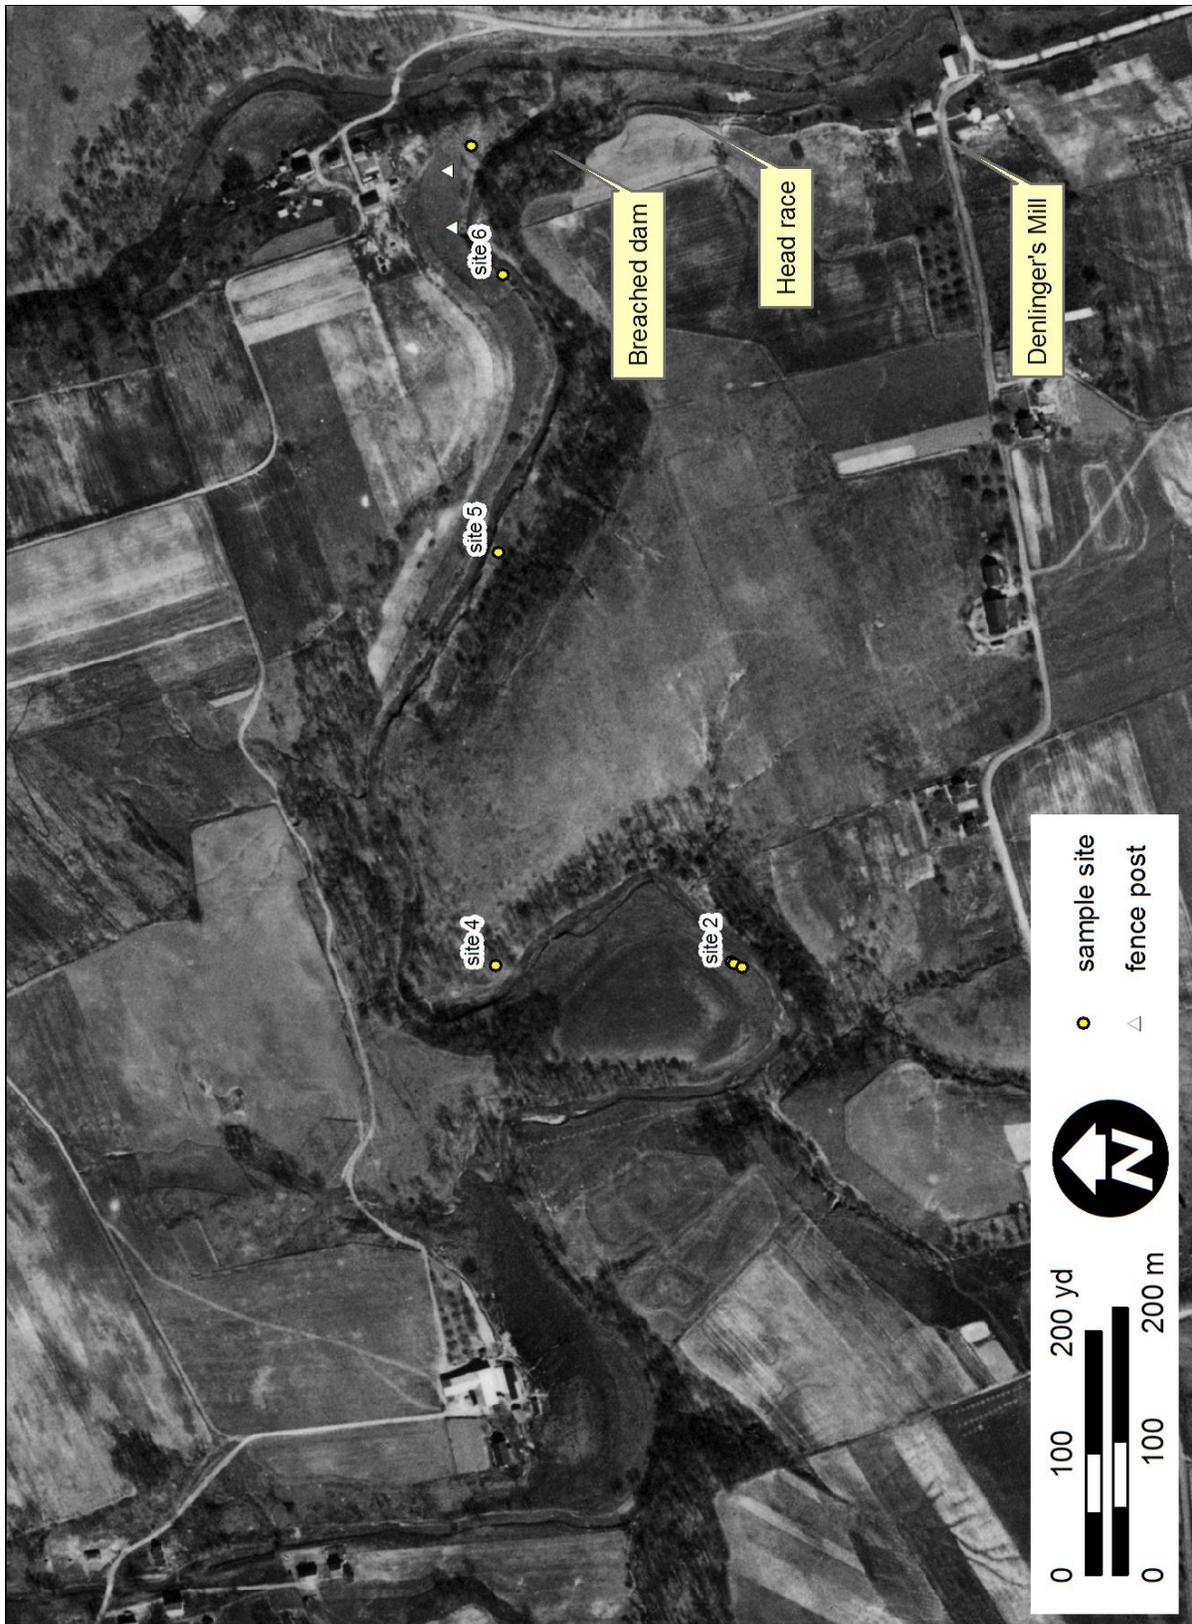
Figure 45. Little Conestoga Creek West Branch, 1940 aerial photo.

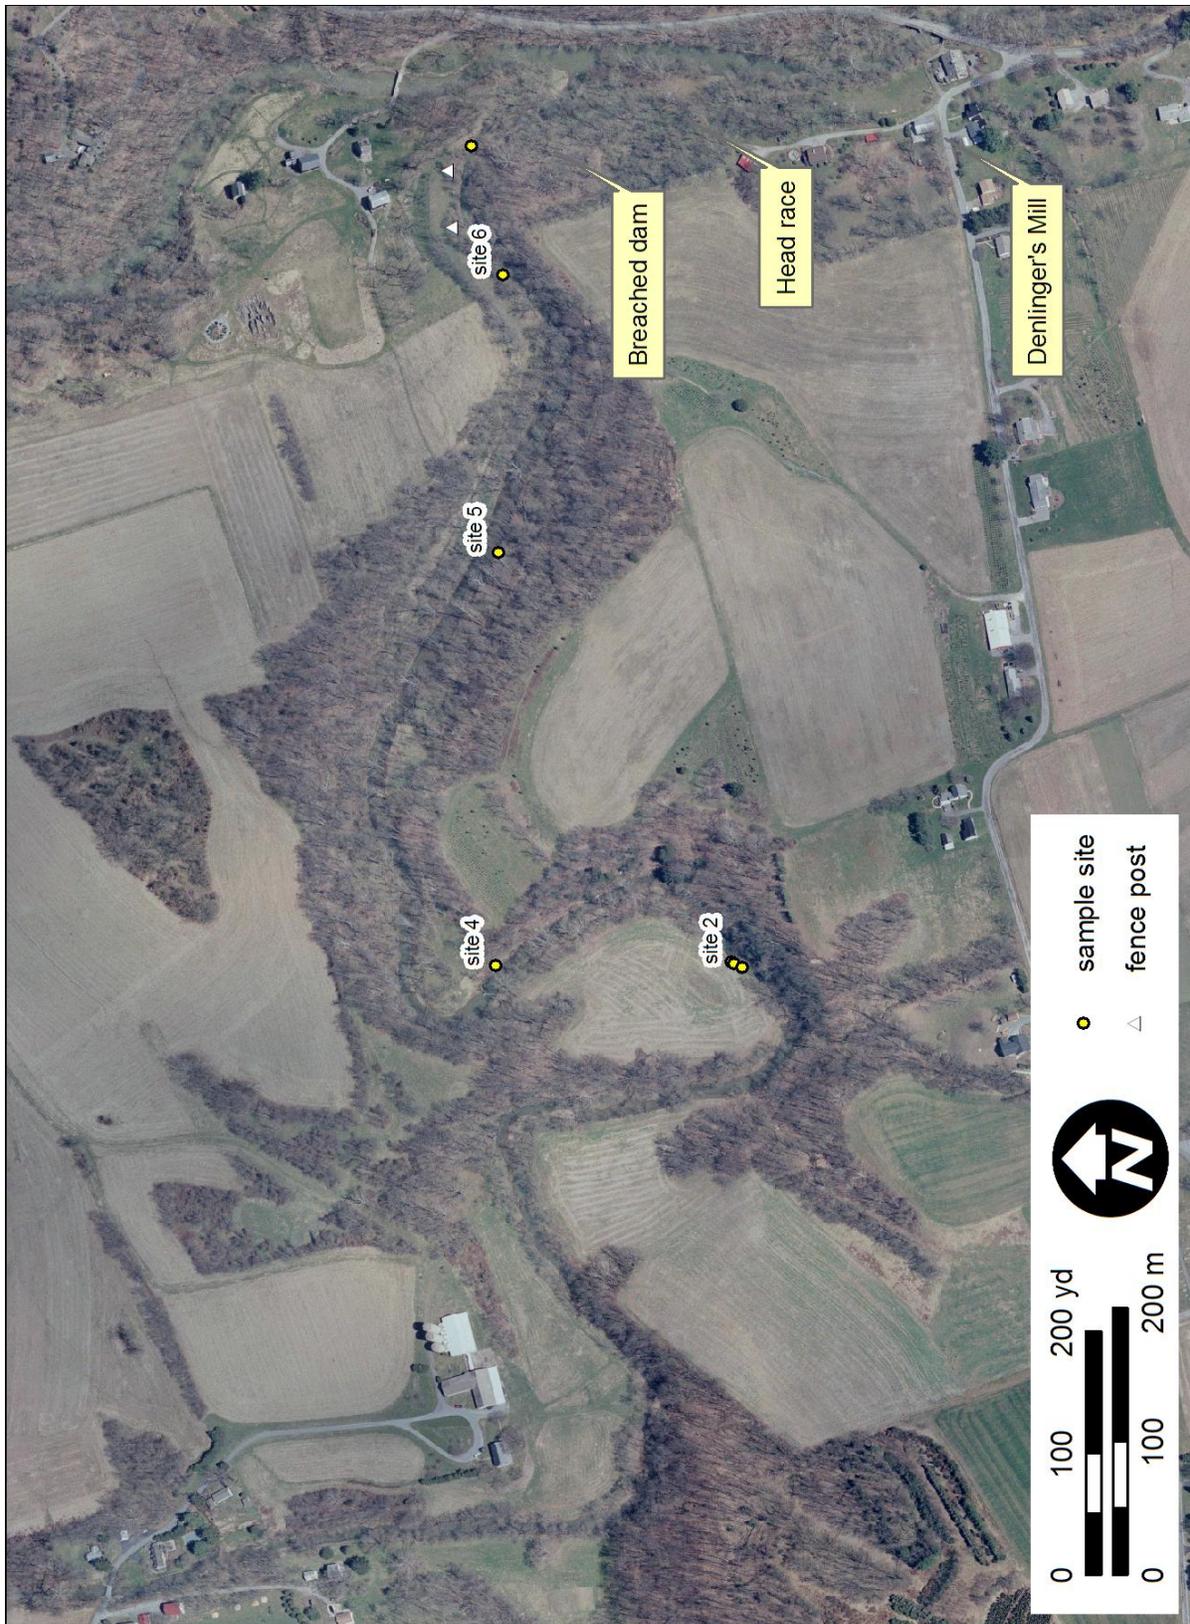
Figure 46. Little Conestoga Creek West Branch, 2005 orthoimage. Yellow points indicate sites where detailed stratigraphic columns were measured.

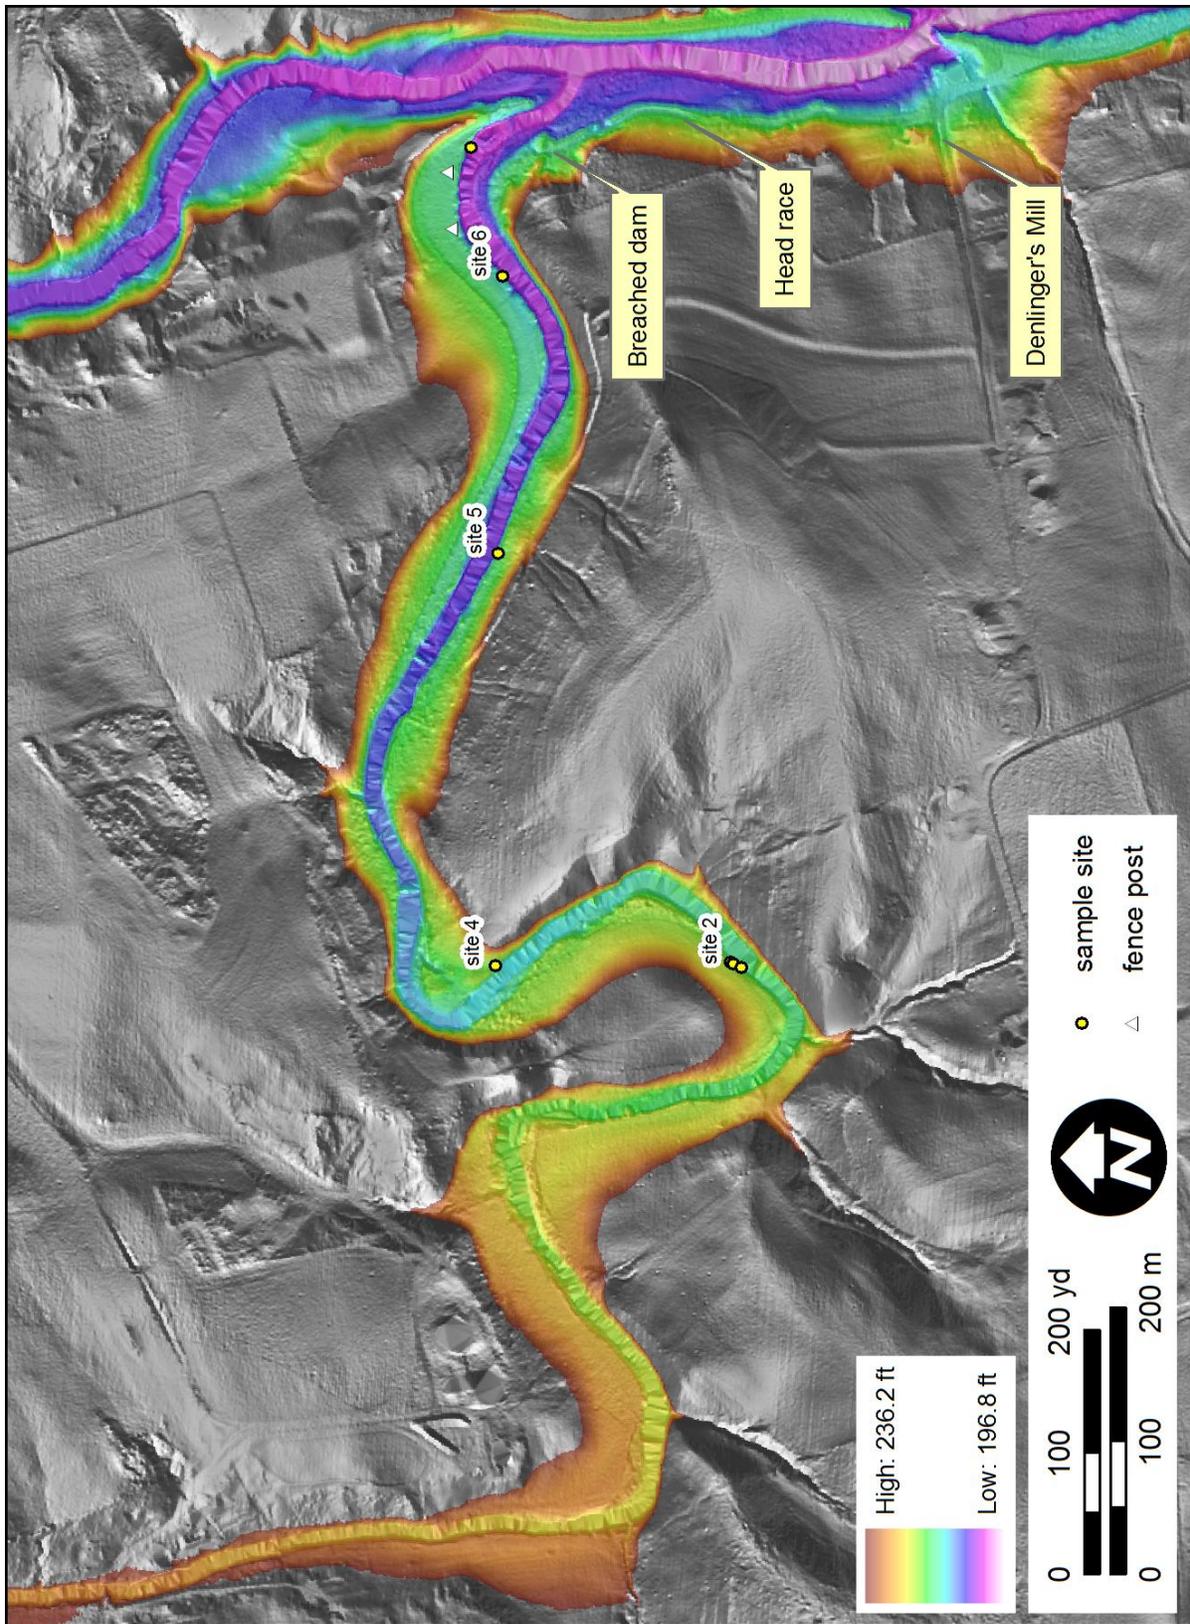
Figure 47. Little Conestoga Creek West Branch, 2005 lidar elevation map. Elevations between 196.8' and 236.2' are colored to aid in seeing elevation change along the channel.
