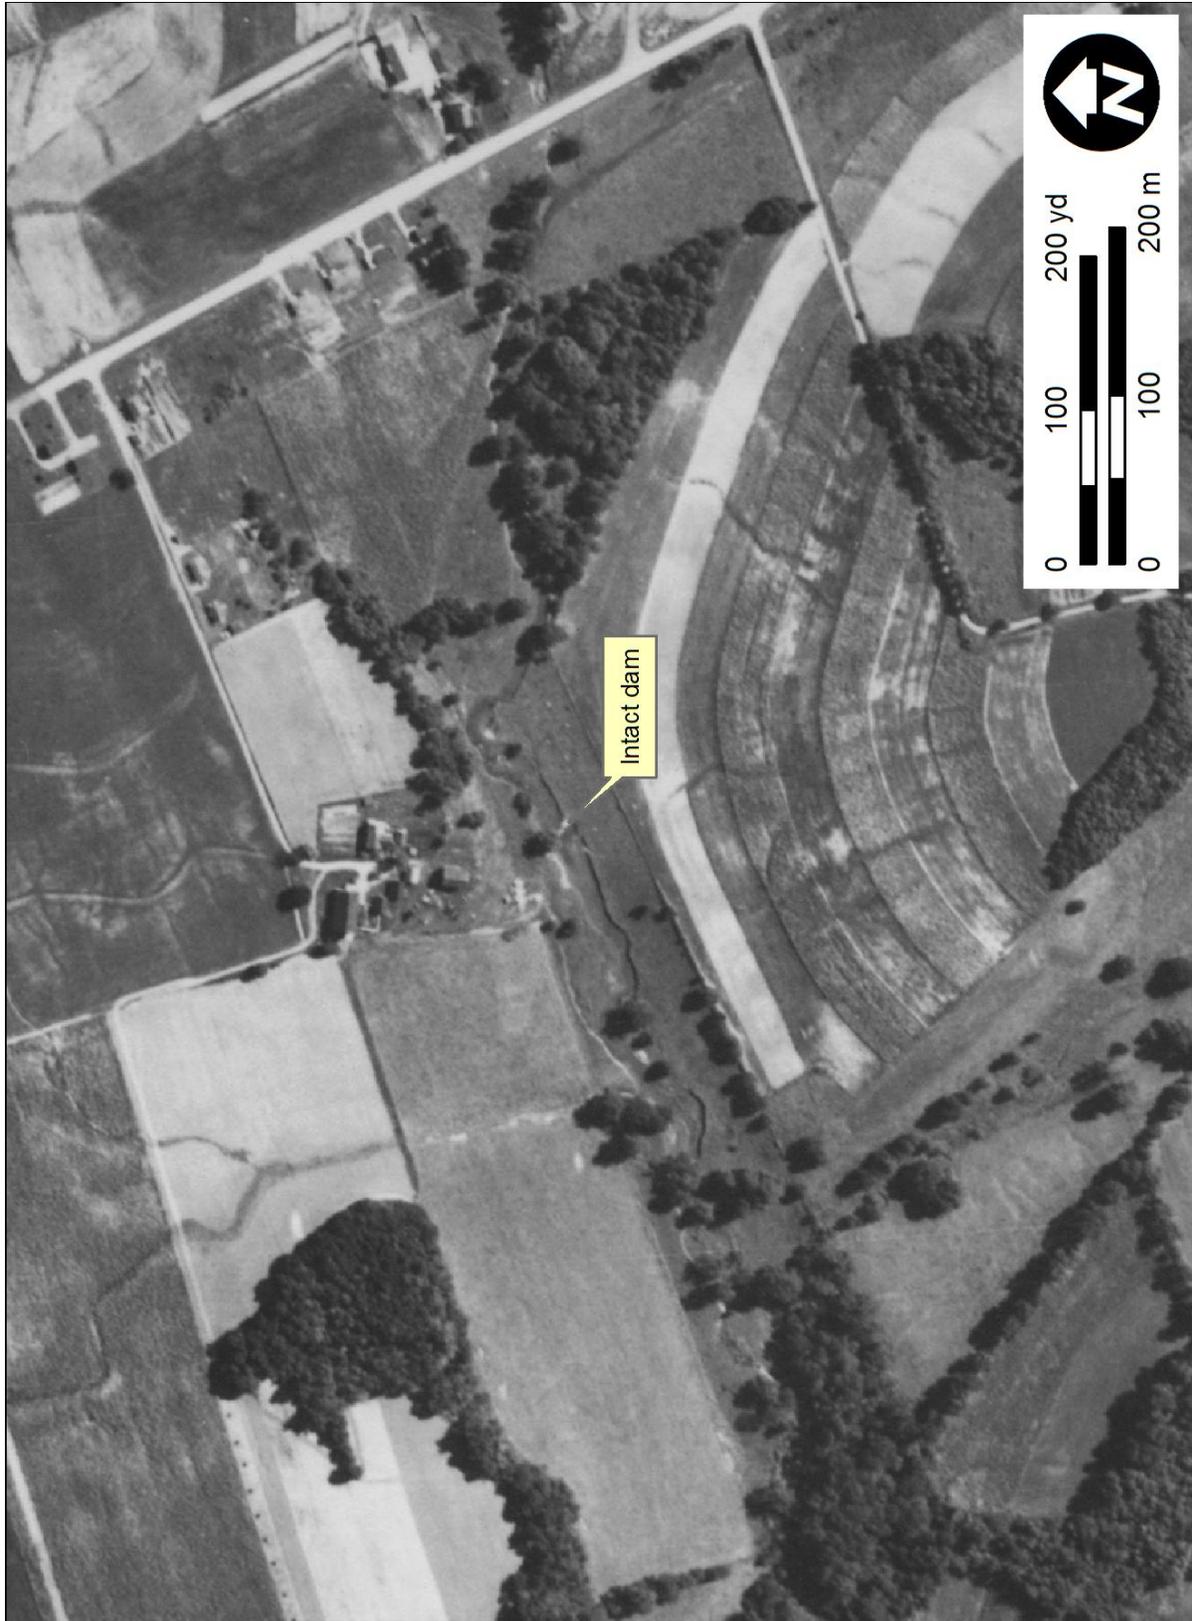
Figure 48. Big Beaver Creek, 1938 aerial photo.

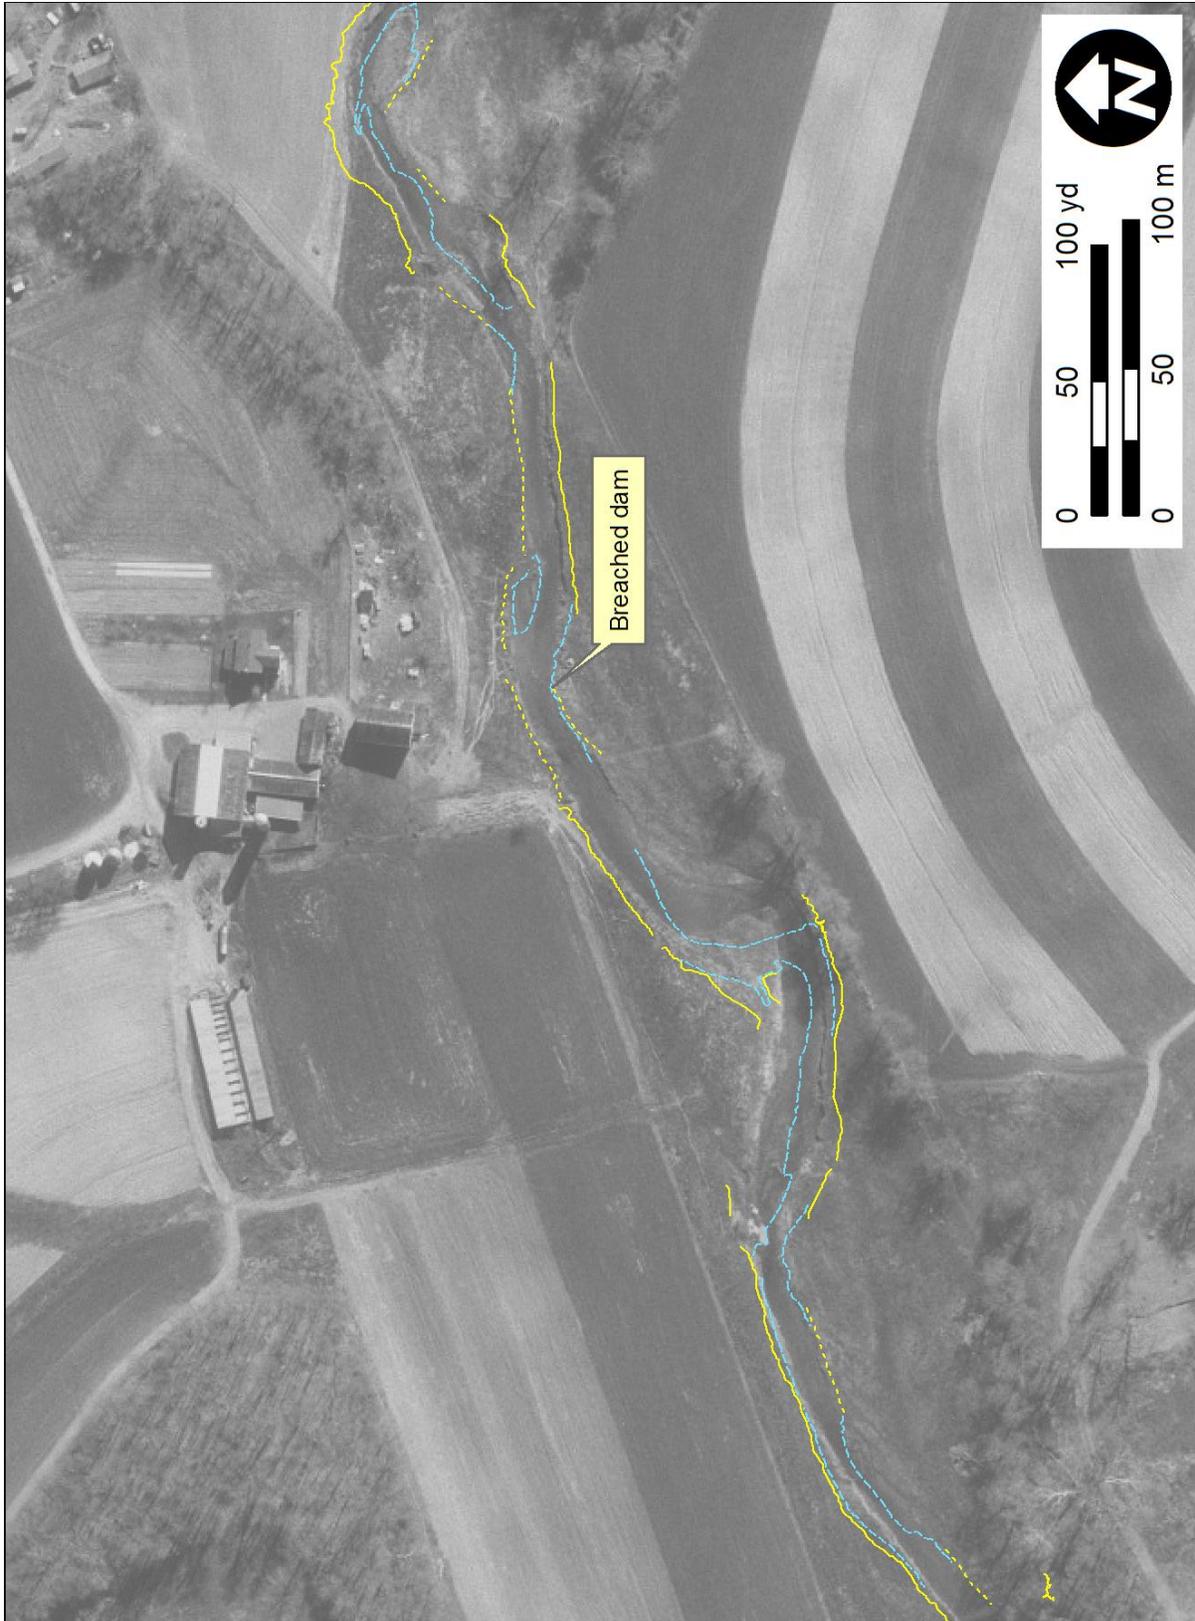
Figure 49. Big Beaver Creek. Surveyed breakline features, 2008, on 2001 orthoimage.

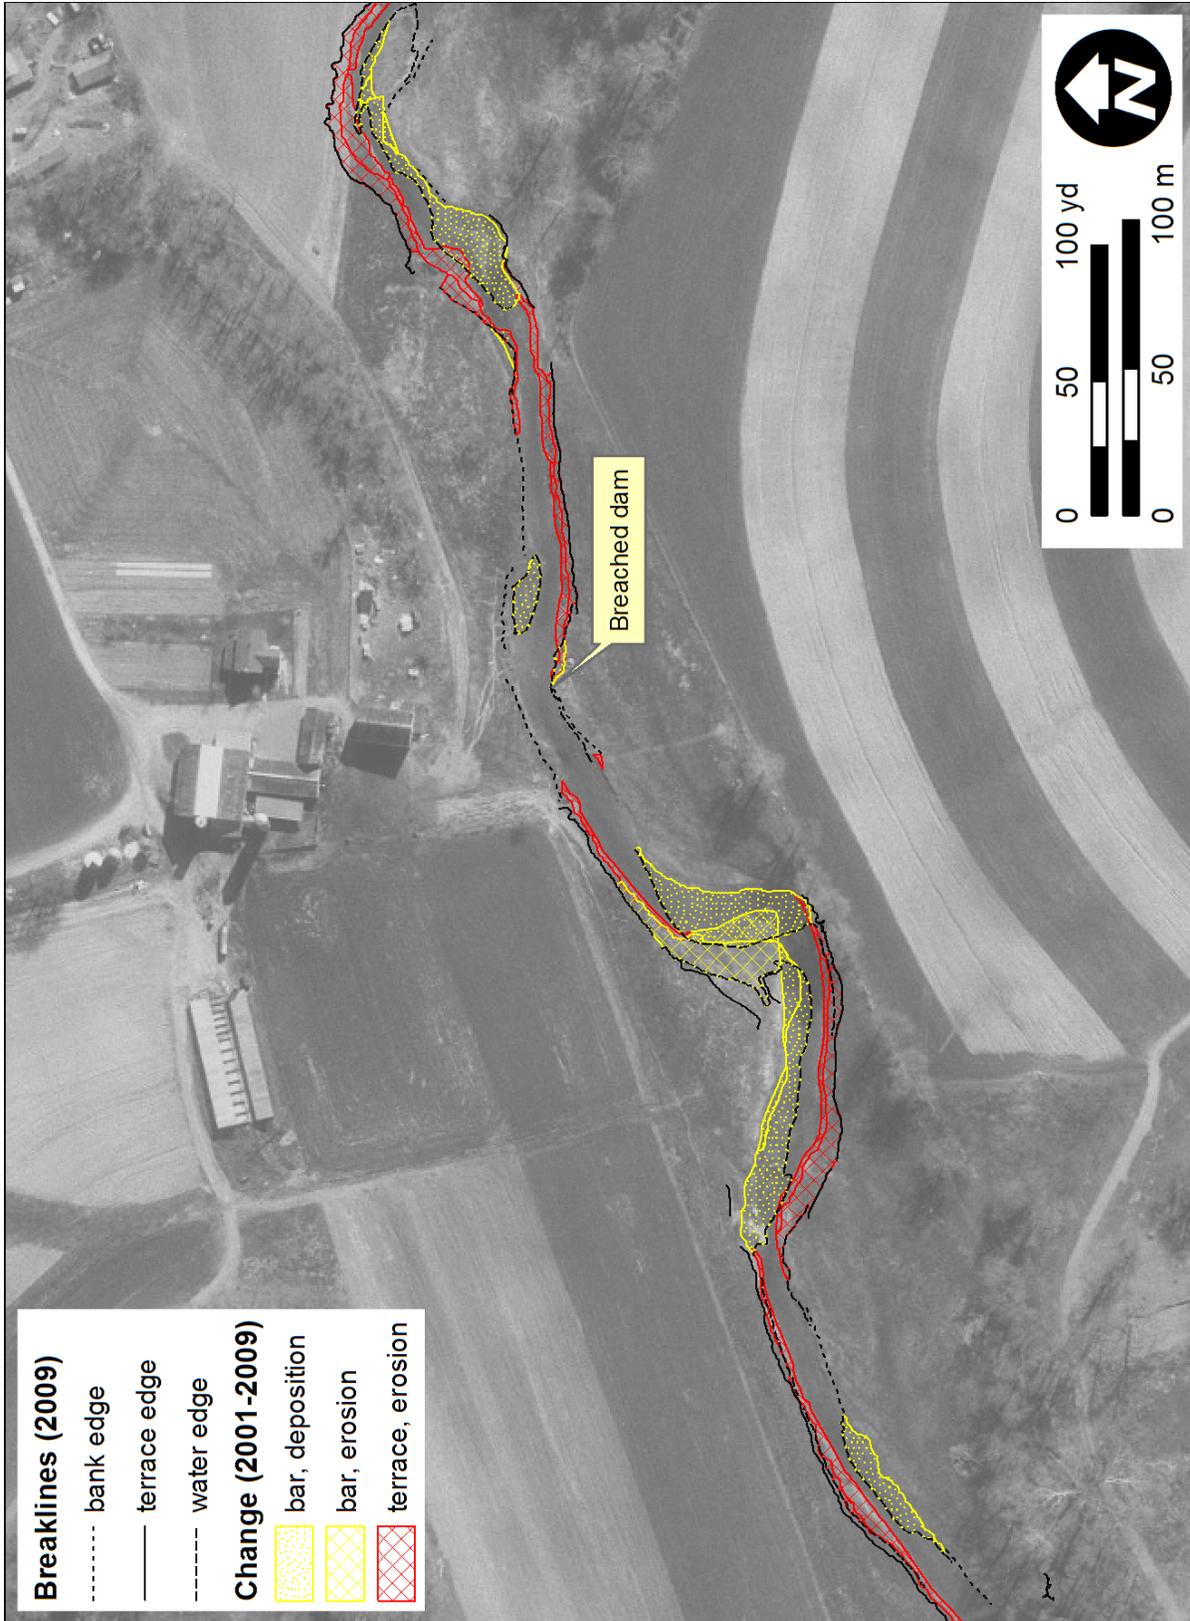
Figure 50. Big Beaver Creek. Changed areas, 2001-2009, on 2001 orthoimage.

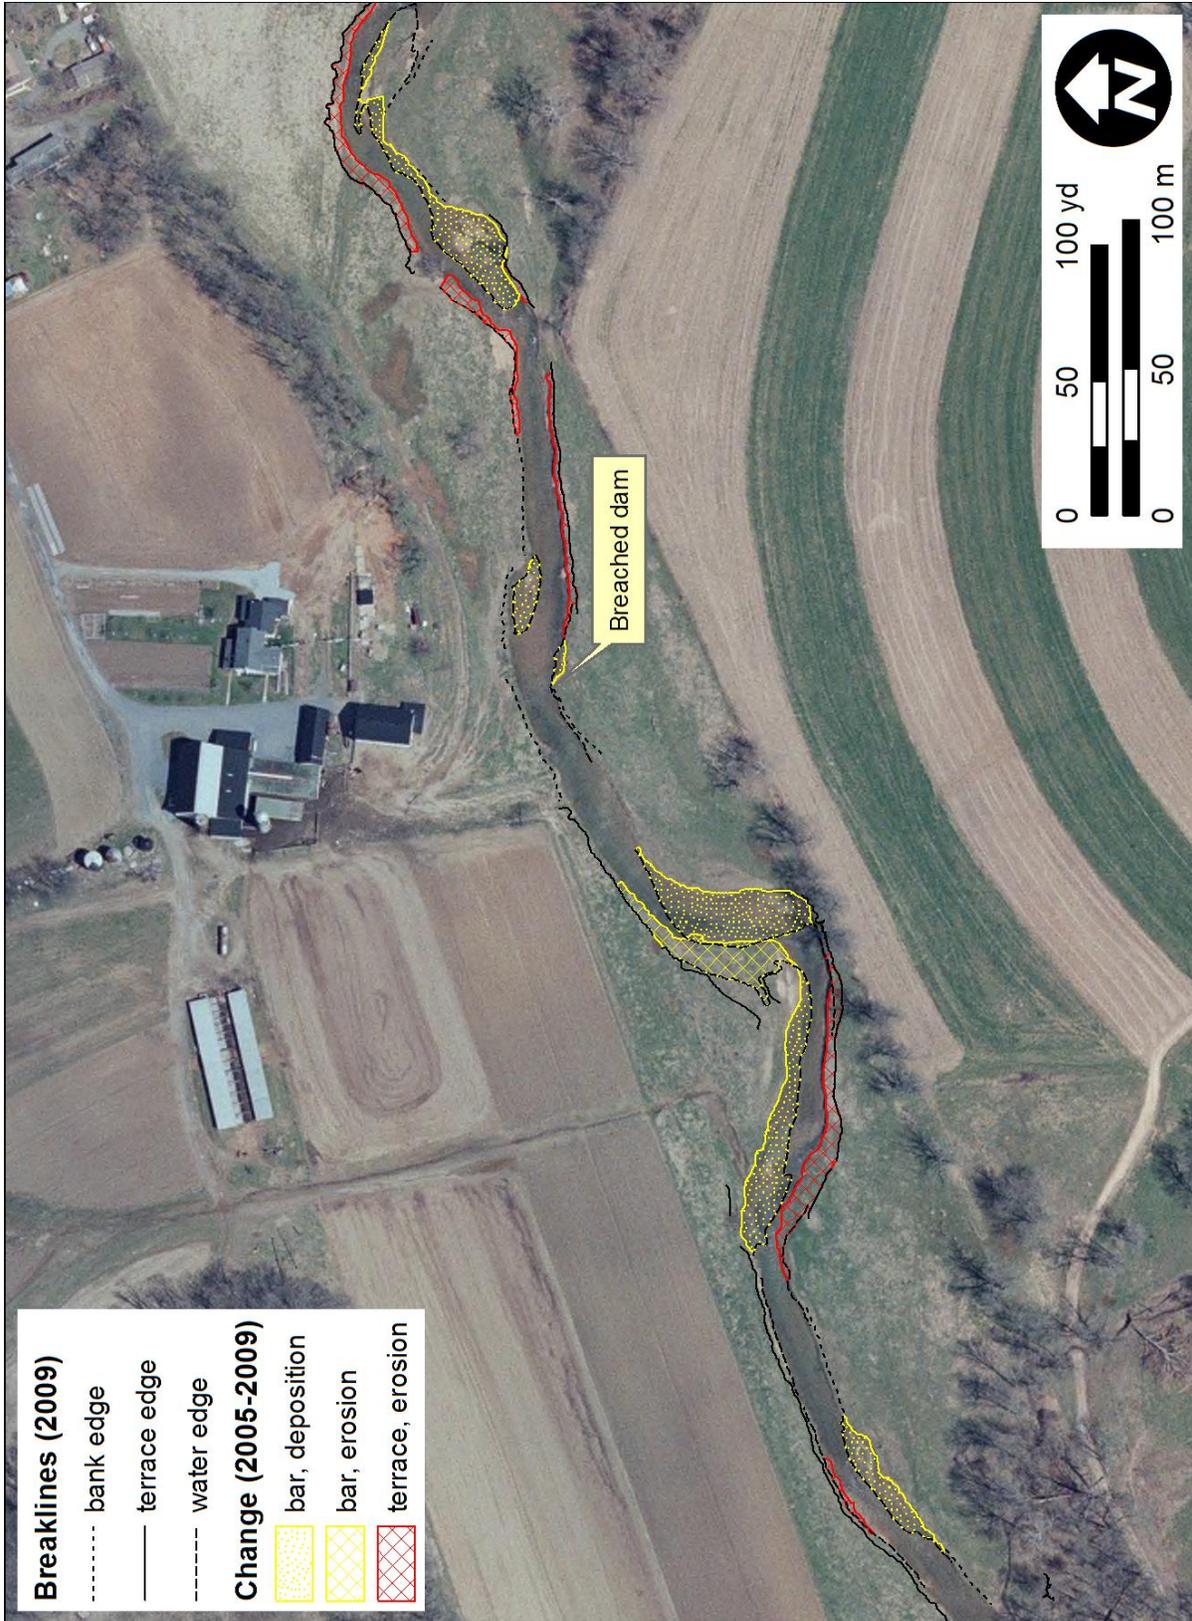
Figure 51. Big Beaver Creek. Changed areas, 2005-2009, on 2005 orthoimage.

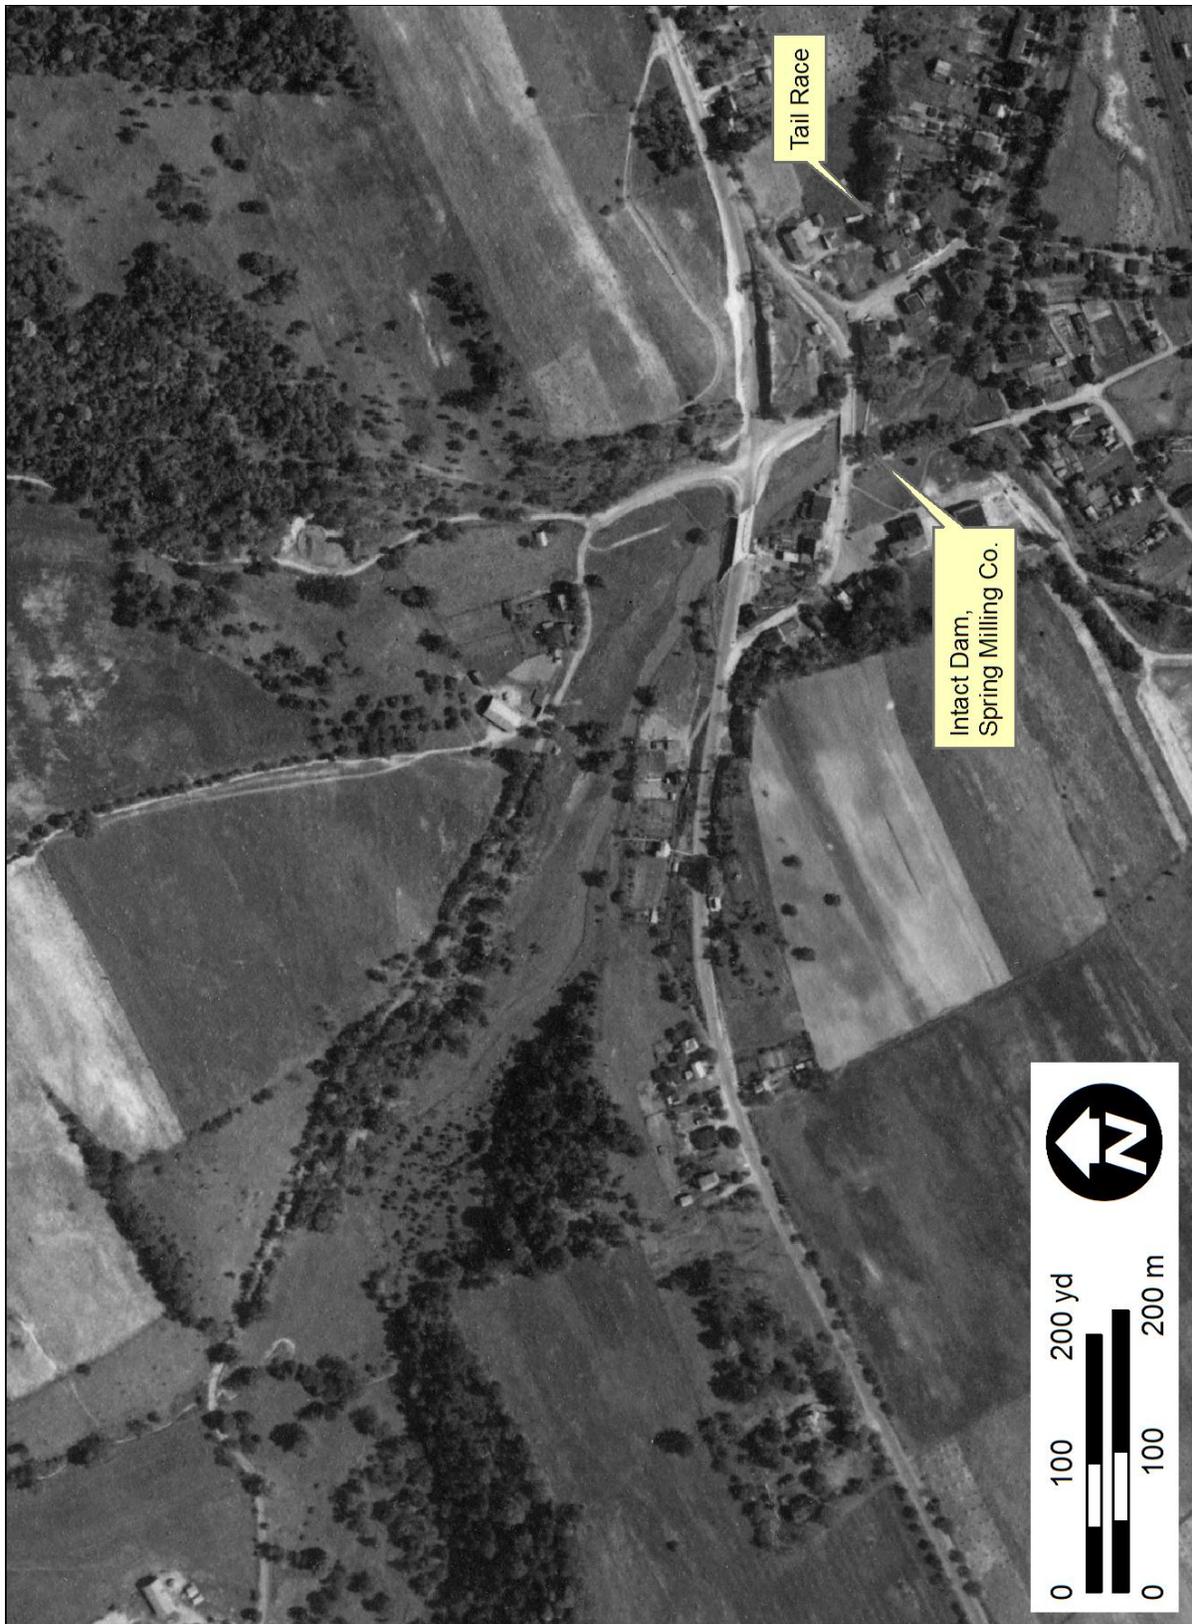
Figure 52. Penns Creek, 1938 aerial photo.

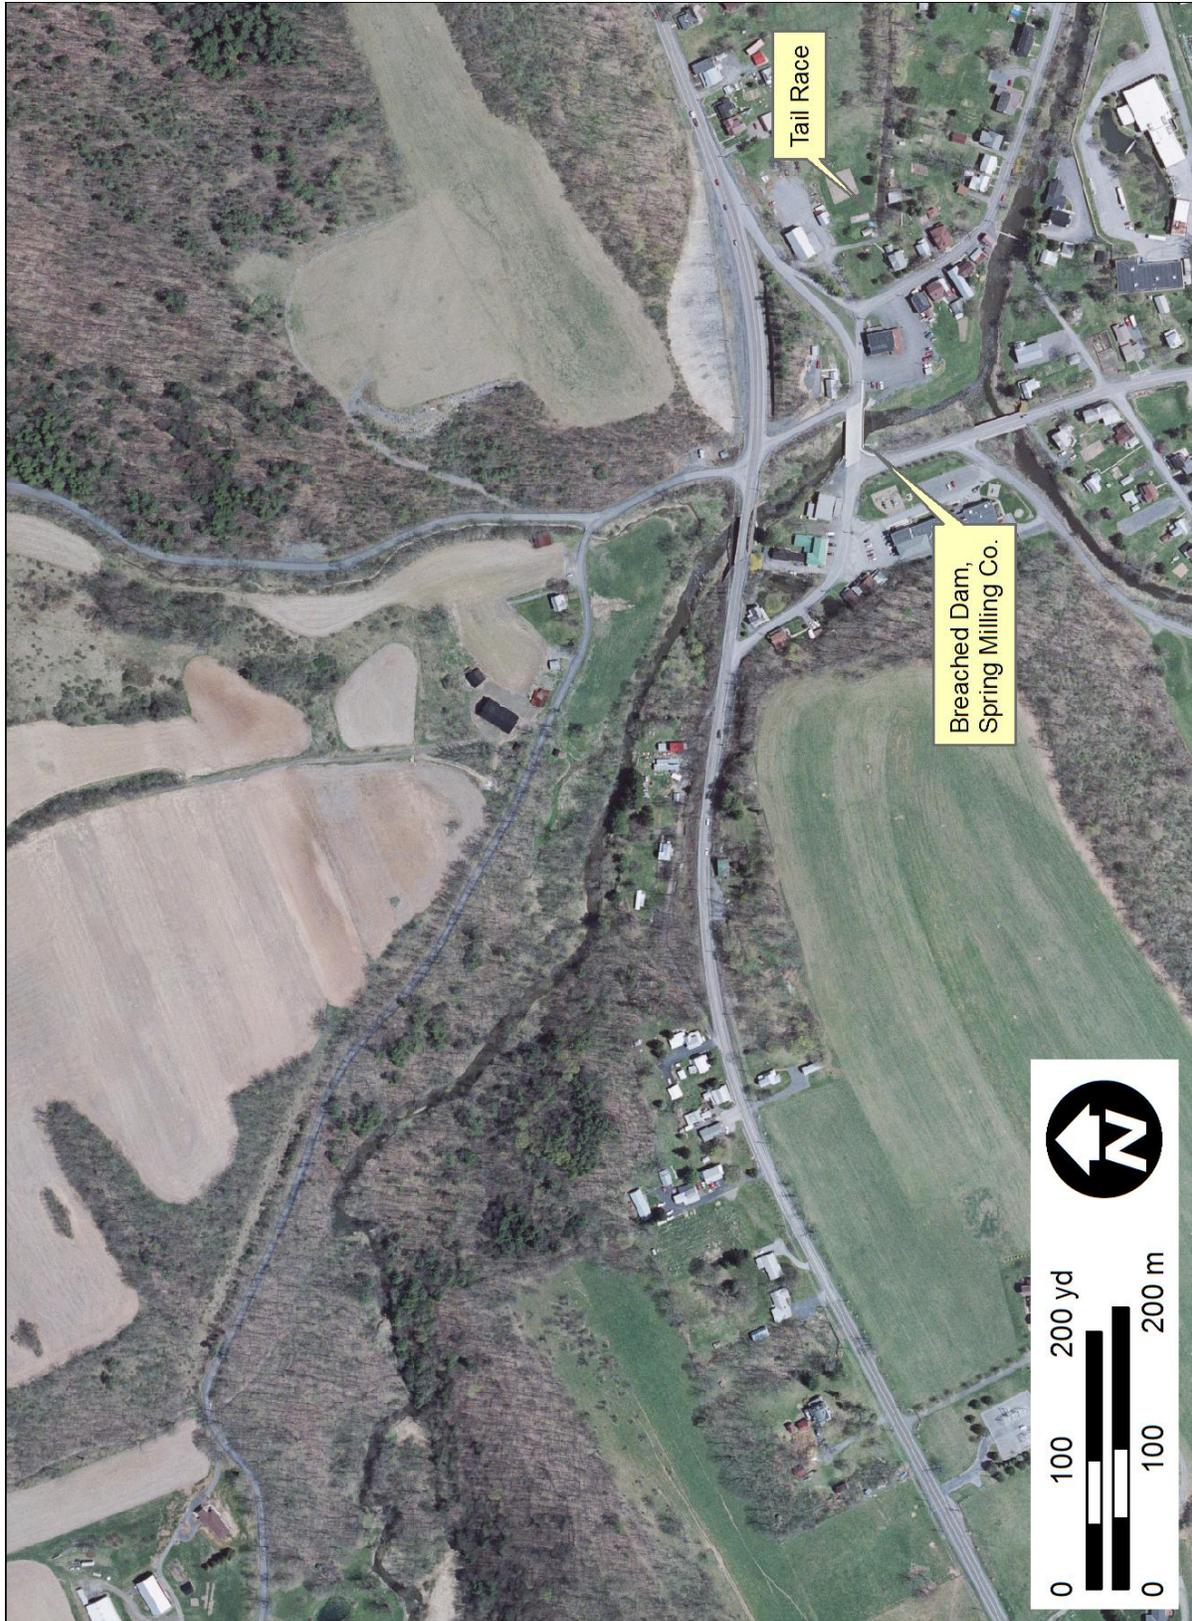
Figure 53. Penns Creek, 2006 orthoimage.

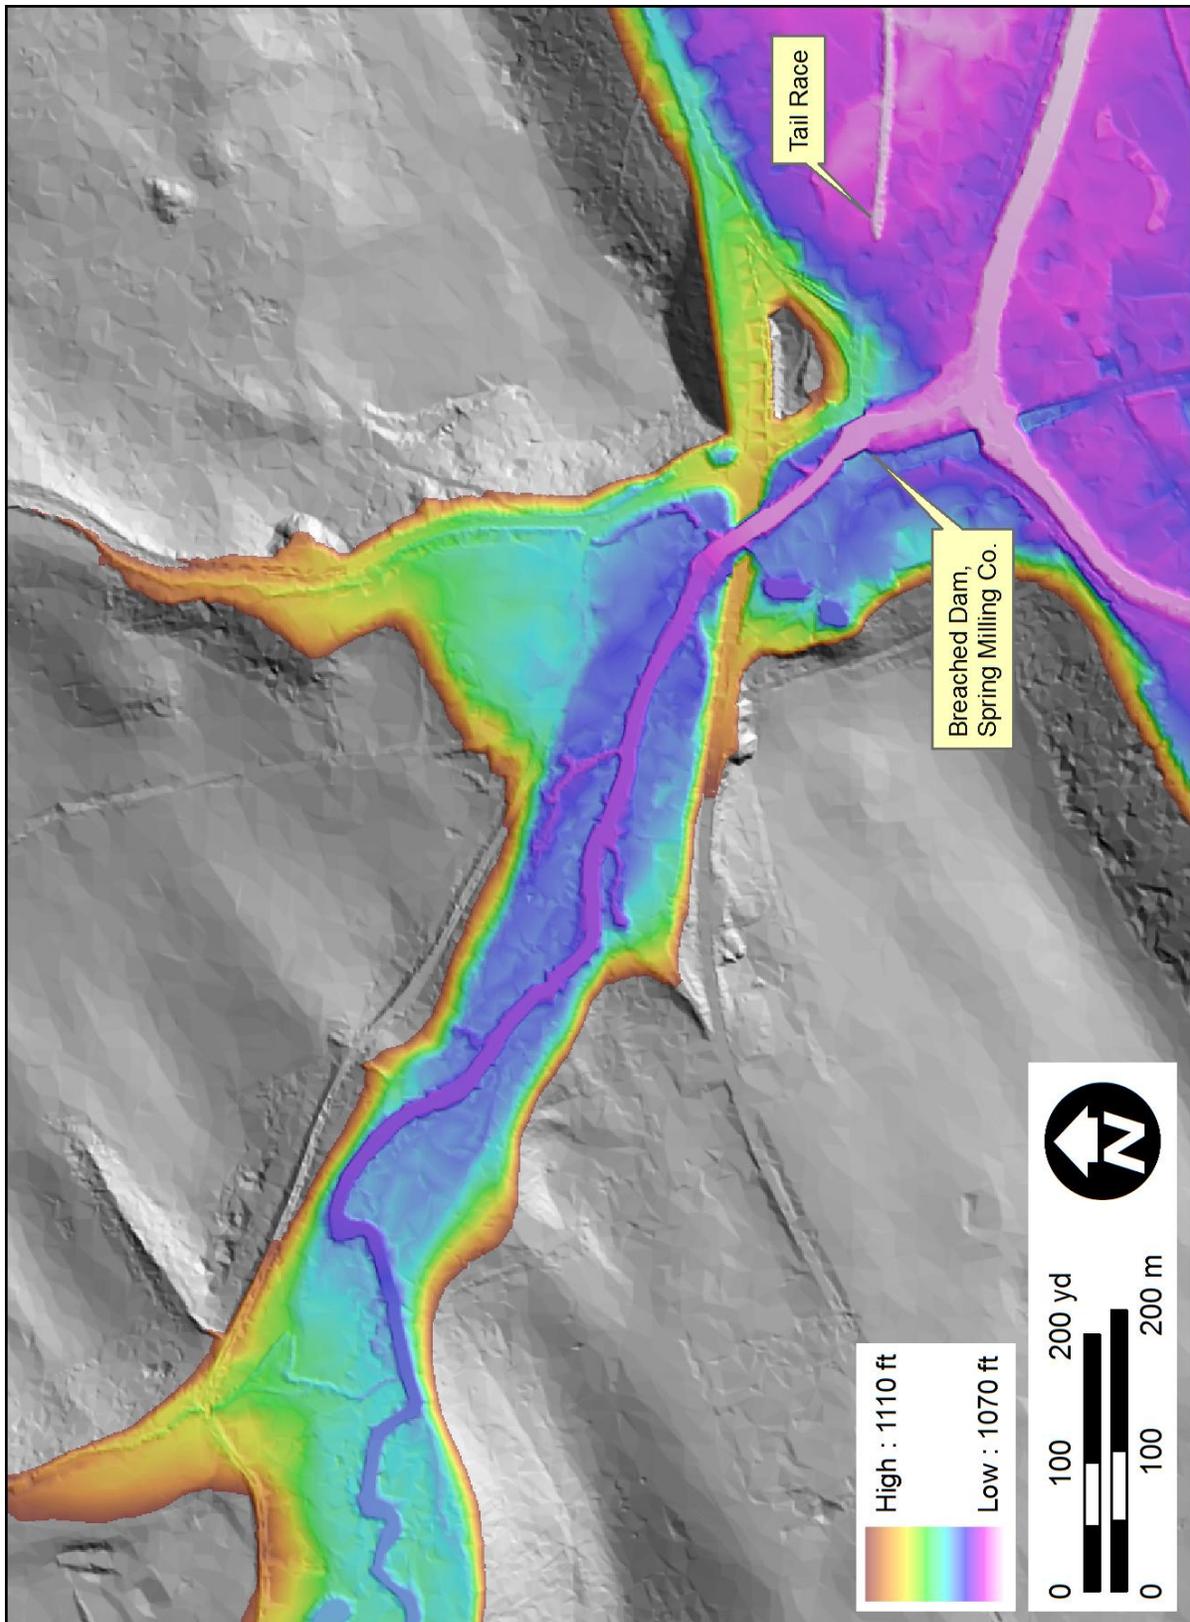
Figure 54. Penns Creek, 2006 lidar. Elevations between 1070' and 1110' are colored to aid in seeing elevation change along the channel.

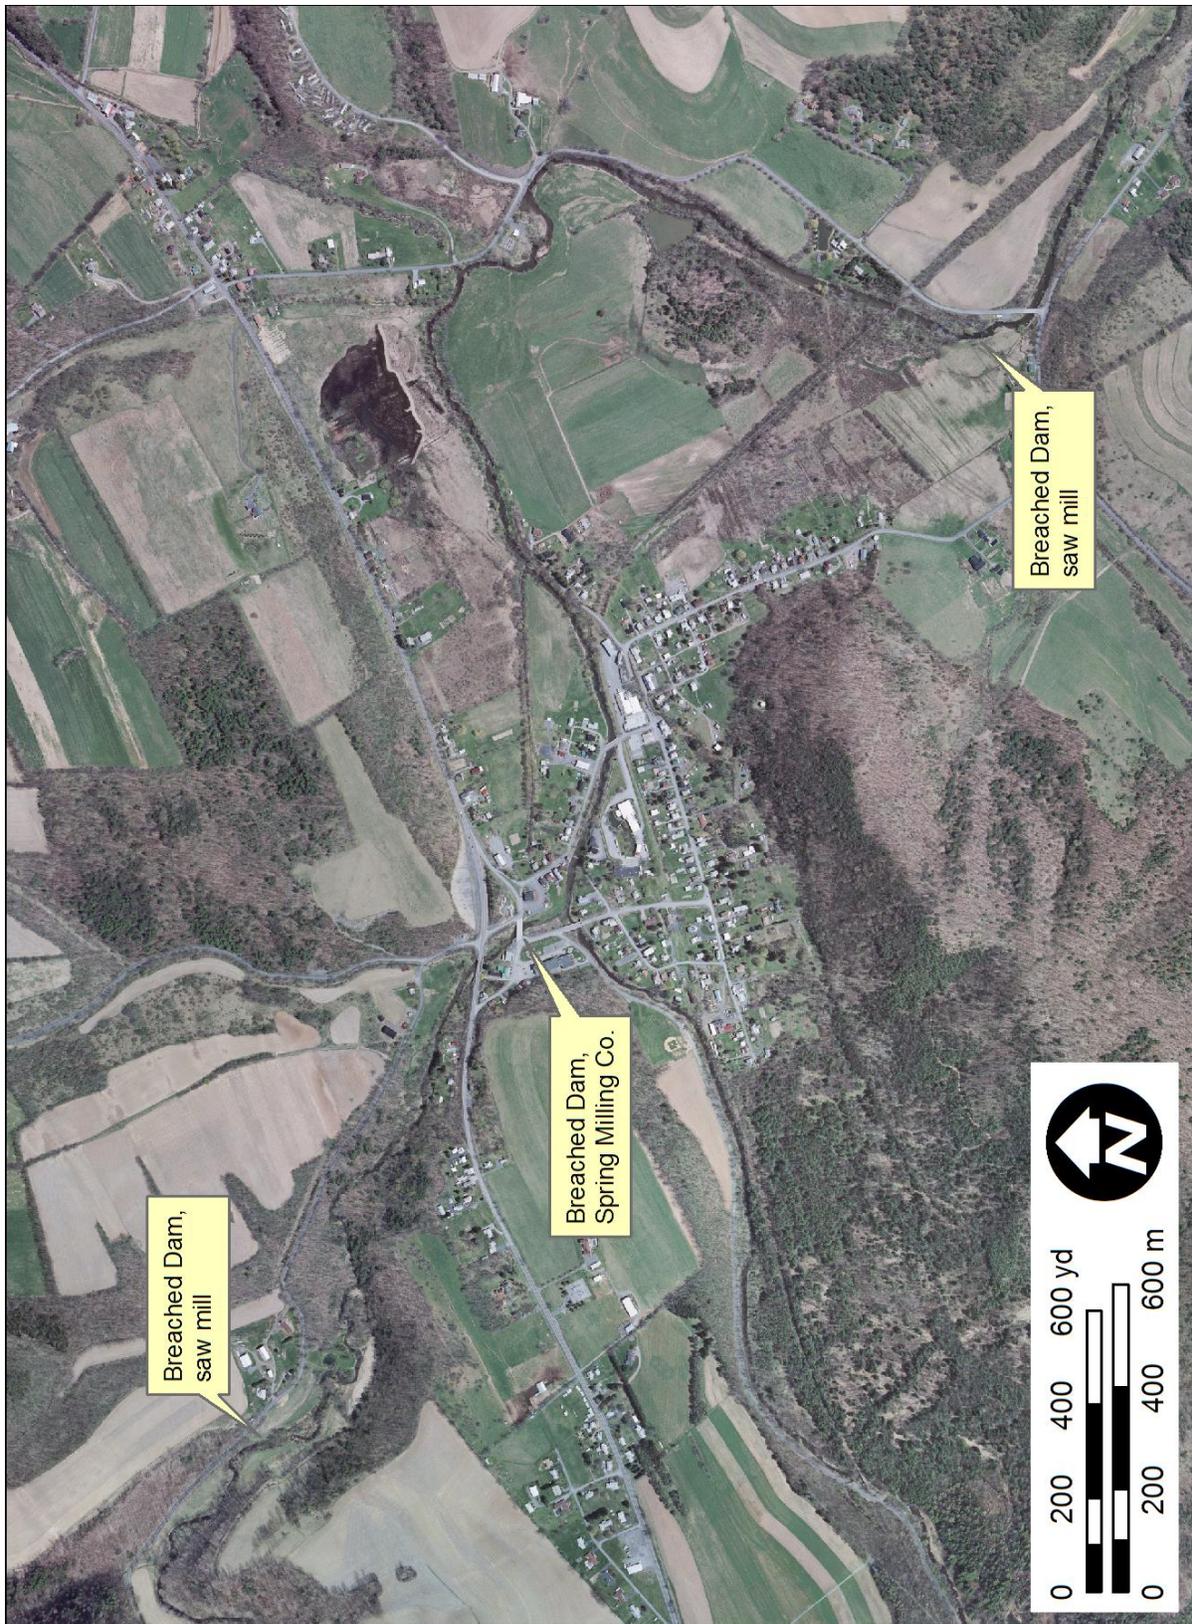
Figure 55. Penns Creek, 2006 orthoimage.

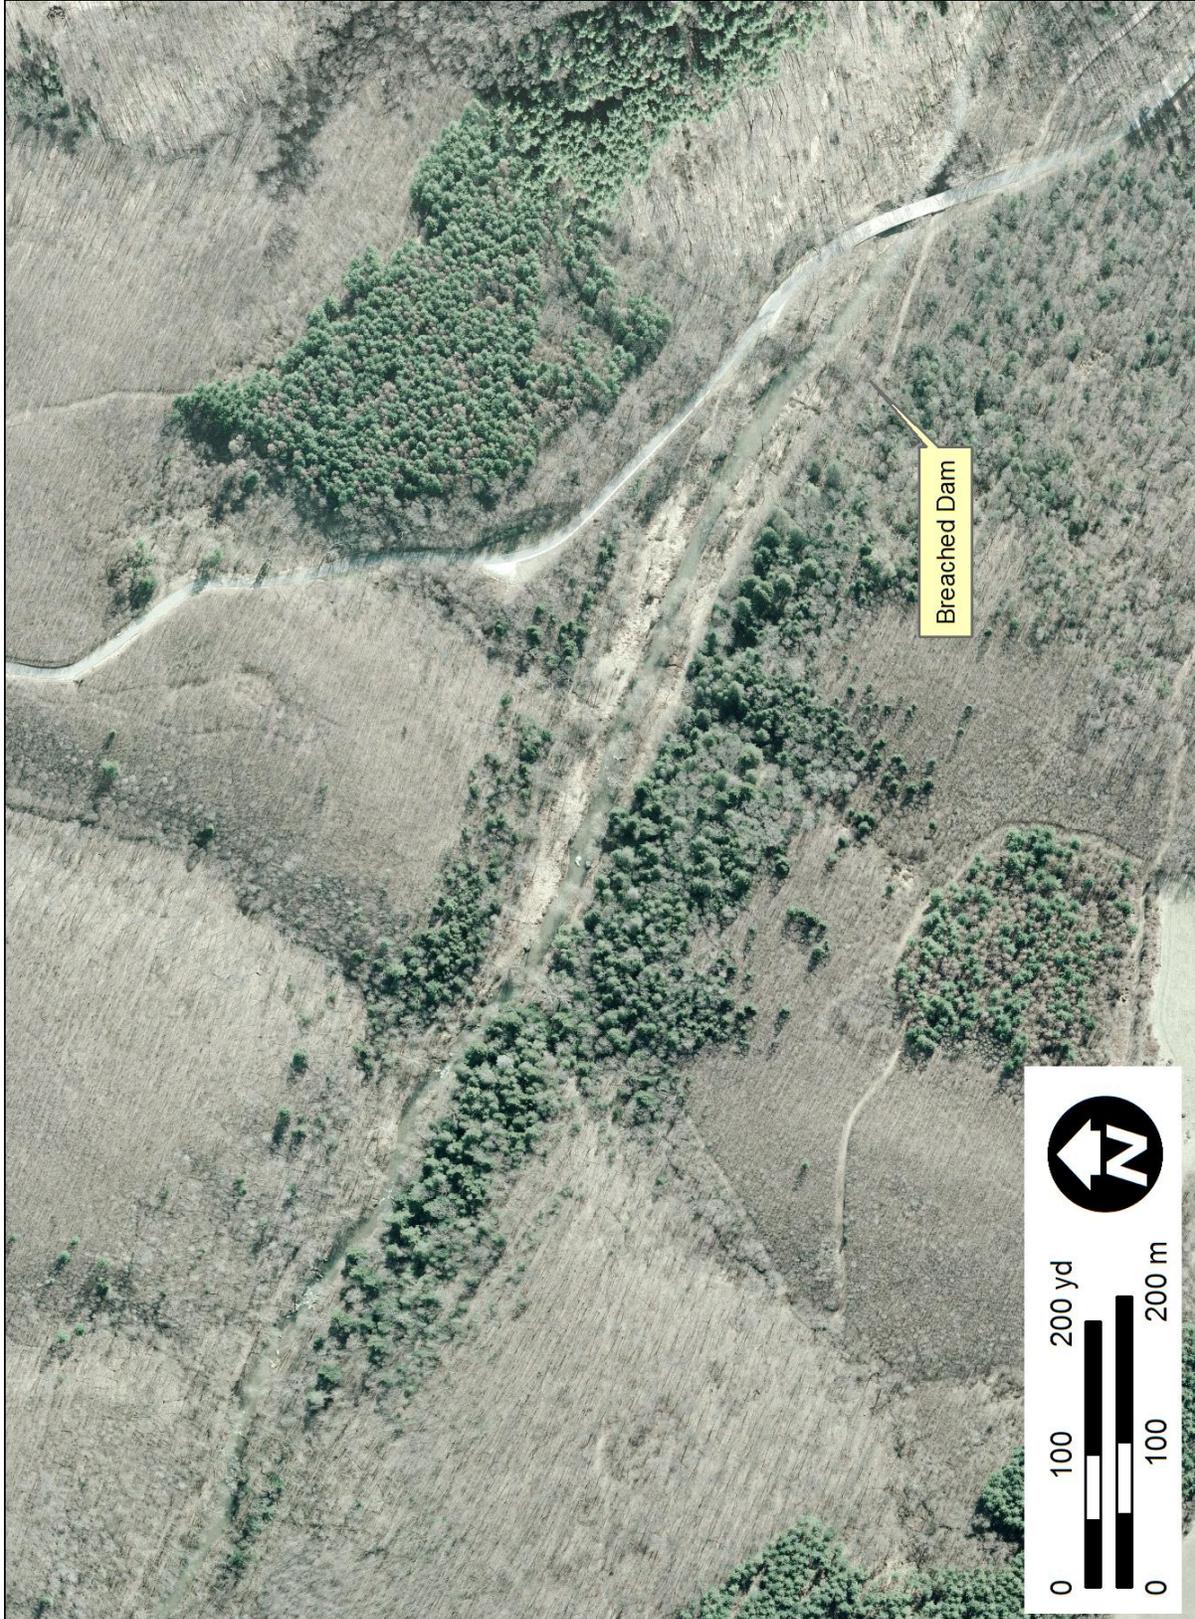
Figure 56. Gunpowder Falls, 2005 orthoimage, with breached Hoffman paper milldam.

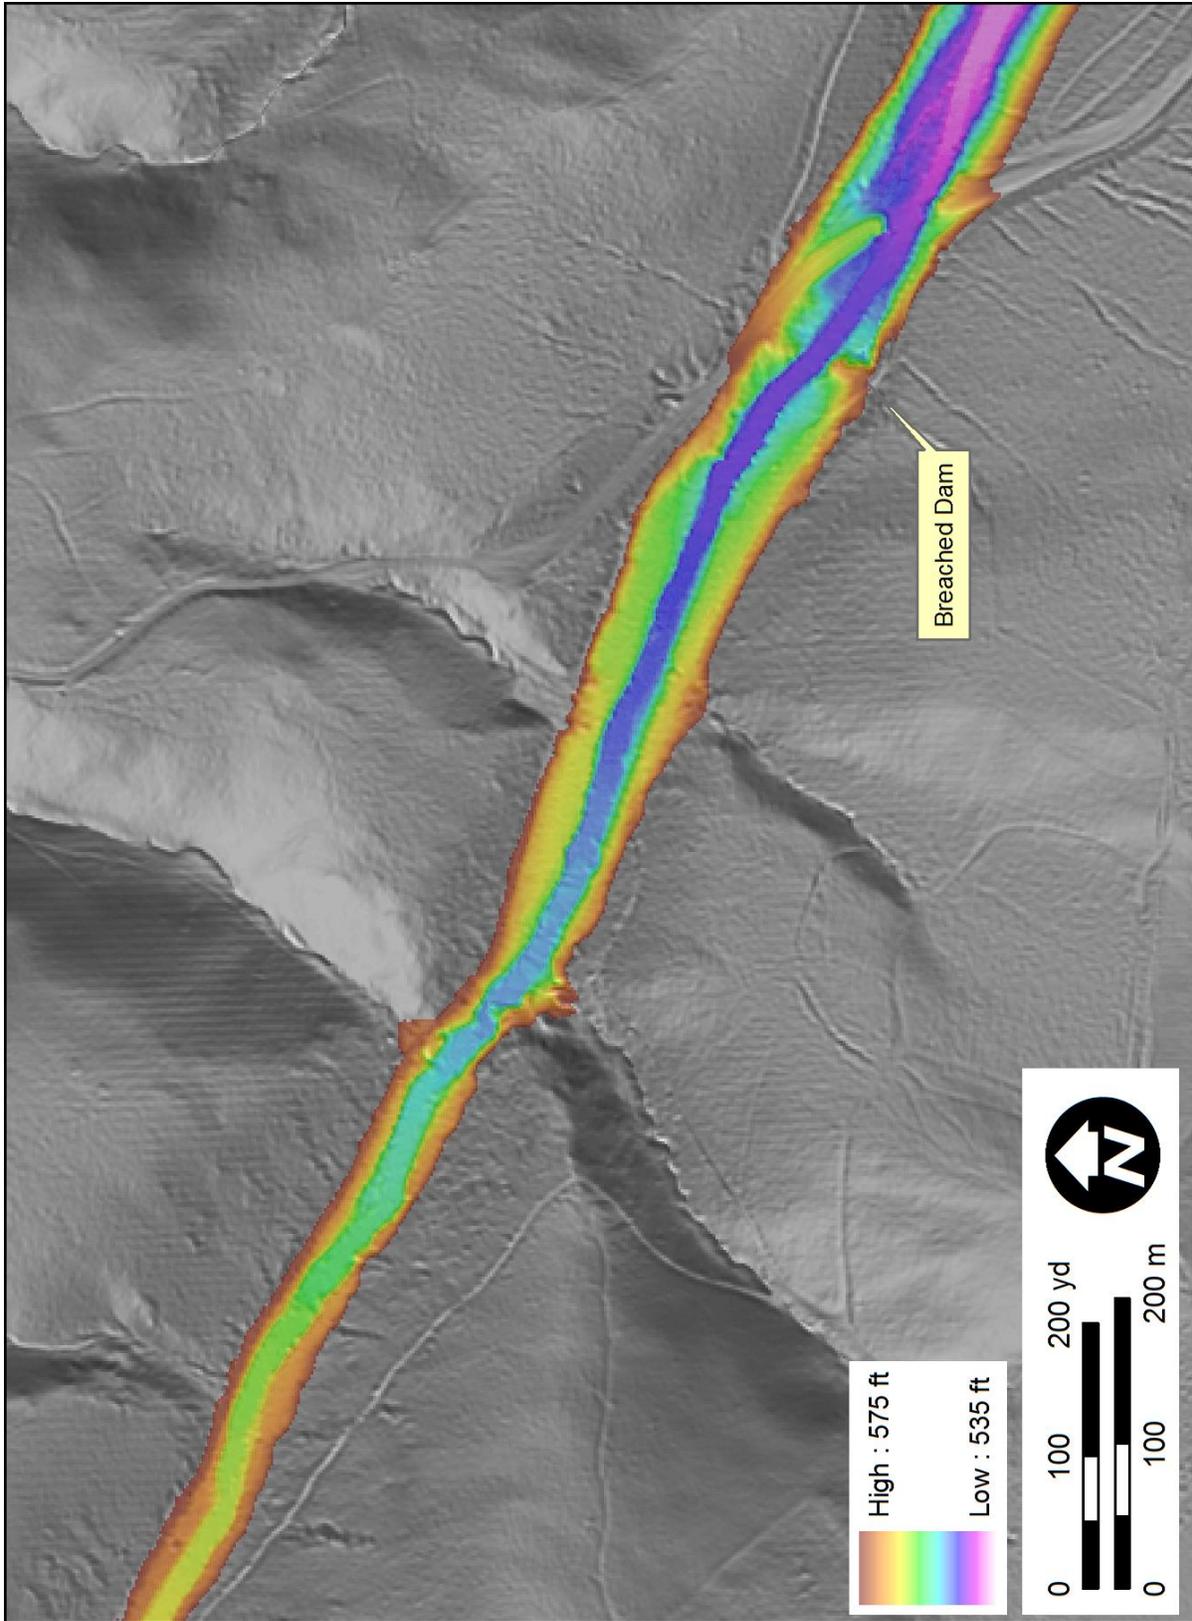
Figure 57. Gunpowder Falls, 2005 lidar, with breached Hoffman paper milldam. Elevations between 535' and 575' are colored to aid in seeing elevation change along the channel.

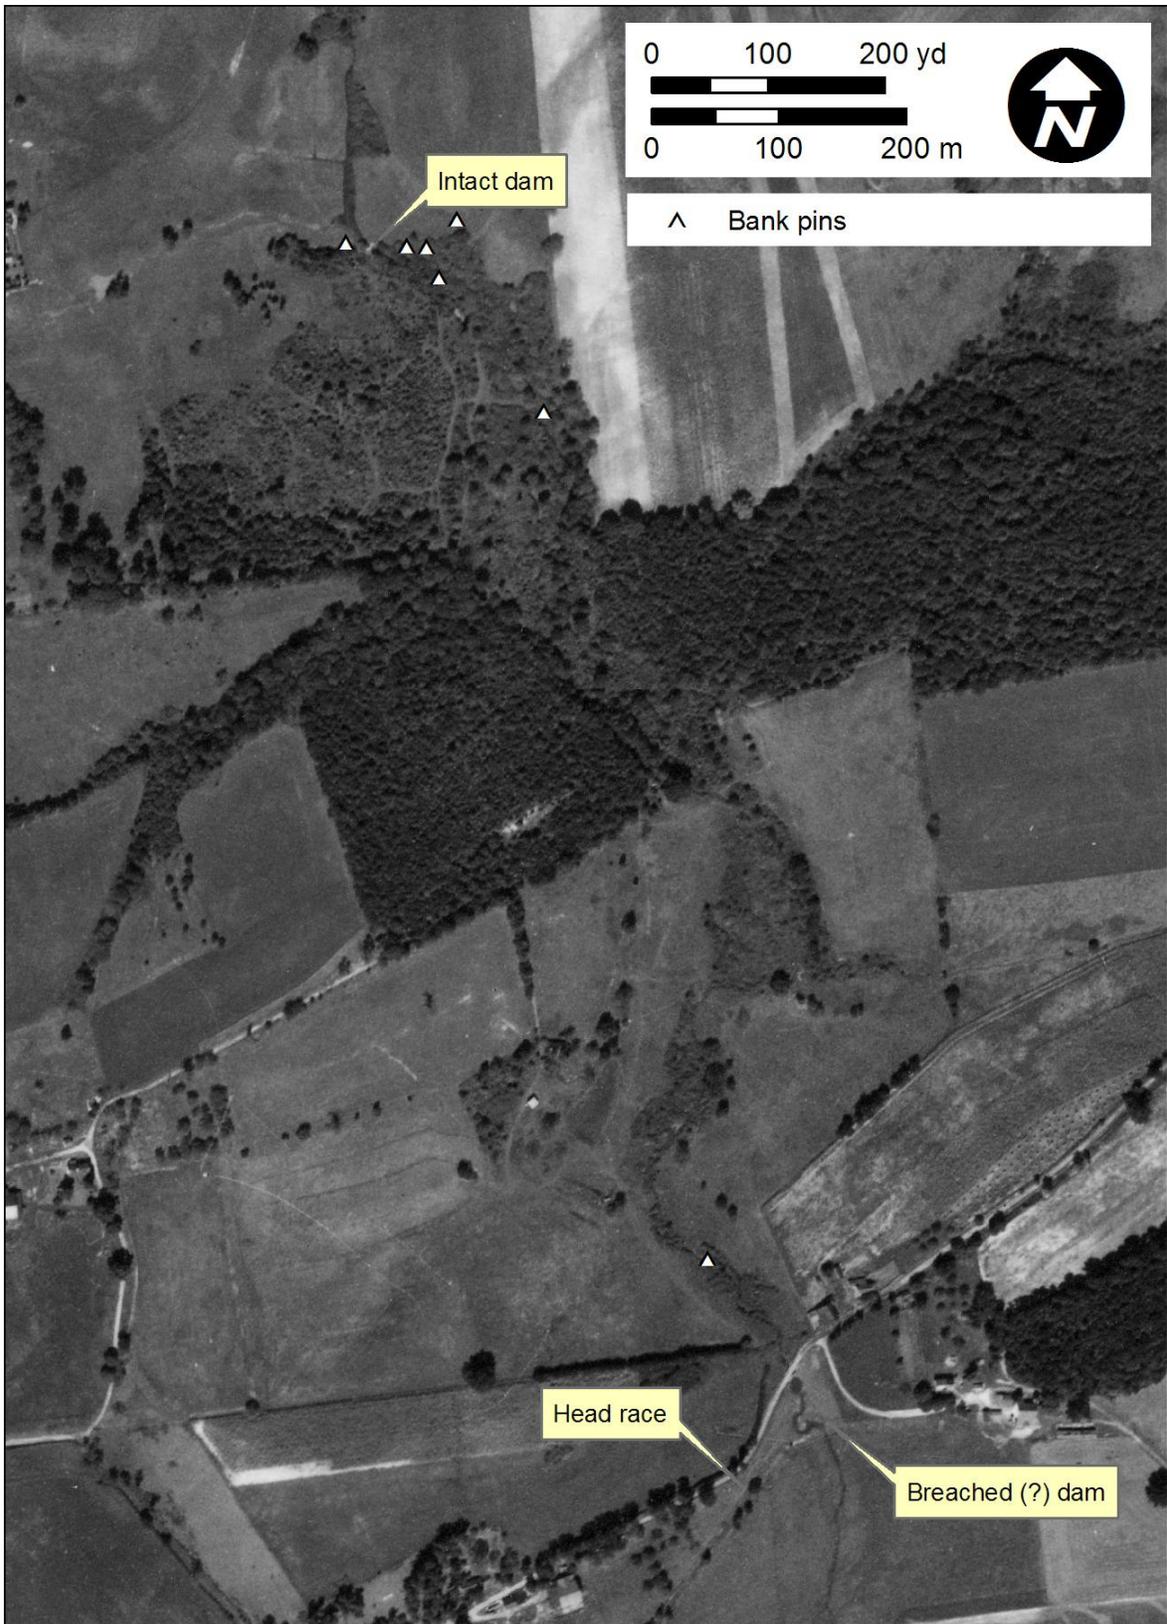
Figure 58. White Clay Creek, 1937 aerial photo. White triangles indicate bank pin locations.

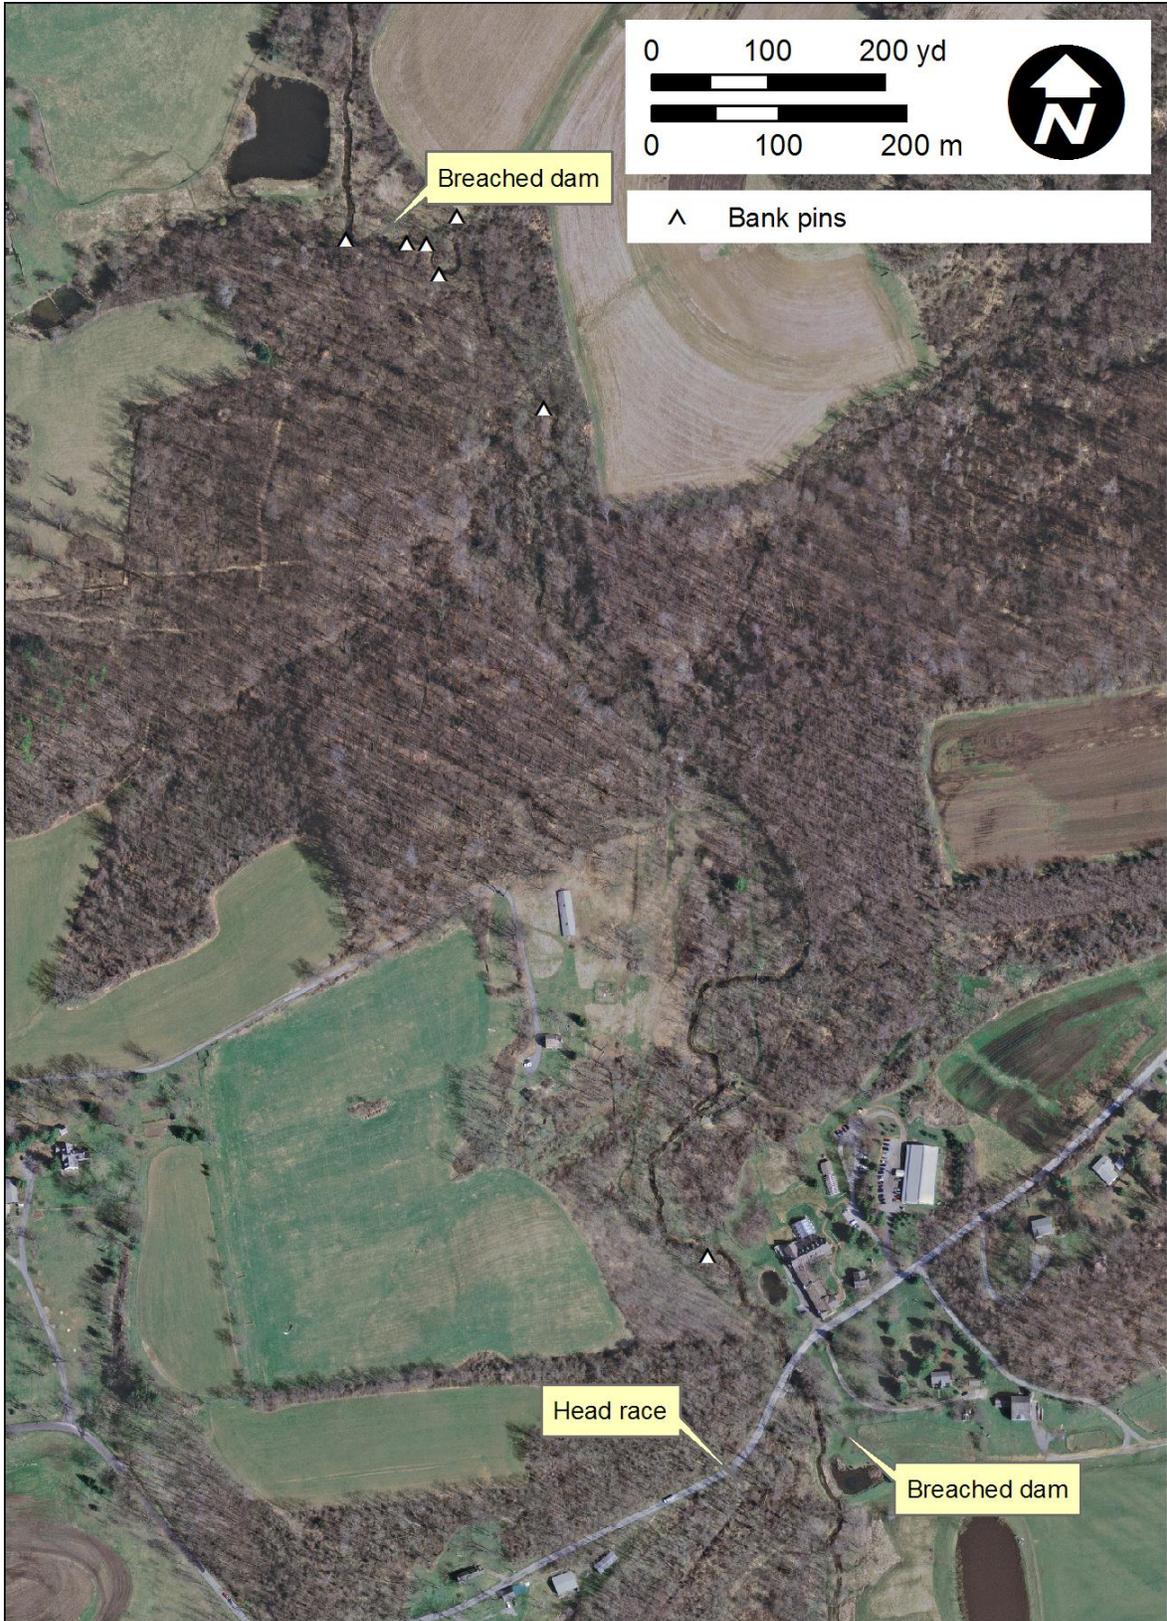
Figure 59. White Clay Creek, 2005 orthoimage. White triangles indicate bank pin locations.
