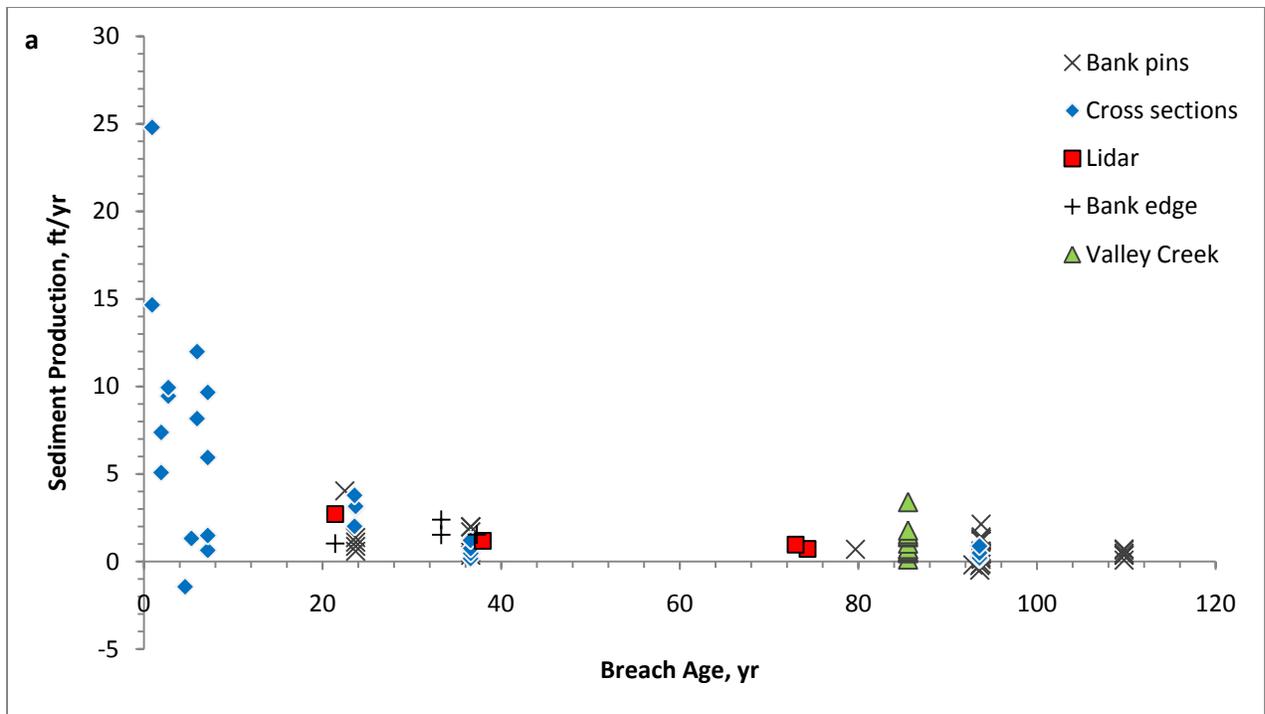
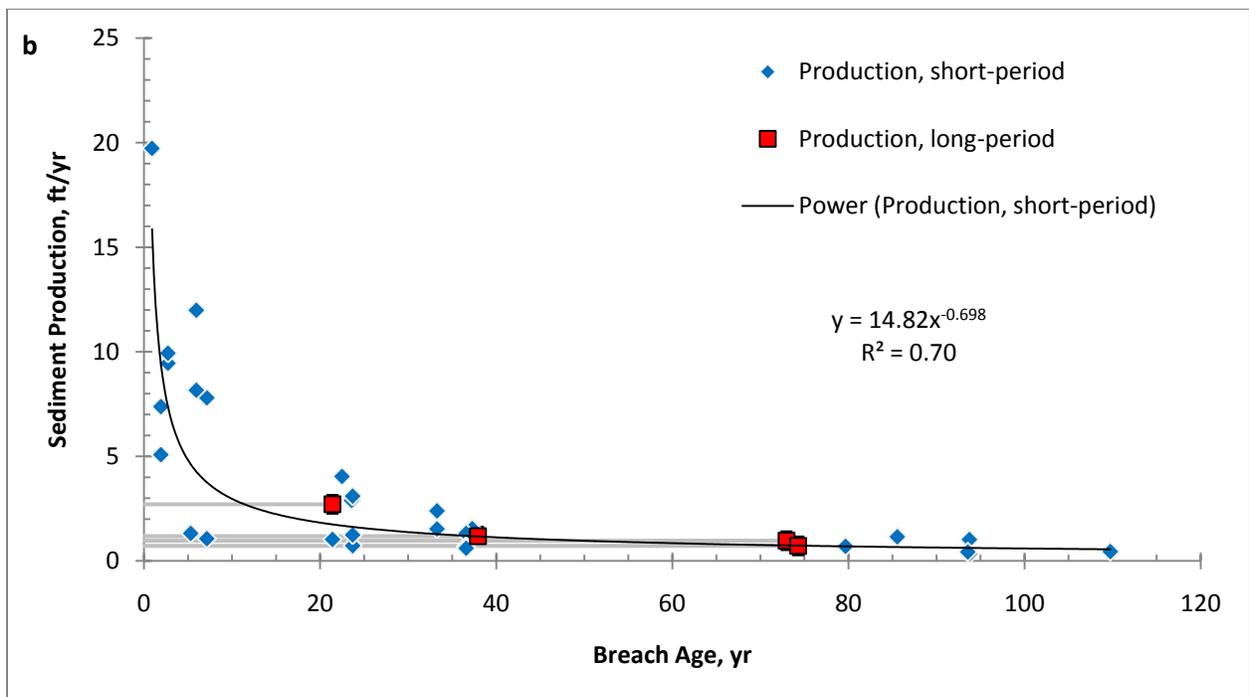
Figure 60. Sediment production in $\text{ft}^3/\text{ft}/\text{ft}/\text{yr}$, or ft/yr , versus time since dam breach in years. (a) Data are presented by method used in investigation. The data for this plot are presented in Appendices C and D and were summarized for each site in Section 4. Valley Creek data from Fraley et al., (2009) are from repeat bank edge and channel cross section surveying. (b) Data are presented by time period of measurement, as short-period and long-period. Horizontal bars indicate the period of measurement for long-period production estimates (from lidar-derived channel volume). Short-period estimates are measurements made over a period of one to five years (from bank pins, cross-sections and bank edge digitization). A power function fit to the data has a relatively high correlation coefficient.

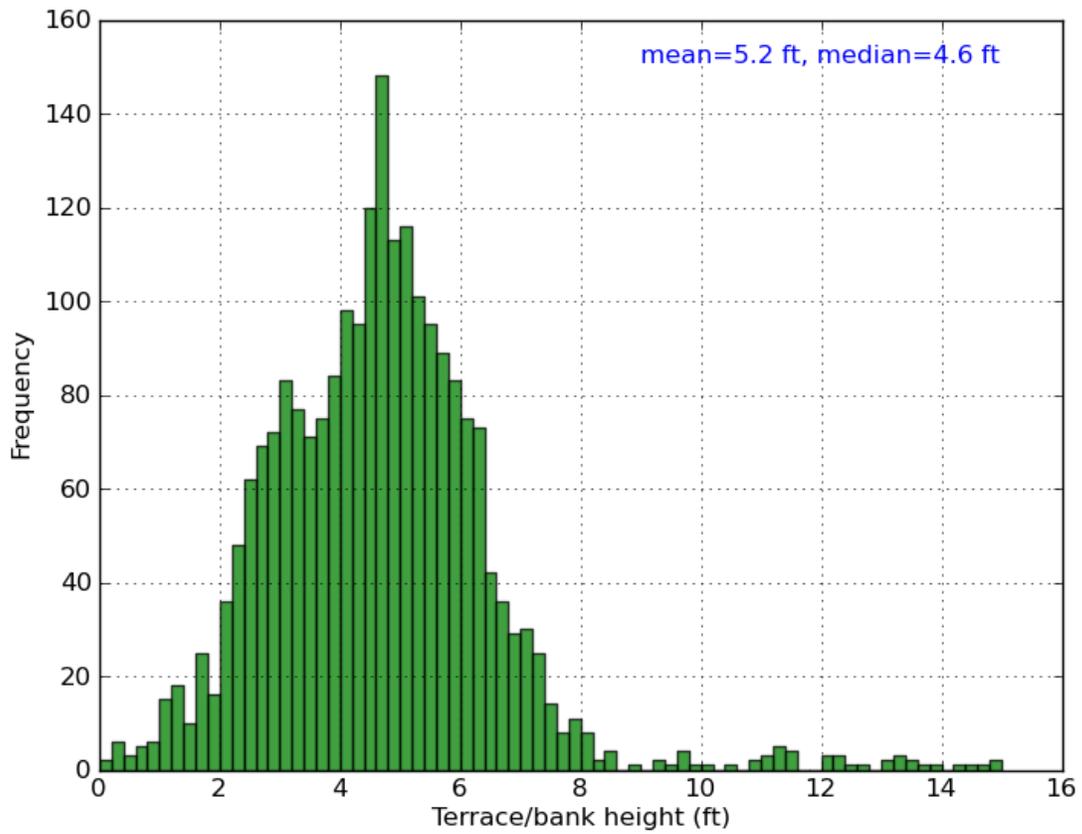
Figure 61. Histogram created by sampling, from lidar, the terrace (or bank) elevation above water surface at twenty meter intervals along the mainstems of Little Conestoga Creek, and Little Conestoga Creek West Branch. Mean height is 5.2 feet. Median height is 4.6 feet.

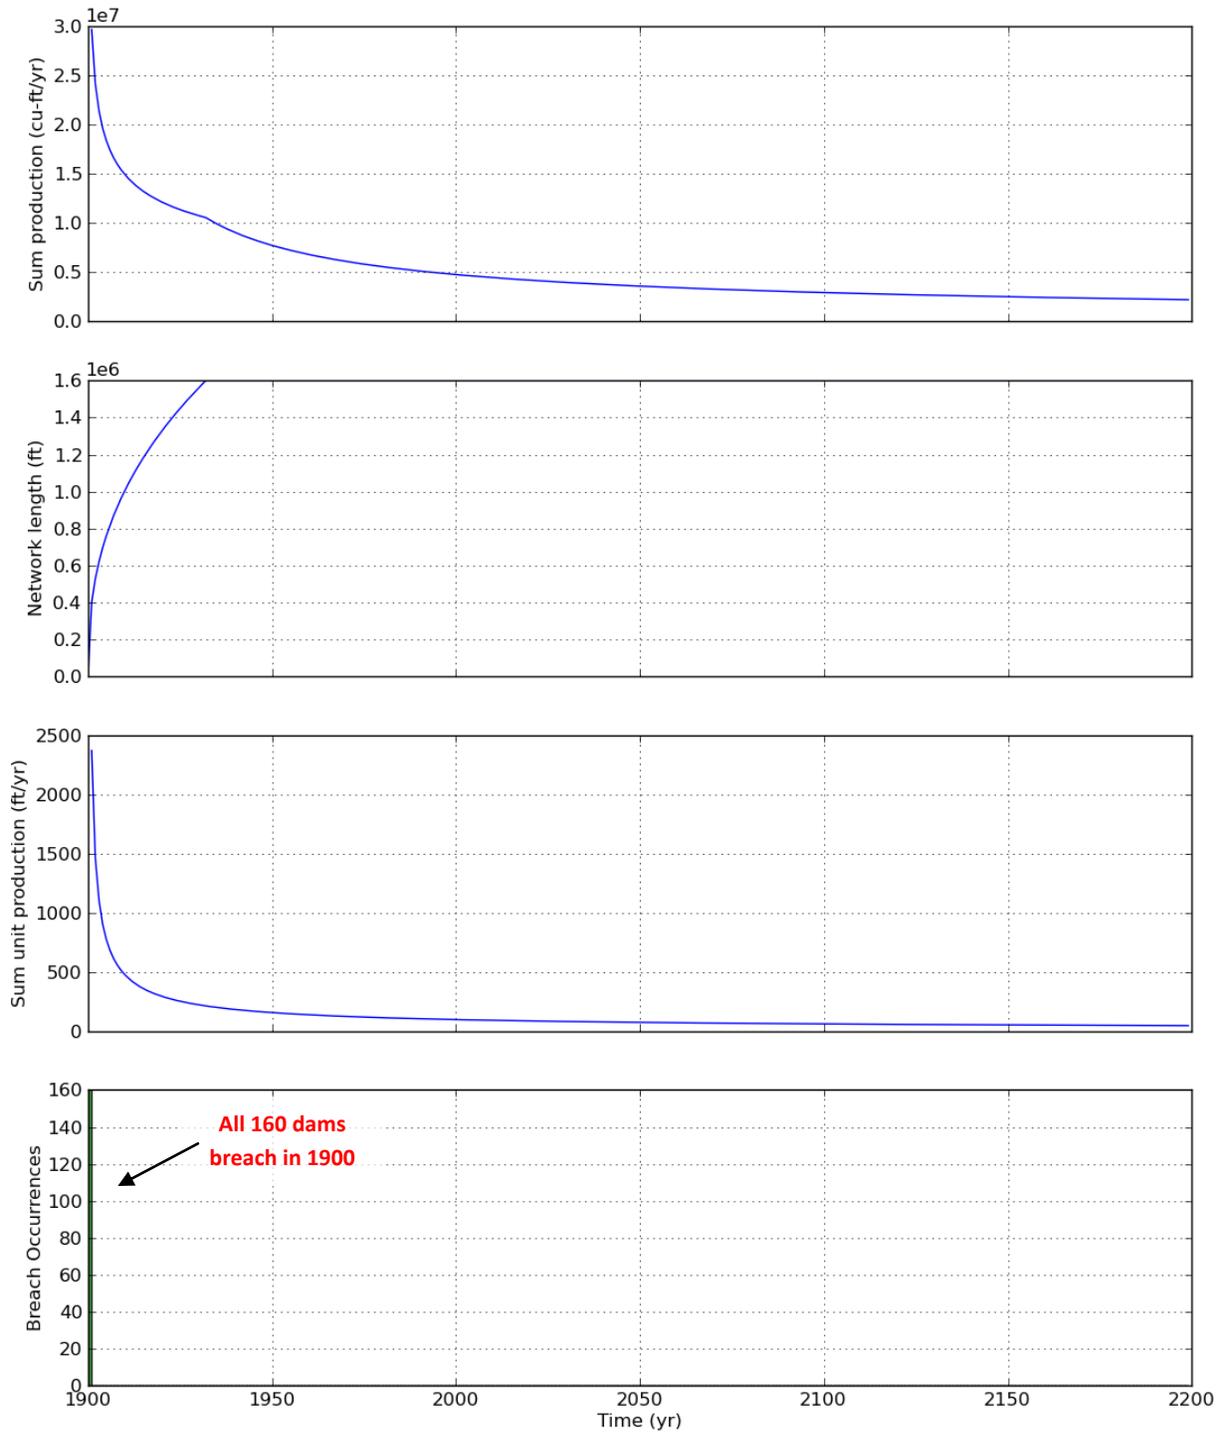
Figure 62. Simulation in which 160 dams breach simultaneously. Sediment production rate at the end of the simulation, in the year 2200, is 2.2 million ft^3/yr from 1.6 million feet of channel length.

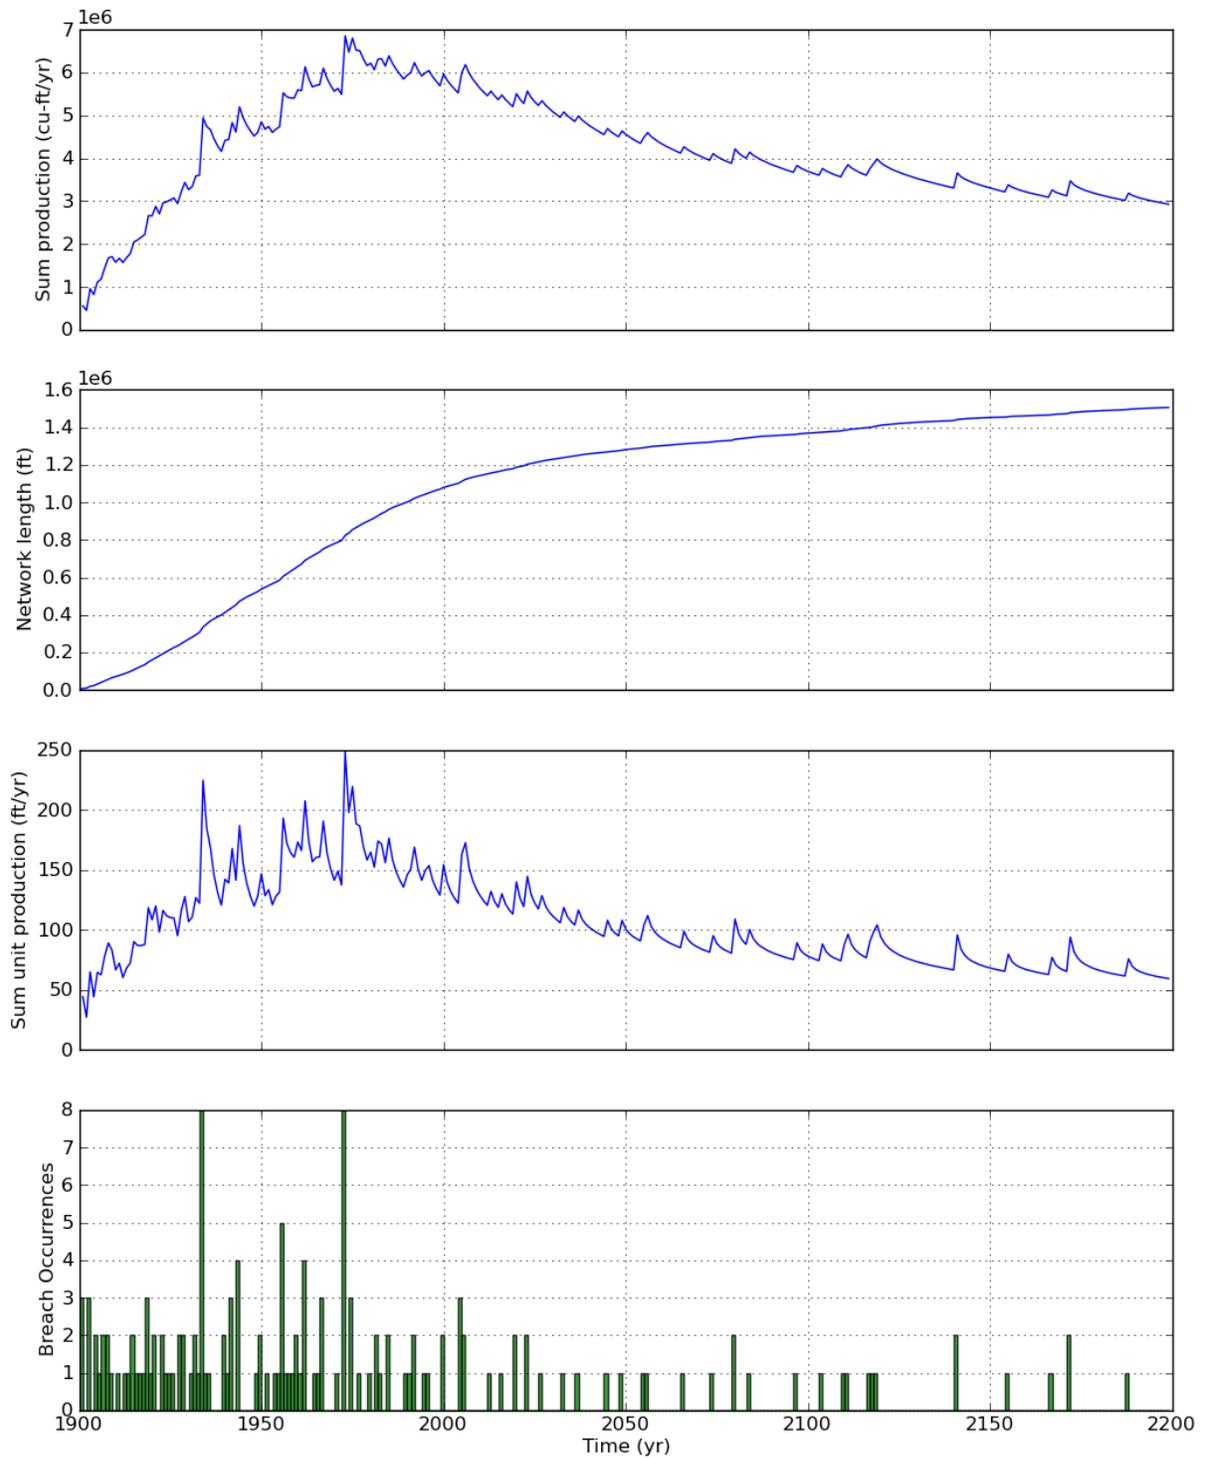
Figure 63. Simulation in which dams within a starting population of 160 dams breach randomly over a 300-year period. Default annual probability of breach is 1%; greater annual probability values are used to simulate effects of major storm events in 1933, 1955, 1972, 2004. At the end of the simulation 151 dams have breached, 9 are not breached, and the sediment production rate is 2.9 million ft³/yr from greater than 1.5 million feet of channel.

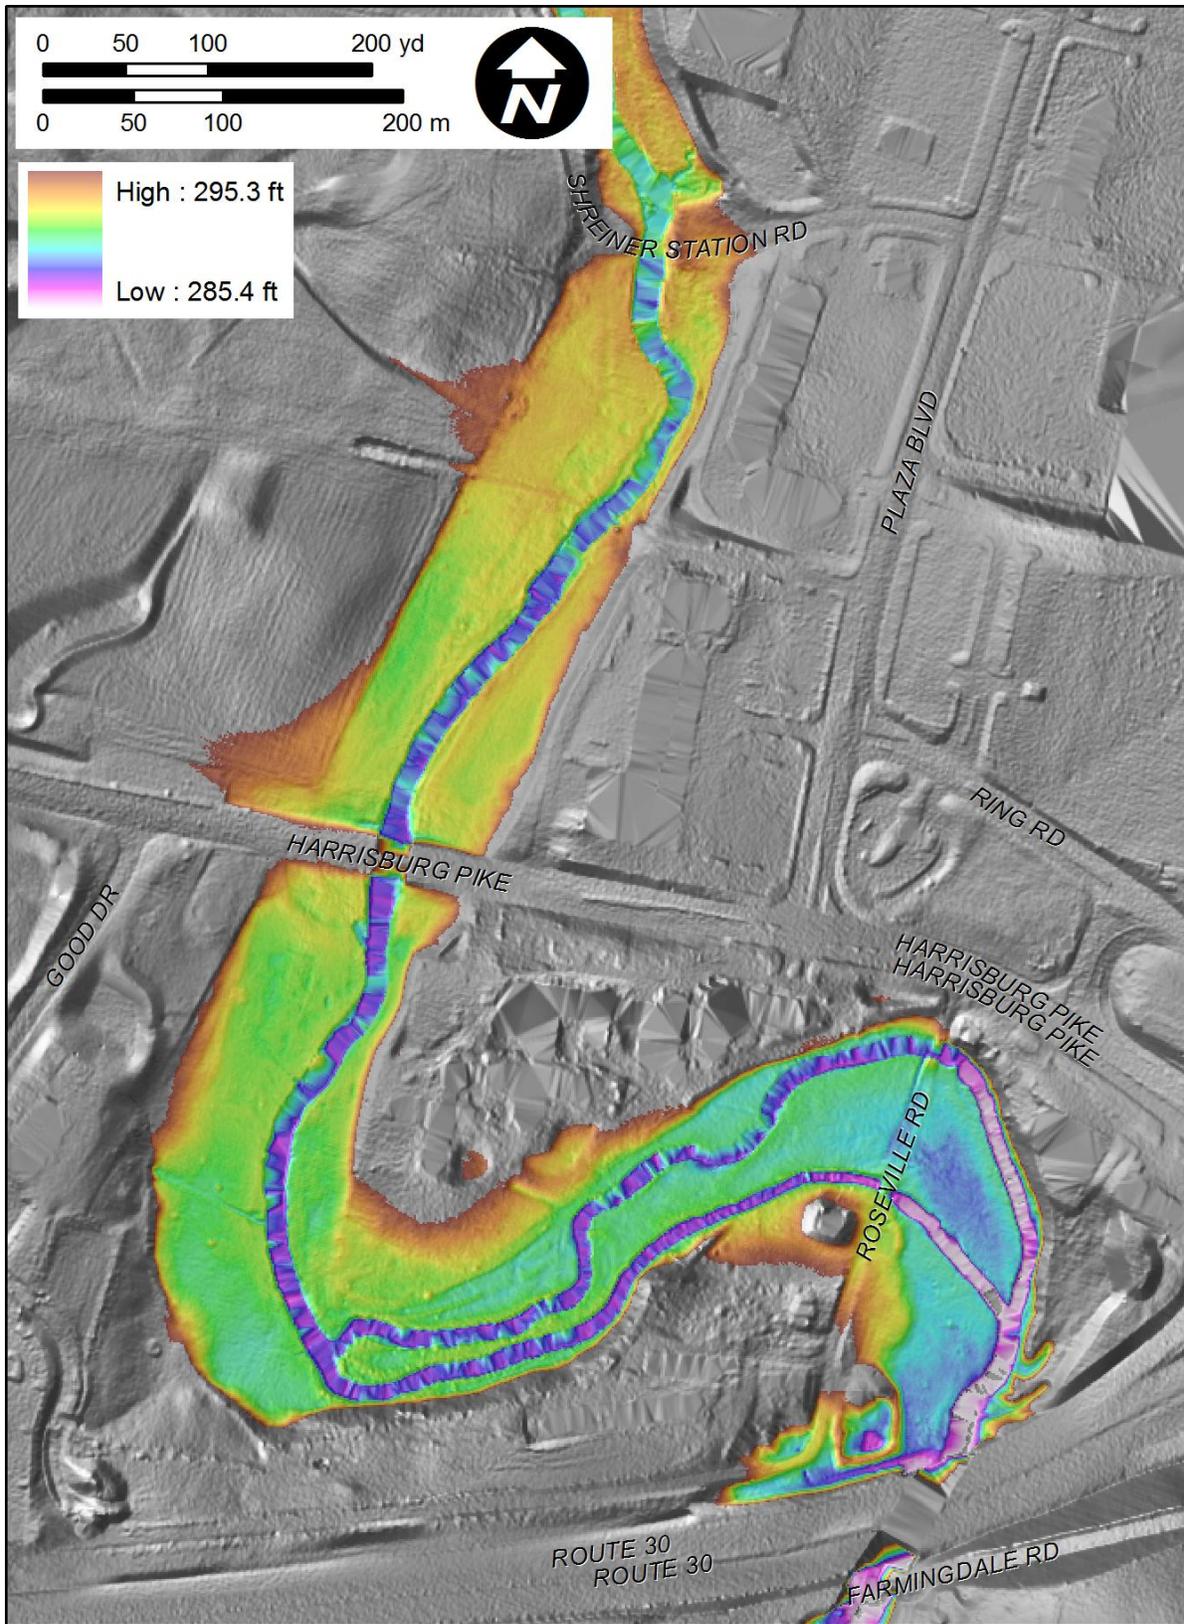
Figure 64. Lidar shaded relief of Little Conestoga Creek near Park City mall (Ring Road) showing variation in bank height and potential areas of erosion and deposition with respect to location of a mill dam and a major road crossing (Harrisburg Pike).
